**COMPARISON OF KINEMATIC ANALYSIS
RESULTS OBTAINED FROM UNMANNED
AERIAL VEHICLE DATA AND SCAN-LINE
DISCONTINUITY MEASUREMENTS IN THE
GNEISS ROCK SLOPES**

by
Melikhan KARAKAŞ

August, 2021
İZMİR

**A Thesis Submitted to the
Graduate School of Natural and Applied Sciences of Dokuz Eylül University
In Partial Fulfillment of the Requirements for the Degree of Master of Science
in Geological Engineering, Applied Geology Program**

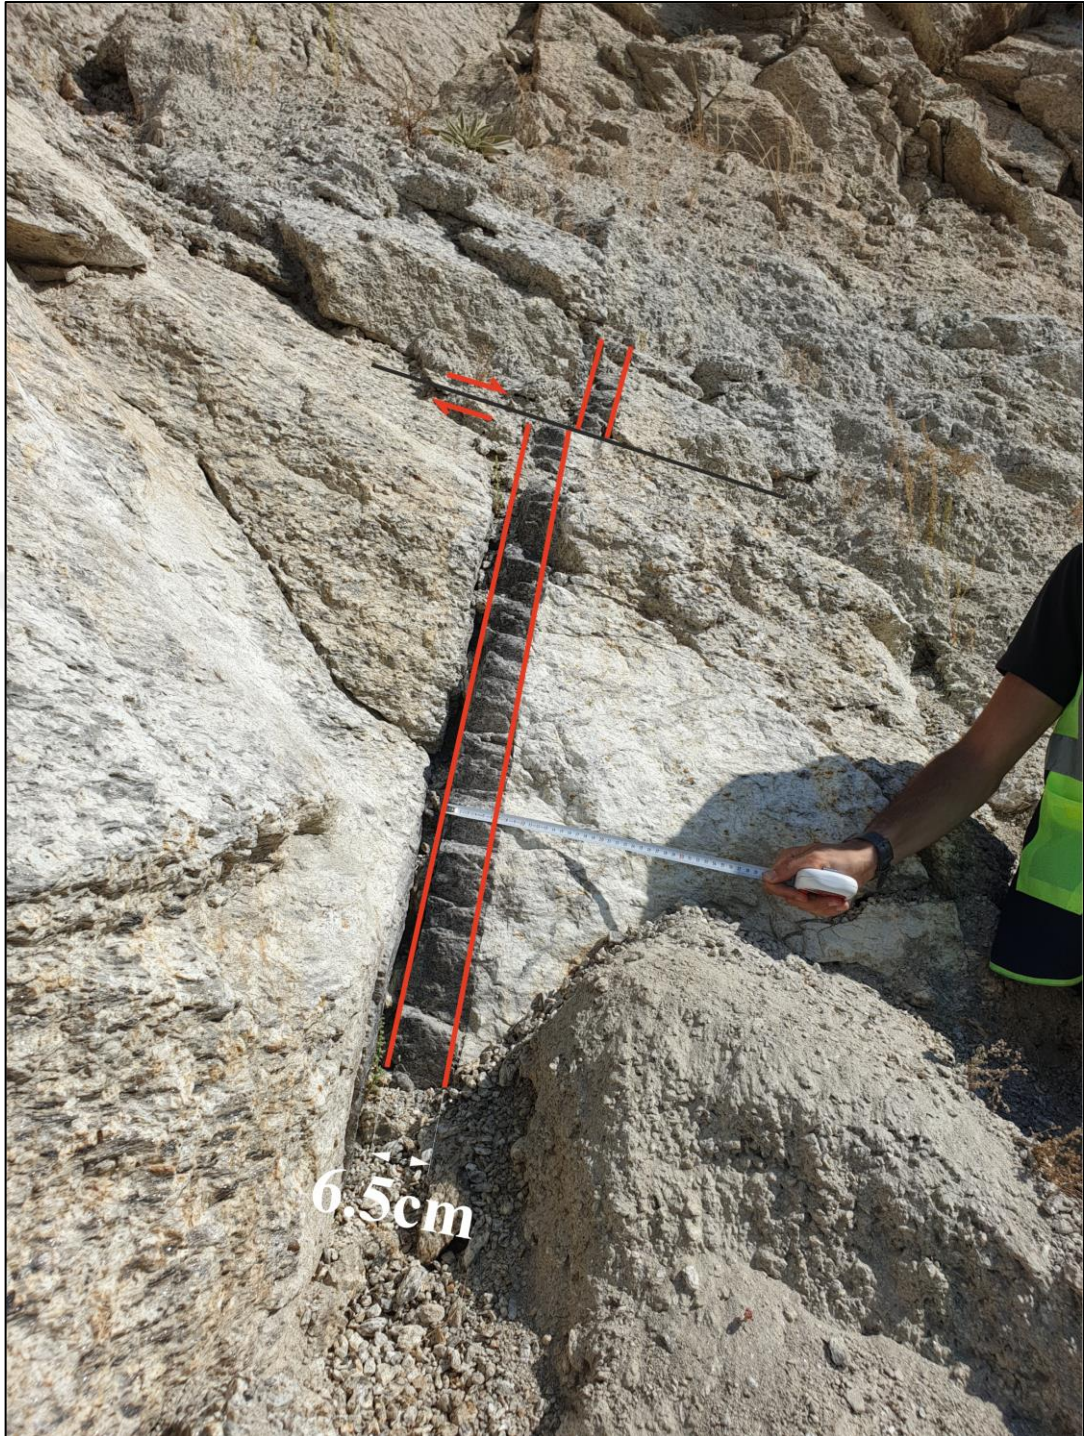
Figure 3.2 Displacement of the 70/040 oriented quartz vein at the observation point 52 in the study area (Personal archive, 2021)

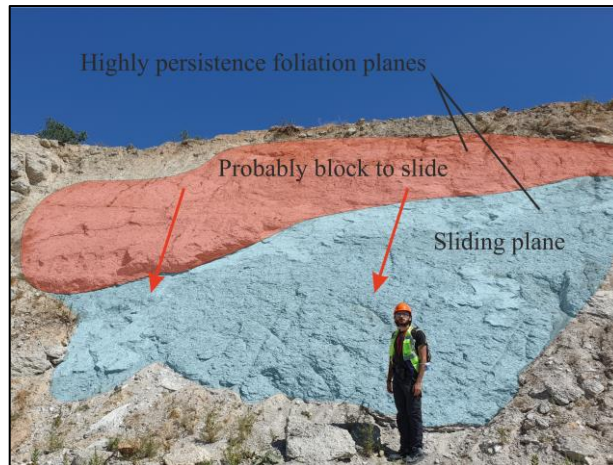
mechanism and cause slope sliding in the quarry (Figure 3.5). Determination of planar slidings caused by foliation planes by kinematic analysis technique is presented in detail in Chapter 5. The average orientation of the foliation planes measured in this thesis was determined as 26/179, and the rose diagram and angular distribution of these 129 foliation planes are given in Figure 3.6.

Figure 3.5 Foliation planes forming a planar sliding mechanism and causing sliding (Personal archive, 2021)

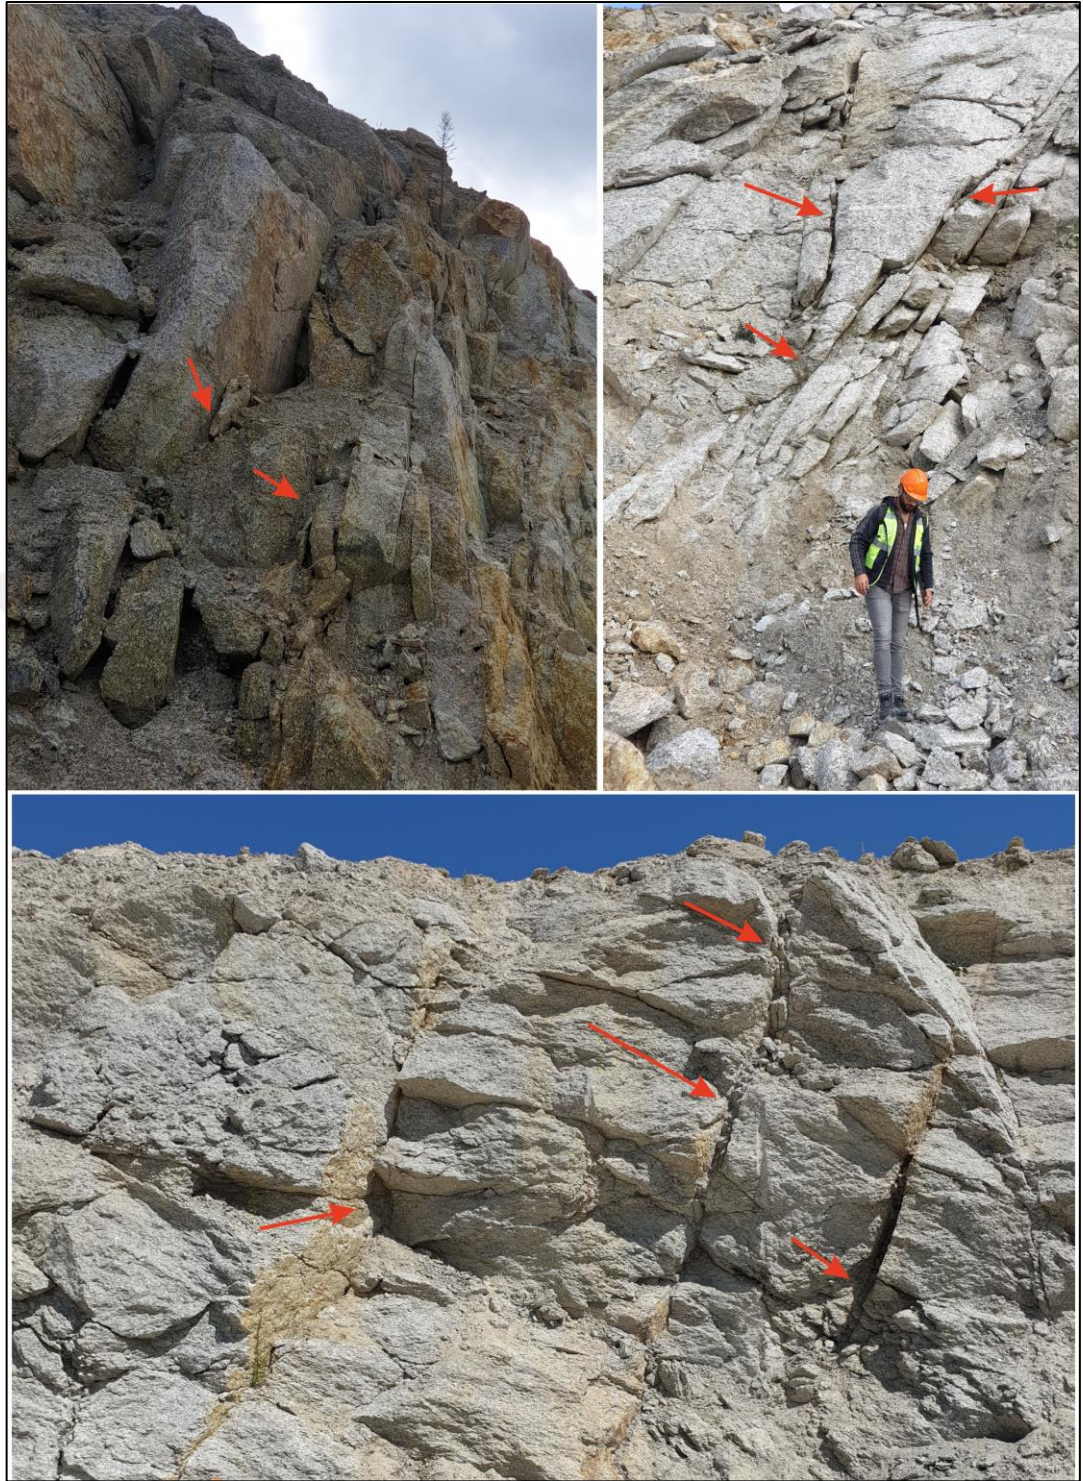
In the examinations made at some observation points in the open pit, it was observed that there was a small amount of filling between the discontinuity walls (Figure 4.4). The thickness of this filling material varies between 0.5 cm and 5 cm. In addition, gneiss weathering product and quartz in some places were observed as filling material in the slopes near the weathering zones. The openings of the discontinuities in the slopes studied in the study area differ from region to region (Figure 4.5). Since the amount of clearance between the discontinuity walls will affect the deformability of the rock, it is also an important parameter in terms of stability. The first factor that has a direct impact on openness; It is the opening between the vibration and energy created by the controlled blasting (presplitting) made due to production in the quarry and the discontinuity walls with less opening. In regions where blasting is not performed, this clearance is relatively less than in other regions and varies between 0.2 cm and 1 cm. Another factor affecting the opening in the study area is that the force acting on the discontinuity walls is eliminated due to the removal of the load, and the planes of weakness such as cracks and fractures pass to the release mechanism, leading to an increase in this opening.

Figure 4.4 Weathering product filling material observed between discontinuity walls on slopes near weathering zones (Personal archive, 2021)

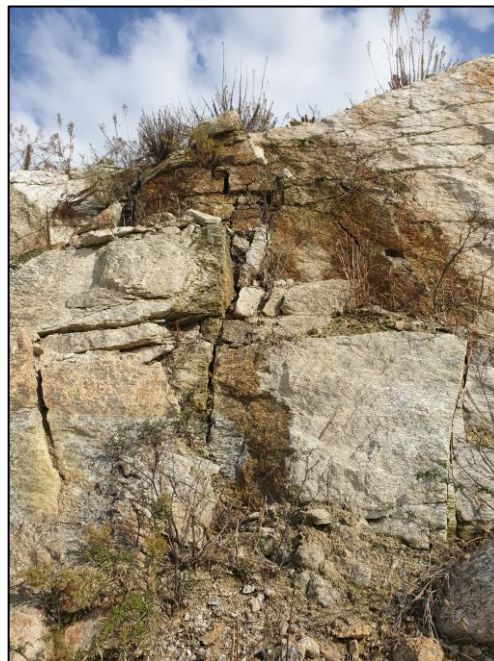
Figure 4.8 Seepage point seen on the slope at the observation location 116 at 470 m elevation (Personal archive, 2021)

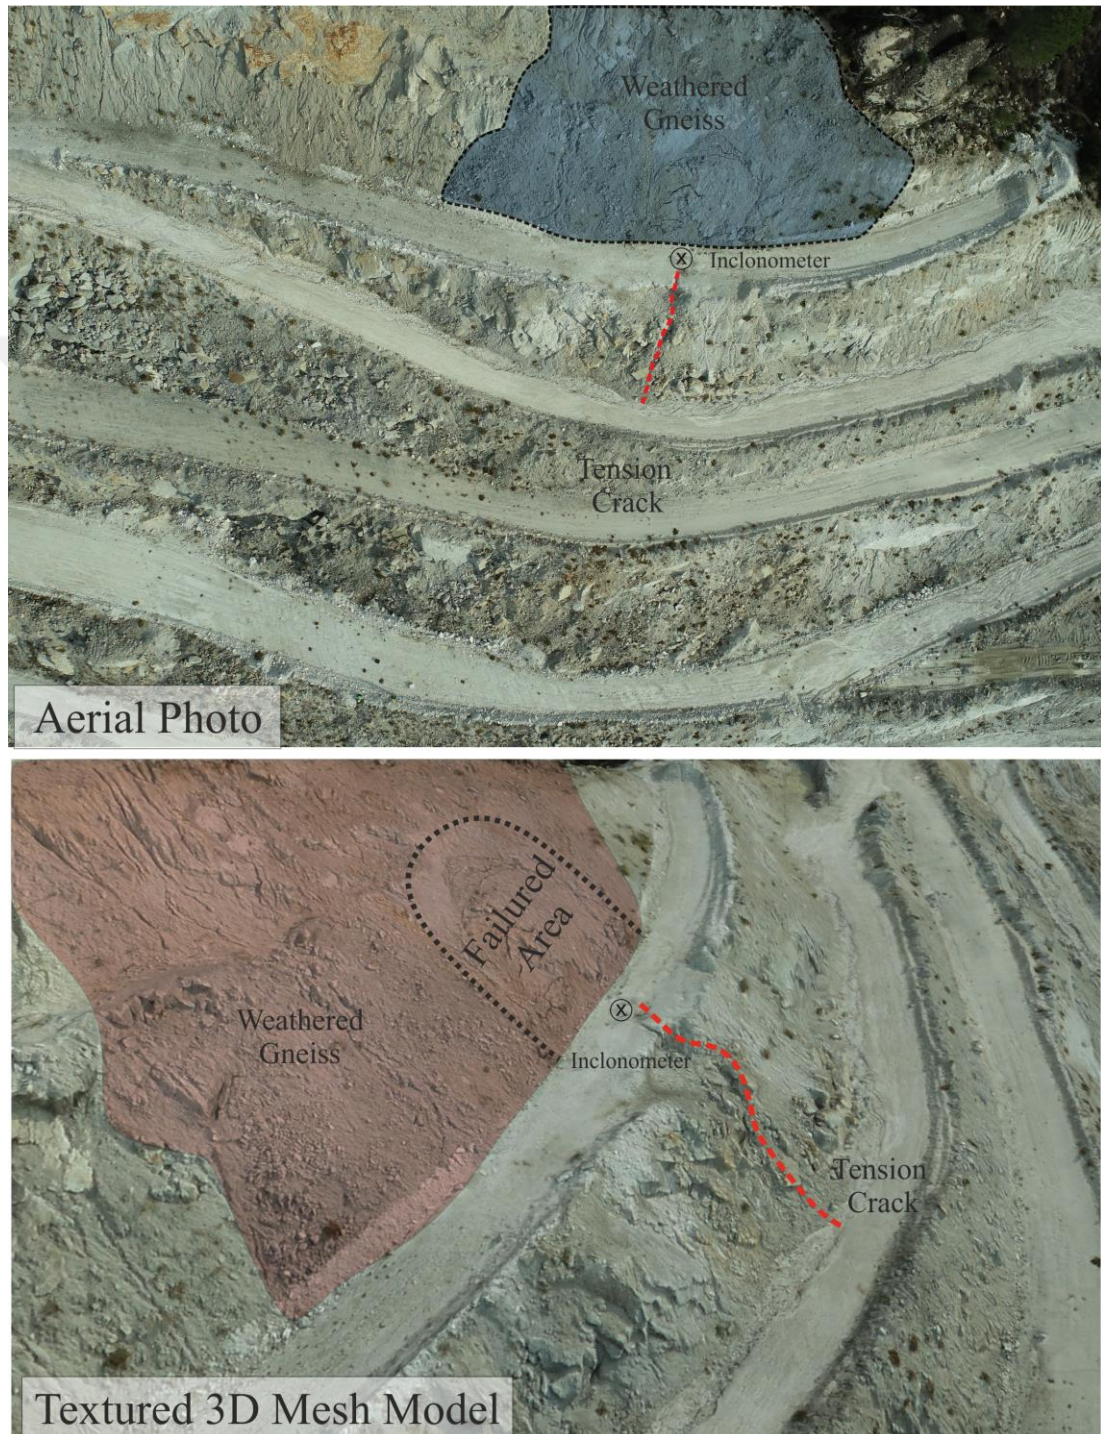
In this study, the readings (measurements) obtained from the inclinometer well and the drillings made from this point were examined and evaluated. The inclinometer well is located at 540 elevation and at the stage where the stress crack is located (Figure 4.16).

Figure 4.16 Stress crack and failed zone located in front of the inclinometer well

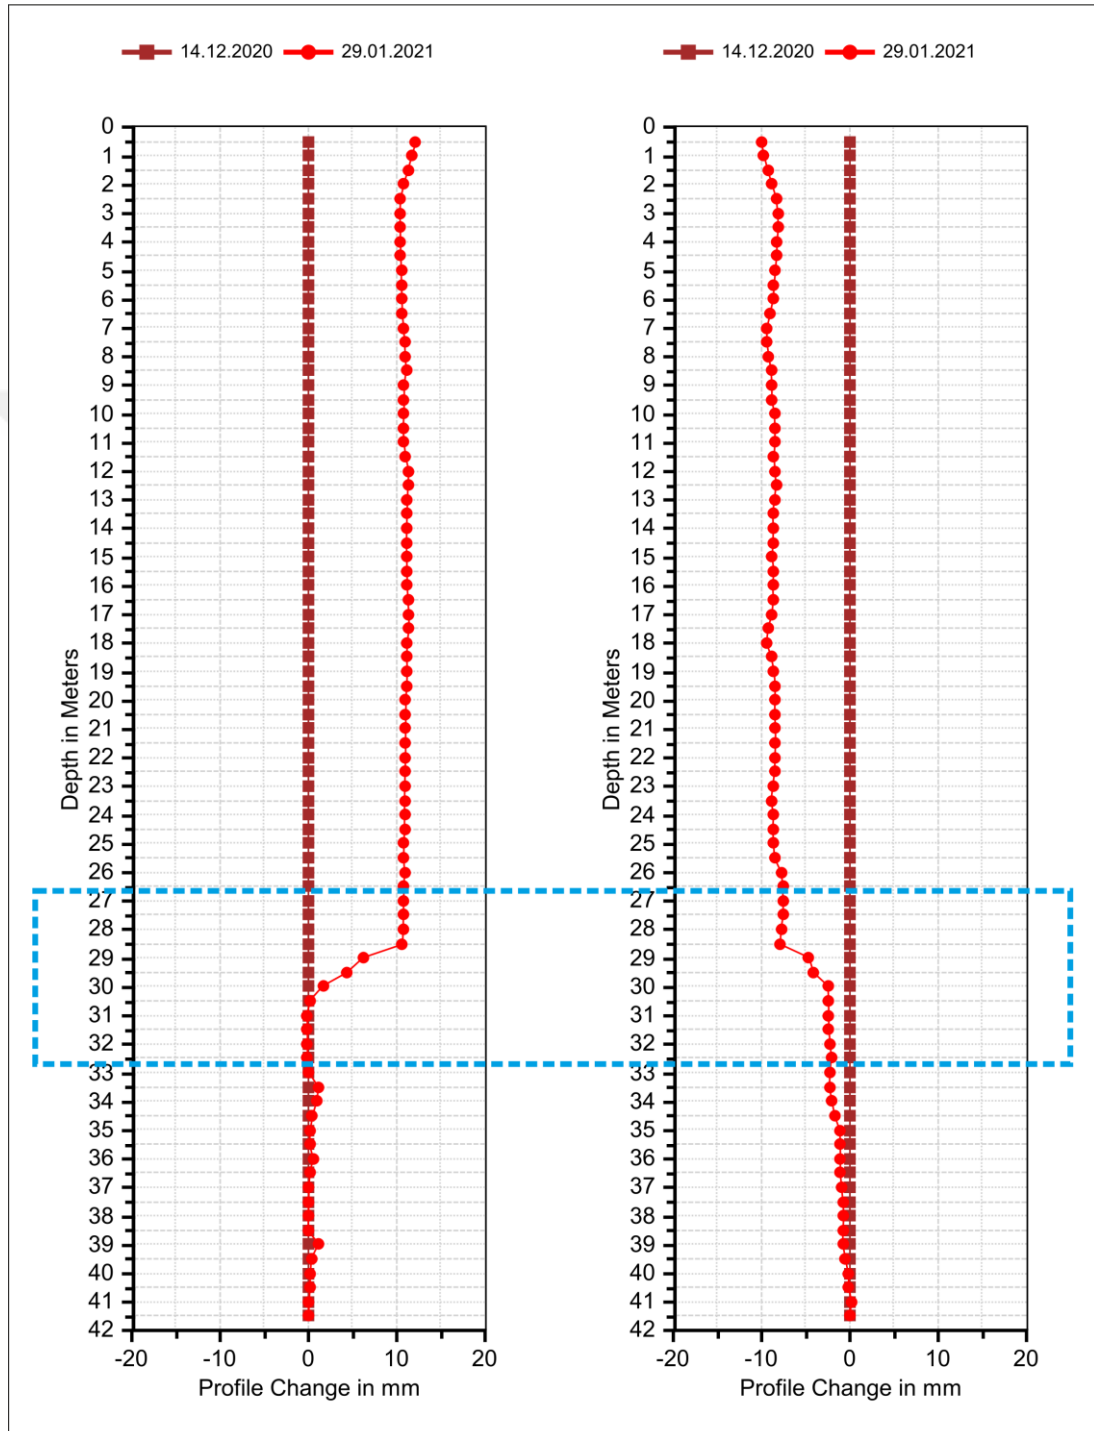
When the inclinometer records were examined, it was observed that between 14.12.2020 and 29.01.2021, there was a 10mm displacement between 28.5 and 30 meters (Figure 4.17).

Figure 4.17 Anomaly observed between 14.12.2020 and 29.01.2021 between approximately 28 and 31 meters

The reason for this change observed between 28-30 meters is thought to be a failure along the sliding circle. This anomaly, which is thought to be a sliding circle, could not show its effect very clearly on the surface. So; It can be considered as a continuous sliding failure in the lower stages (stages below 540 elevation), heel swelling due to the sliding circle, and/or failure to follow the traces of stress cracks in stages above 540 elevation.

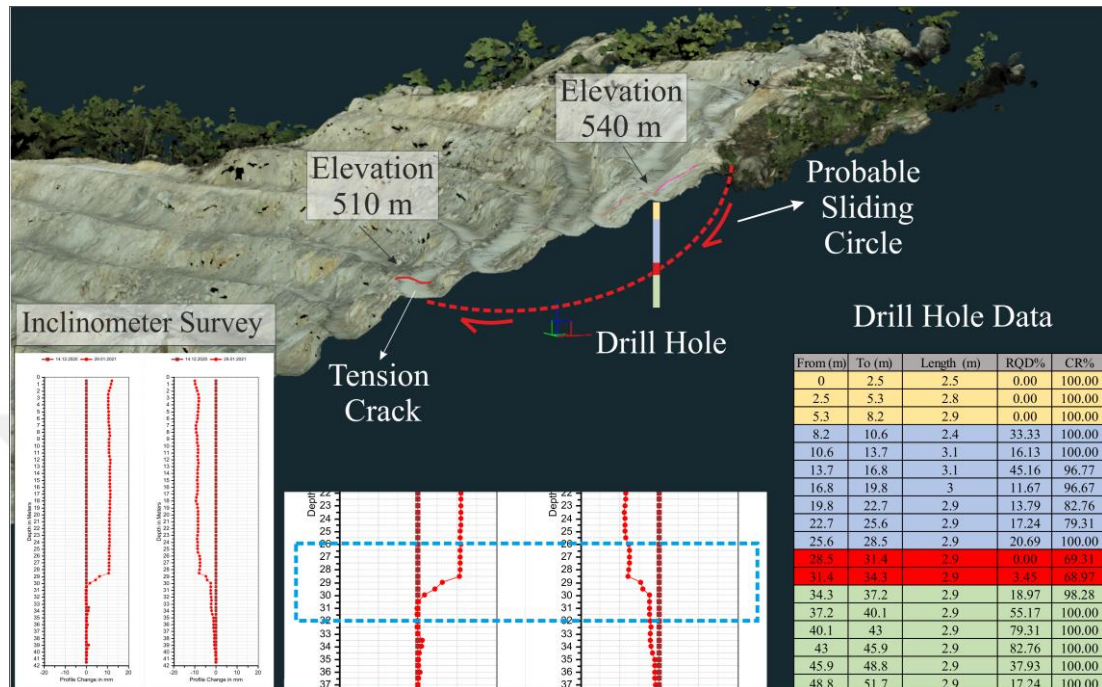
negative effects of vibration waves developed due to blasting did not have a negative effect on the development of this sliding circle. It is interpreted that this possible sliding circle may develop between these two stress cracks as shown in Figure 4.18.

Figure 4.18 The probable sliding circle drawn between the stress cracks observed between the 540th and 512th elevation, based on the drilling and inclinometer data

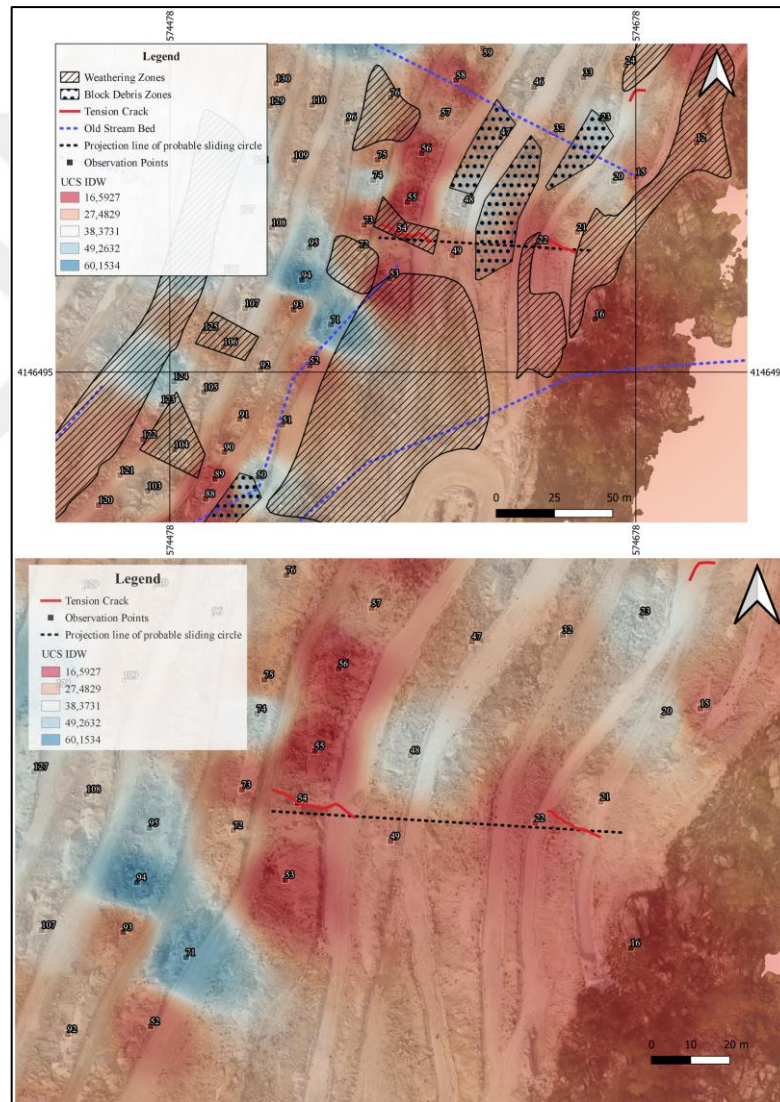
If we examine this sliding circle with other parameters; It has been observed that it is under many environmental and geomechanical effects. As seen in the thematic map created with the UCS values presented in Figures 4.13 and 4.14, the possible sliding circle drawn shows a projection in the region where the UCS values are low, including the observation points 21, 22 48, 49, 53, 54 and 55 (Figure 4.19). The low results in the Schmidt hammer tests performed at these observation points indicate that circular slippage may occur along the relevant line in this region. At the same time, as seen in the weathering zones map (Figure 5.1) shown under the main title of “Weather and Alteration”, which will be presented in the next section, the projection of the probable sliding circle passes through the zone containing the weathering and debris material zone. In this zone, which contains weathered and debris materials, the material (geomechanical and geotechnical) properties of the rock mass have low values (weak), and there are slopes made of material that lost its rock feature and turned into soil in some regions (Example; Figure 5.2). The physical weathering of the rock mass under

various influences is explained in detail in the next section. However, the old stream beds, which are also included in the maps in Figures 2.2, 5.1 and 6.7, constitute the main element that supports this physical weathering mechanism. When the old stream beds continued their activities, the waters coming along the stream bed softened the geological units (metamorphic units) (changed the material properties by reducing their strength) and played a role in reducing the strength parameters. Accordingly, the cohesion value (c) decreased along the stress (tension) cracks, leading to circular shear failure.

Figure 4.19 The relationship of the possible sliding circle with the UCS values and other parameters; (A) The projection line of the probable sliding circle is located near weathering zone, block debris zone and the impact area of old stream beds (B) Plain view of the relationship of the projection with the UCS values and stress cracks

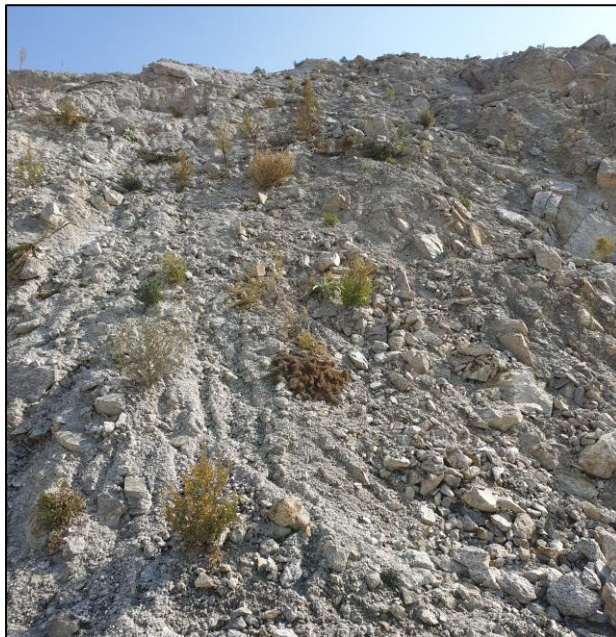
Figure 5.2 The weathering and loss of rock feature observed on the slope at the 111th Observation Point (Personal archive, 2021)

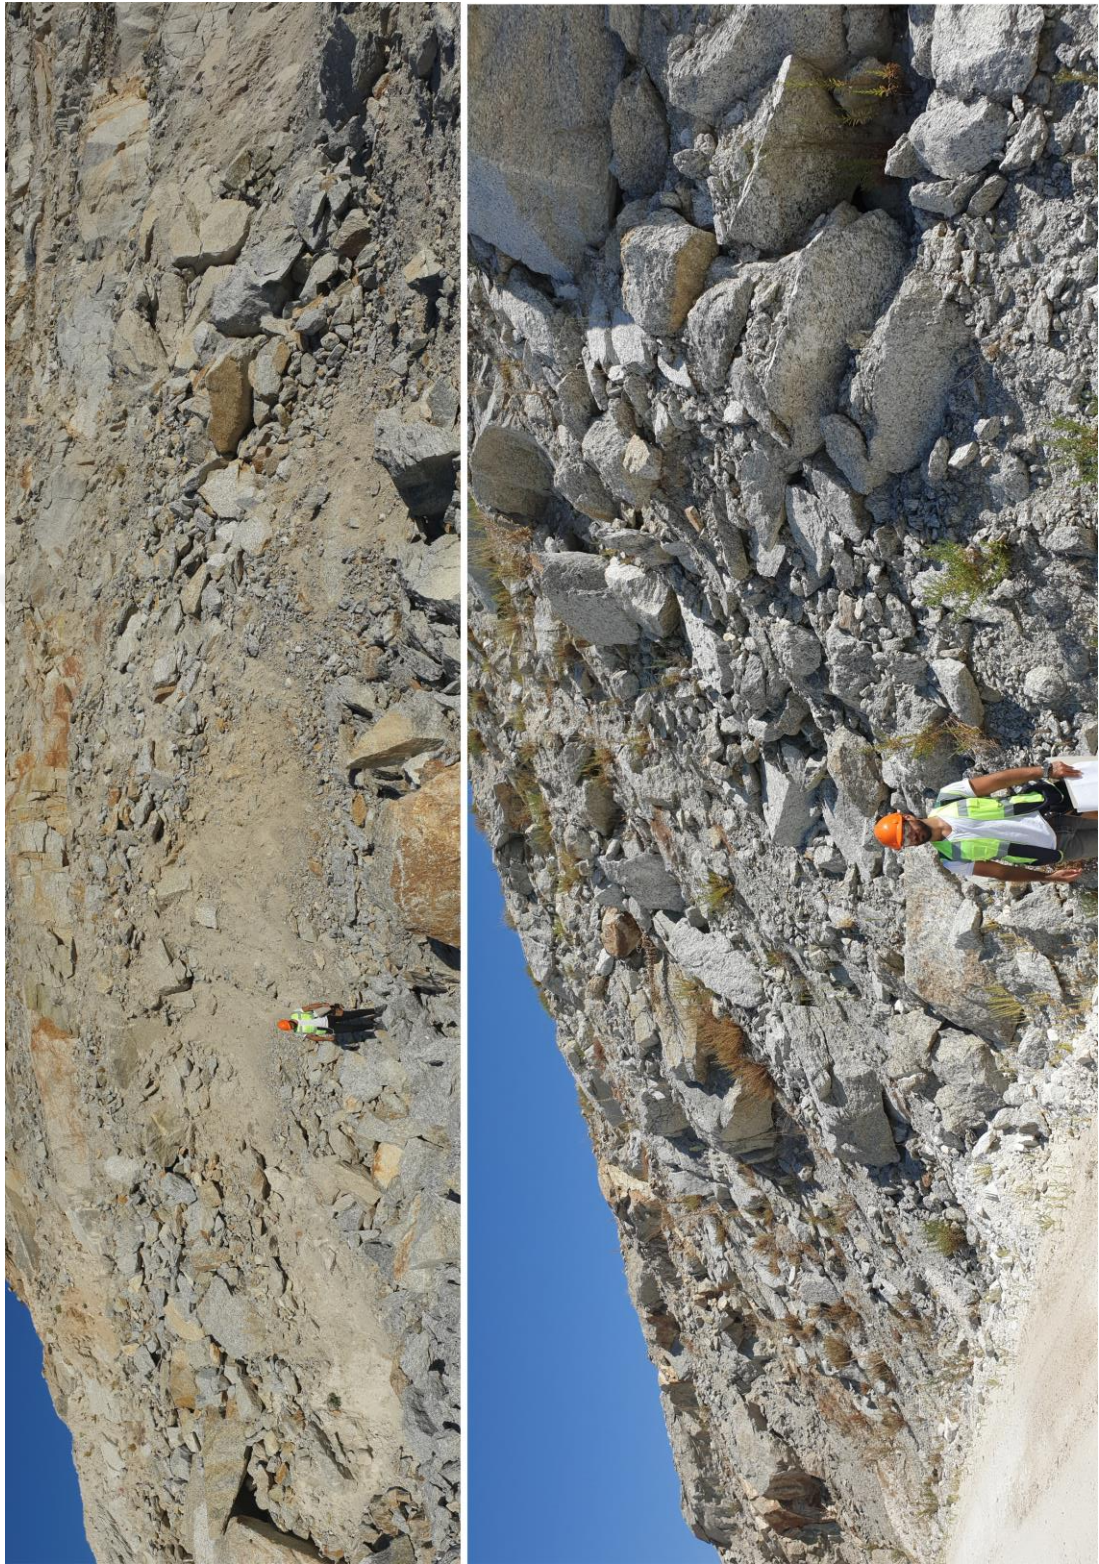
Weathering can be defined as changes in the surface or interior of rocks by exposure to physical or chemical effects. There are serious changes in the strength of the rock mass, which has been weathered under the influence of various environmental factors, and this change may result in instability problems. These environmental factors; are various parameters such as wind, water condition, load lift. In this open pit, the strength of the rock mass decreased due to these environmental factors, causing stability problems. As shown in Figure 2.2, the fact that the enterprise is located in many stream bed regions and that it receives excessive precipitation in winter due to the climate effect has reduced the strength of these rocks and adversely affected them. Likewise, due to the excavations made due to production and the corrections made in the stages during the slope design stage, as a result of the pressure release, the rocks underwent physical weathering and decreased in their mechanical properties and lost their rock properties (Figure 5.2). Due to these environmental effects, the dominant weathering status in the quarry was determined as MW and MW-HW. The impact areas of these observed weathering states were determined and the map in Figure 18 is shown. Due to the decreasing rock strength due to weathering, block debris and slidings of different sizes can be seen clearly in the quarry (Figure 5.3).

Figure 5.3 Block debris due to weathering seen at observation points 47 and 101(Personal archive, 2021)

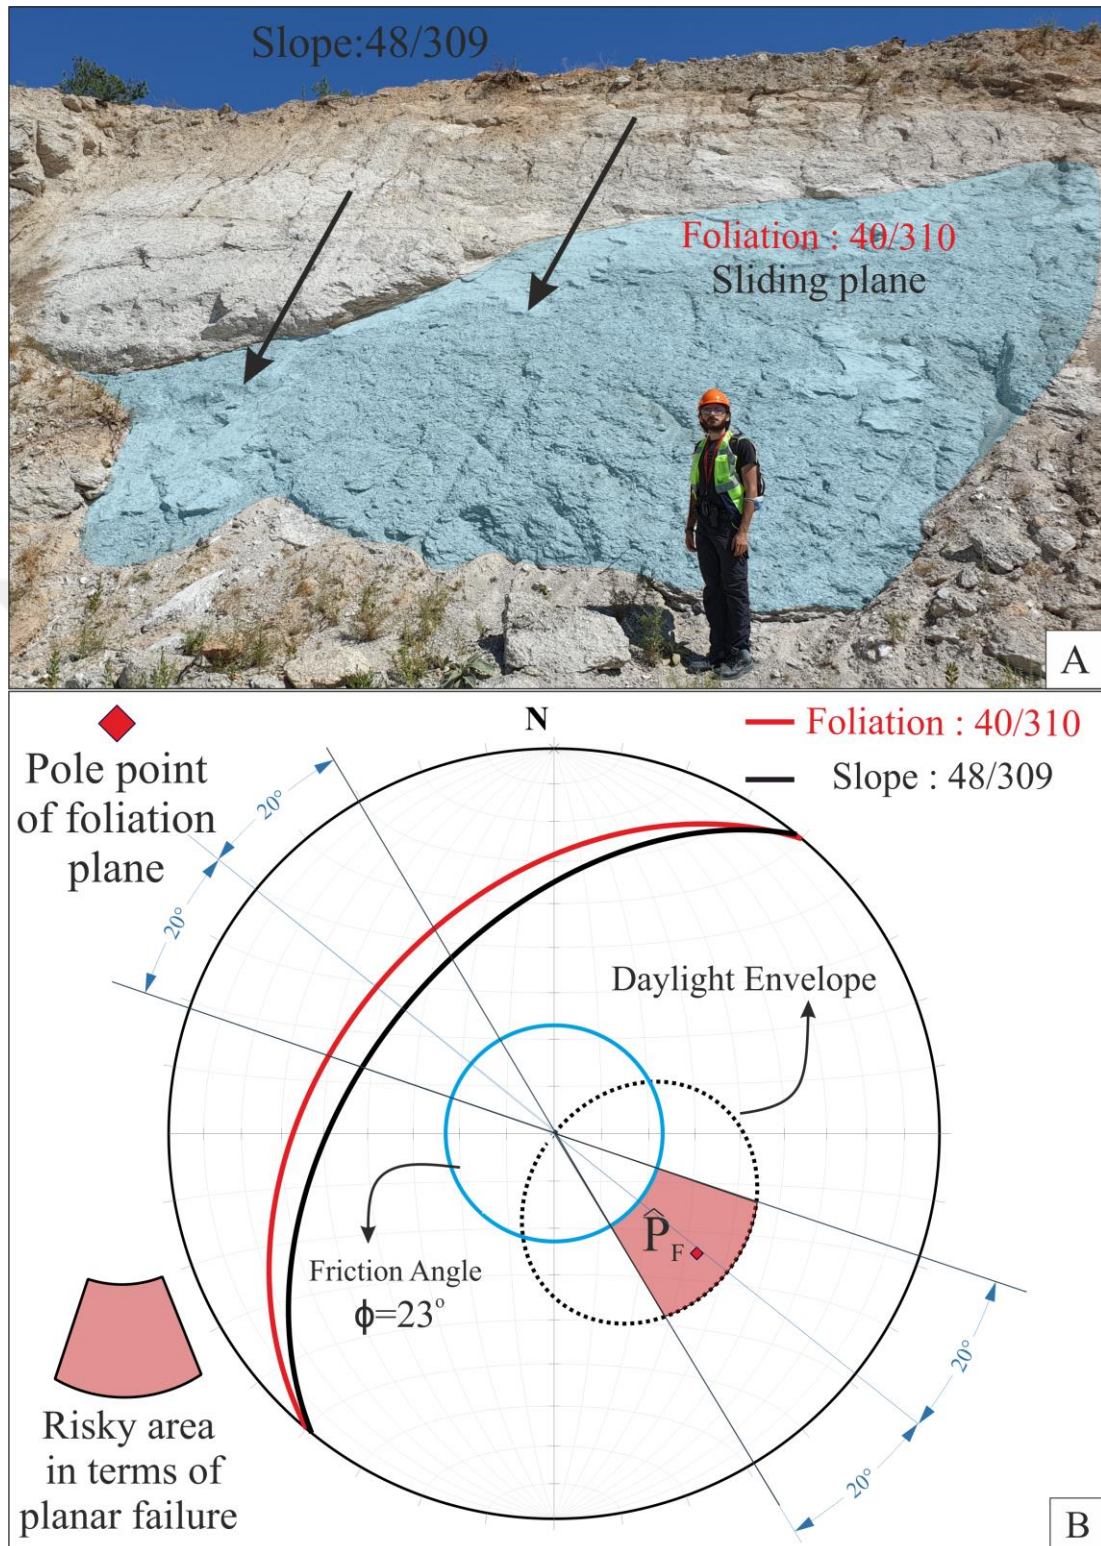
Figure 6.3 Planar sliding failure caused by foliation planes; (A) Field view, (B) Kinematic analysis (Lower hemisphere)

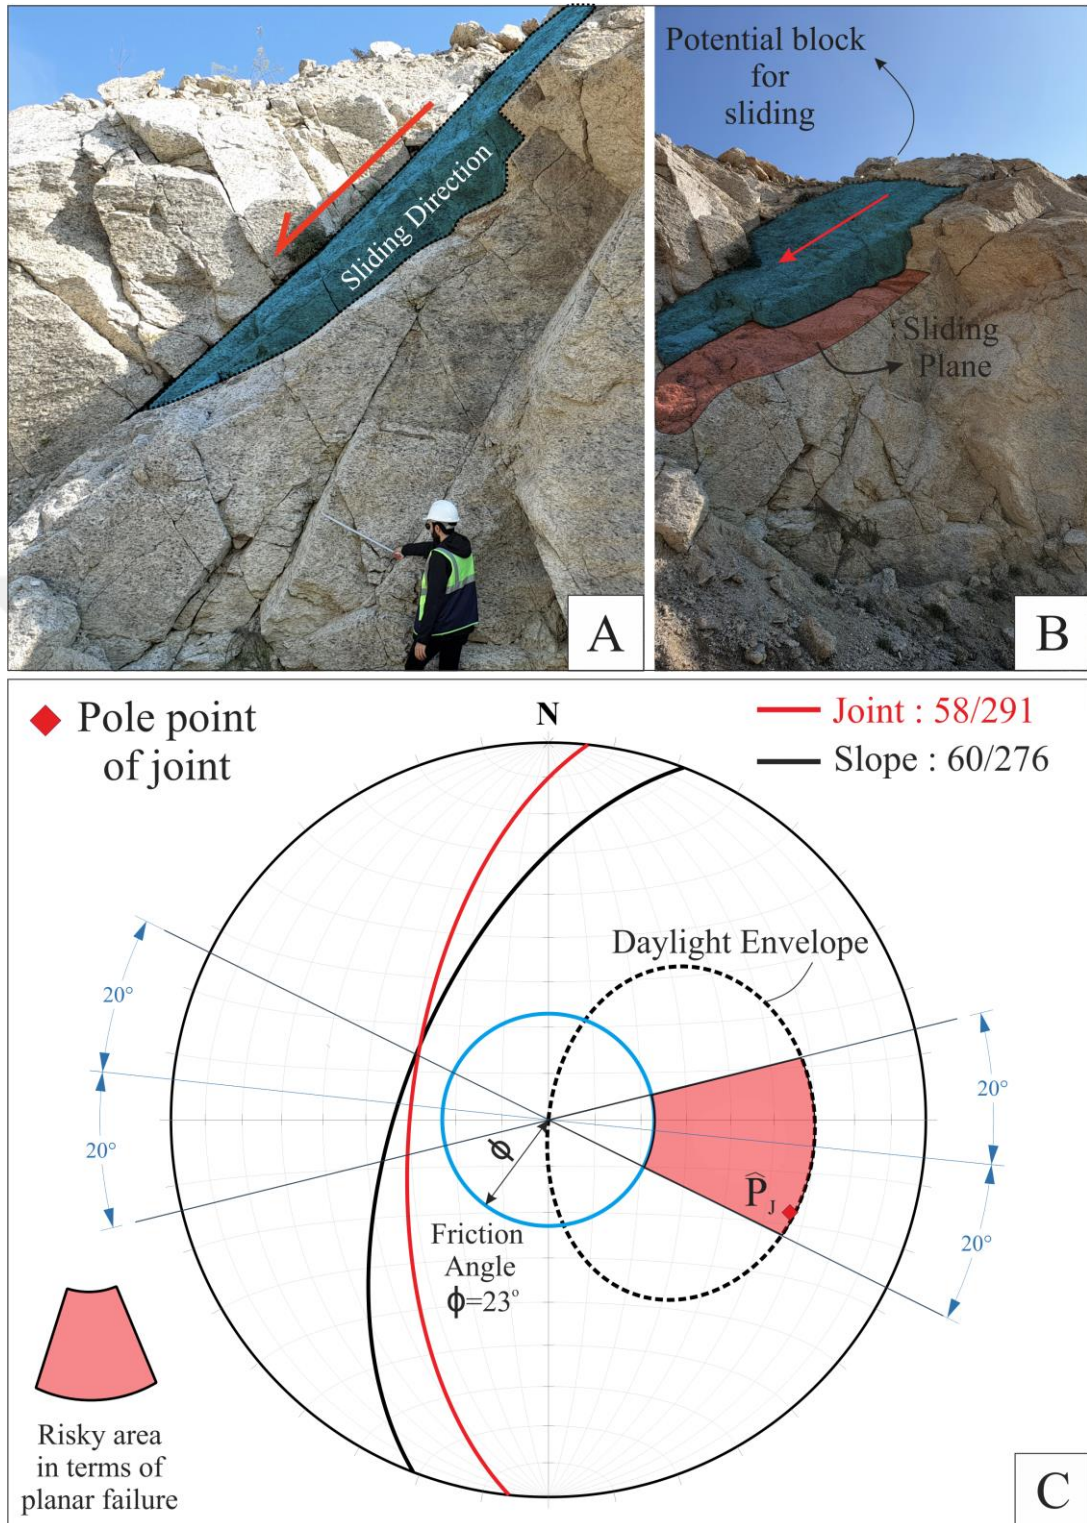
Figure 6.5 Planar sliding failure caused by joints; (A) The view of the sliding in the field and the direction of the sliding, (B) The block and sliding plane that is likely to sliding, (C) Kinematic analysis of the planar failure

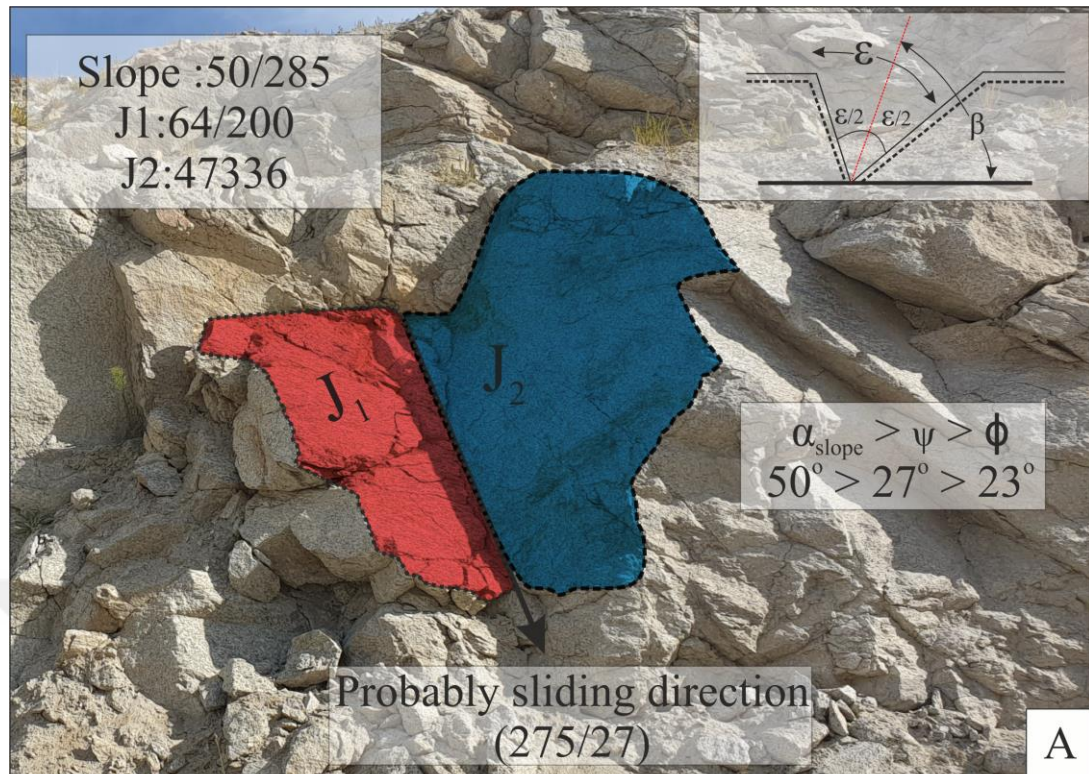
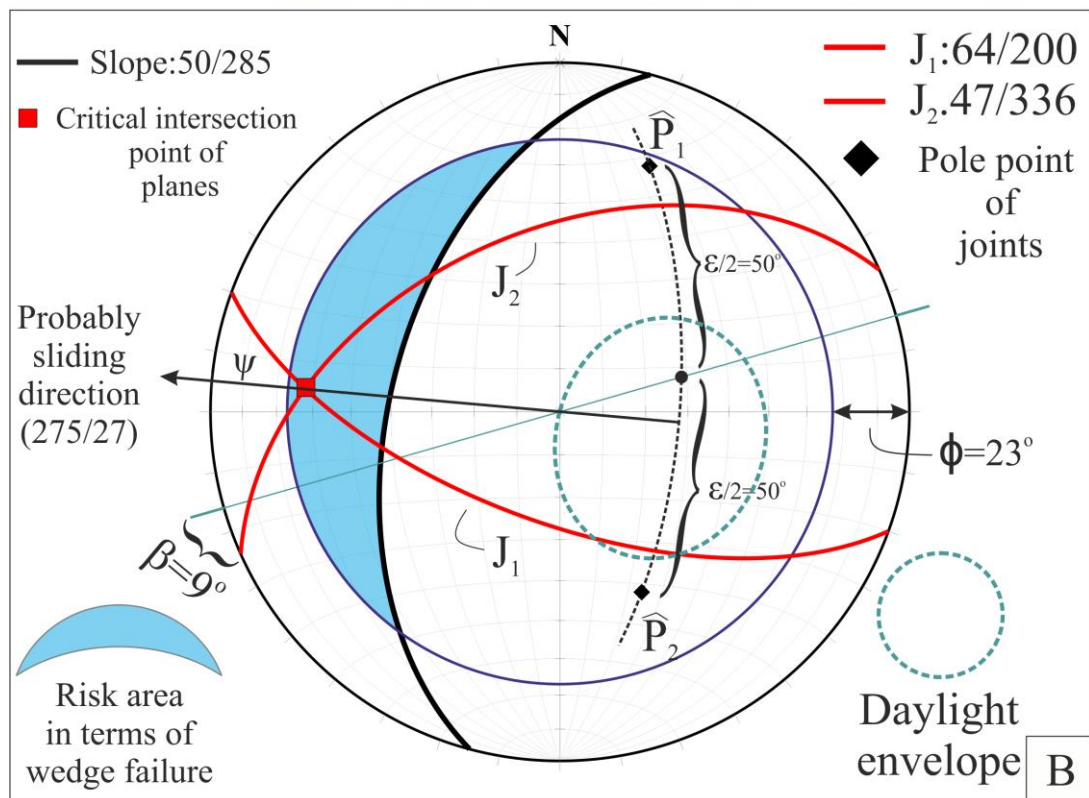
Figure 6.8 Wedge type sliding failure, (A) View of planes forming the wedge in the field, (B) Kinematic analysis of wedge type sliding failure

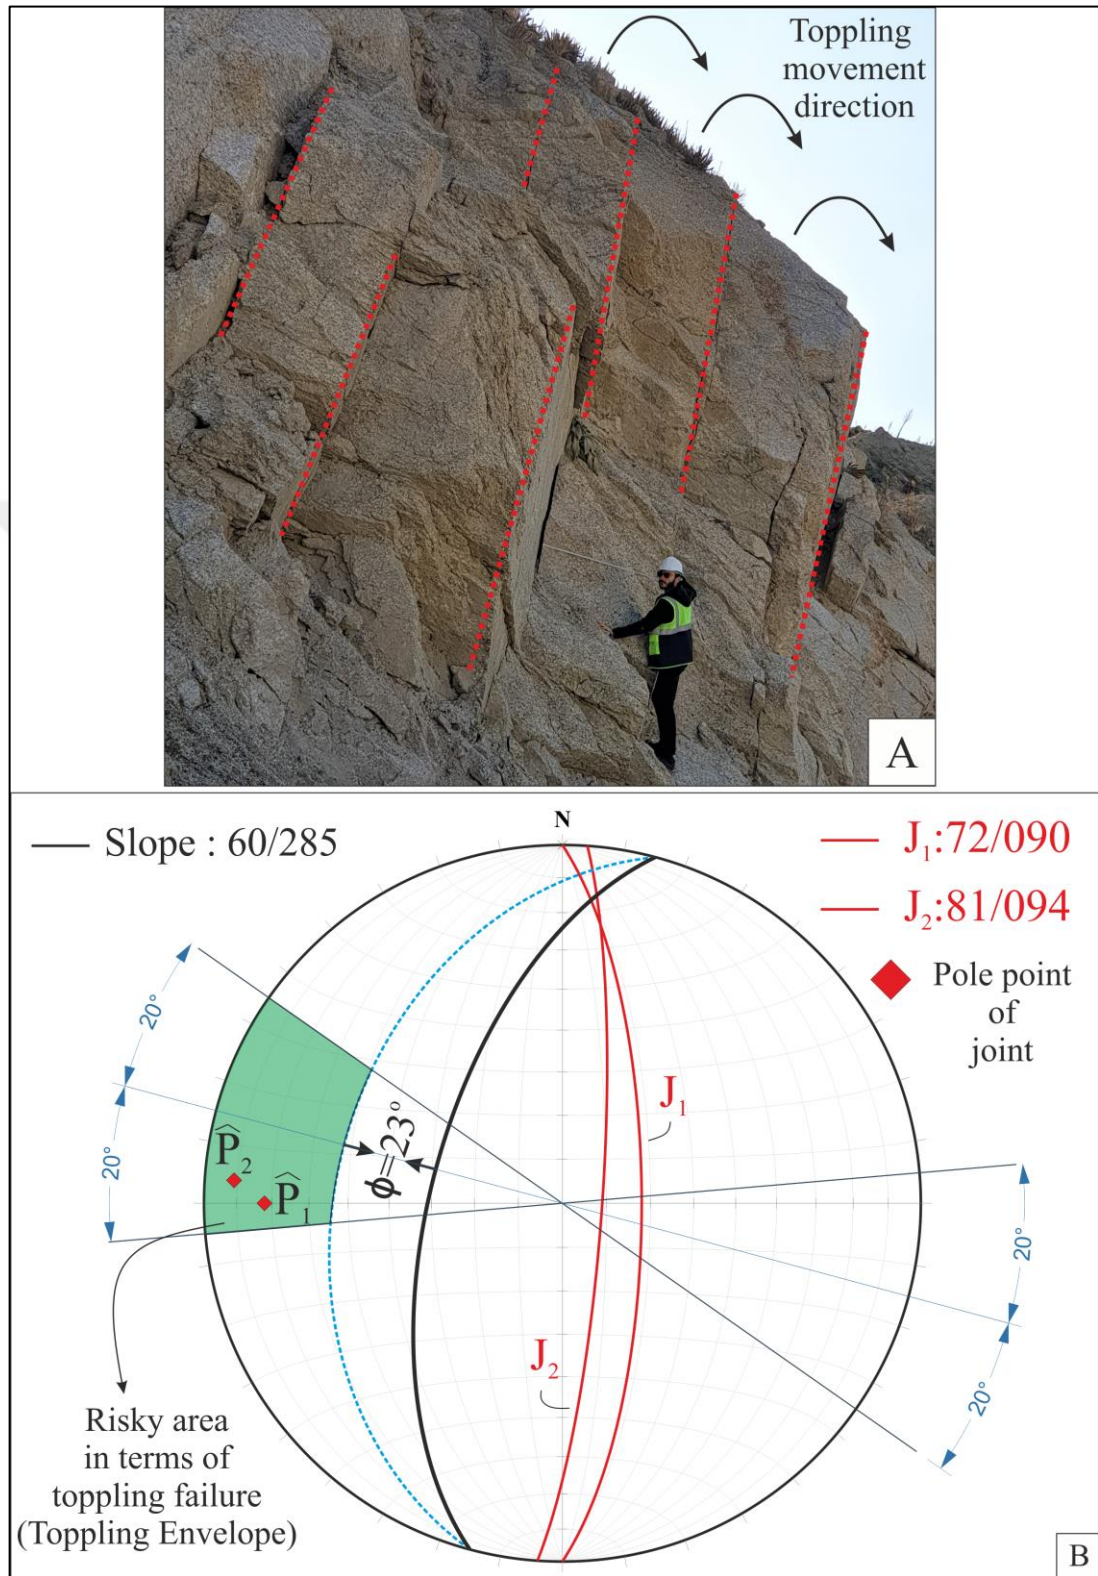
Figure 6.12 Flexural toppling failure; (A) High angle discontinuities and possible toppling blocks in the field view, (B) Kinematic analysis of flexural toppling failure

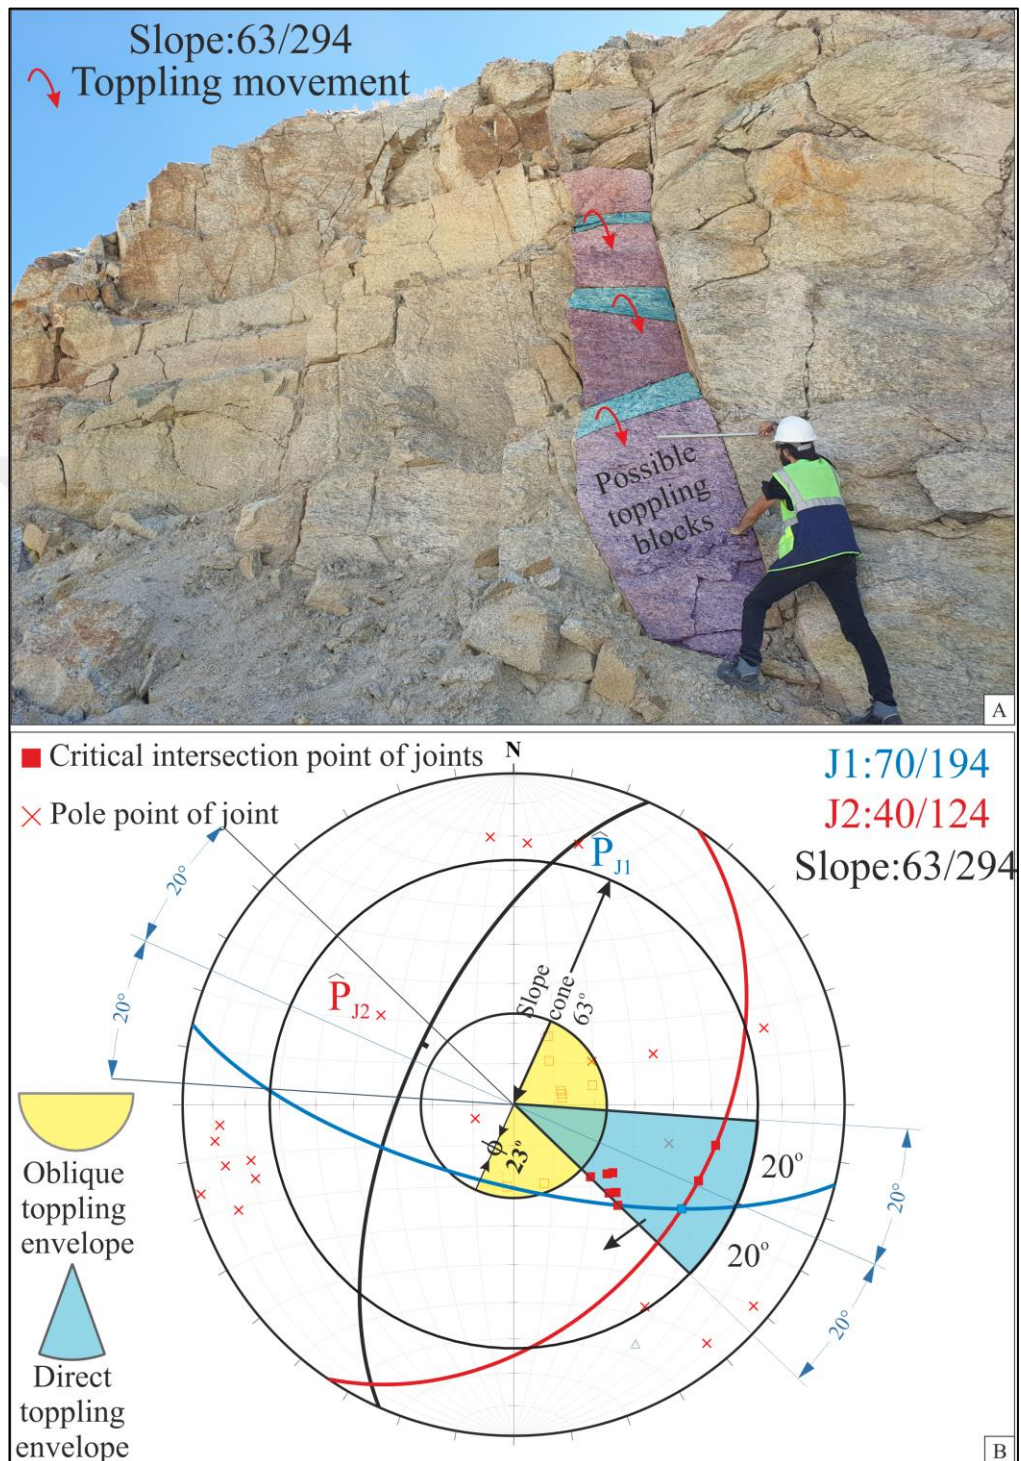
Figure 6.14 Direct toppling type failure; (A) Blocks formed by sets of joints perpendicular to each other, (B) Kinematic analysis of direct (block) toppling type failure

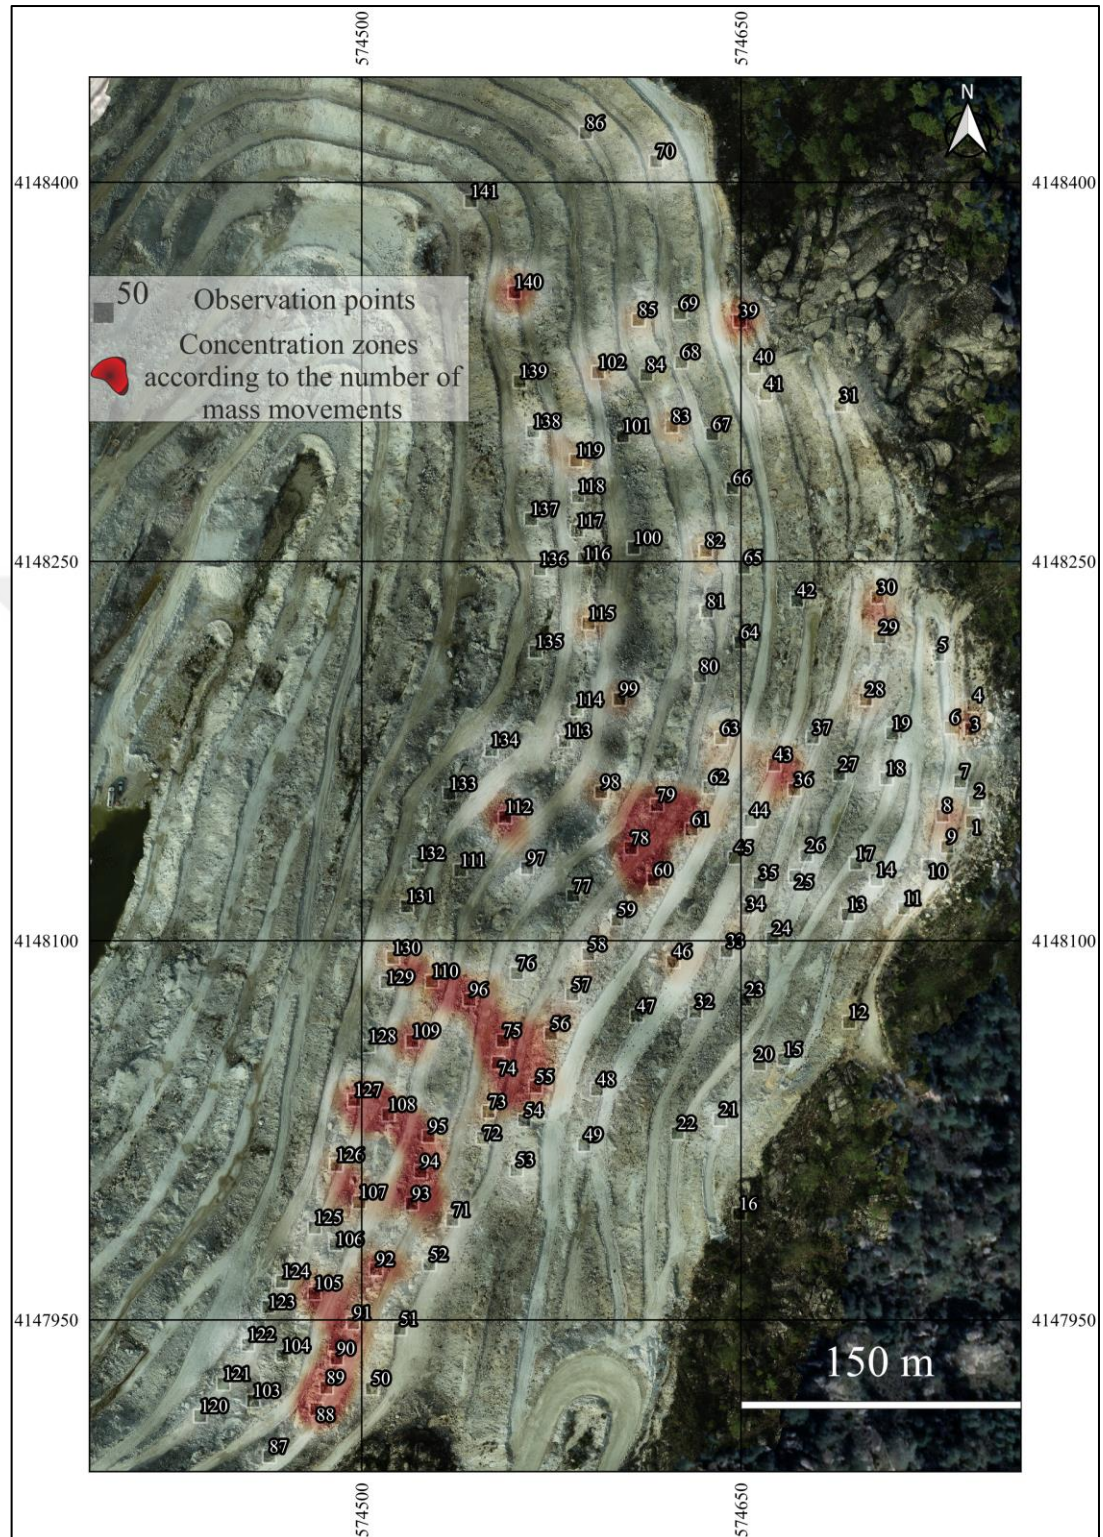
Figure 7.9 Concentrations of mass movements detected in the eastern part of Open Pit, produced using the heat map (Kernel Density) technique
