THE RESEARCH OF HISTORICAL ENVIRONMENT IN BADEMLİ

A Thesis Submitted to the
Graduate School of Natural and Applied Sciences of
Dokuz Eylül University

In Partial Fulfillment of the Requirements for
the Degree of Masters of Science in Architectural Restoration Program

by
Adem ÖZÇELİK

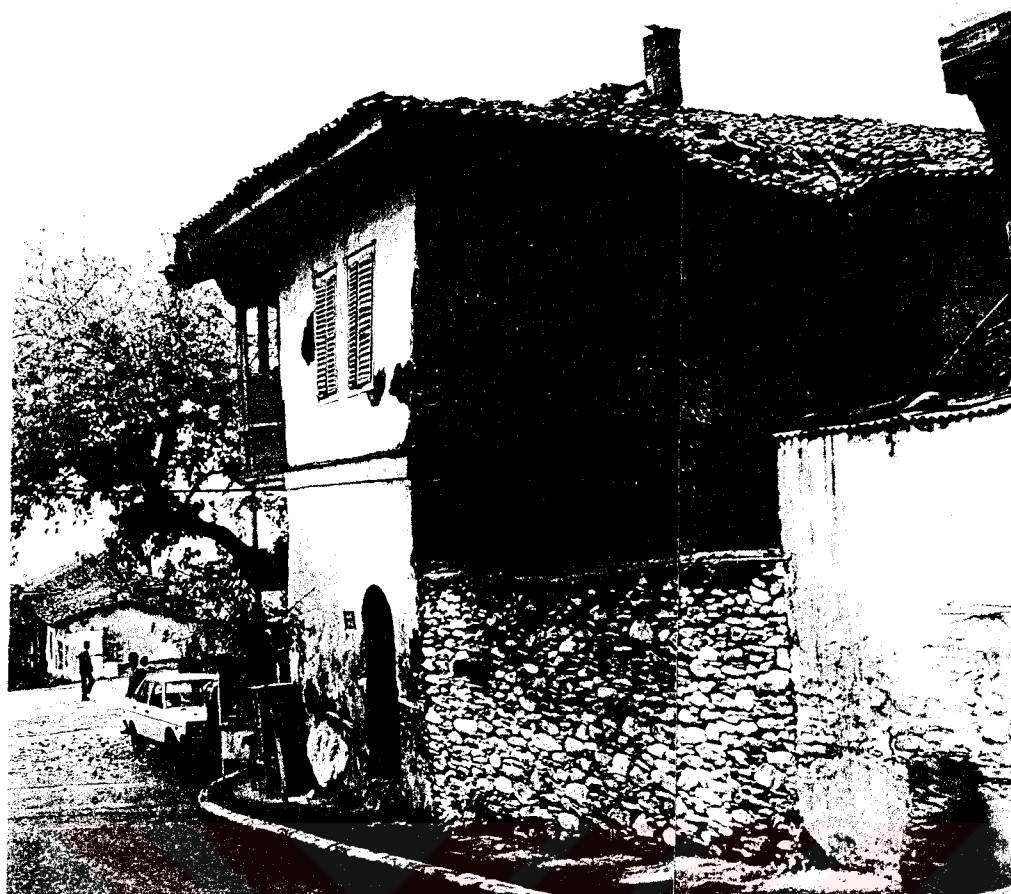
FIG.4.1 SEREF YALCIN HOUSE WHICH HAVE BEGAN TO DECAY AT THE UPPER PART KALEICI ST. NO:42

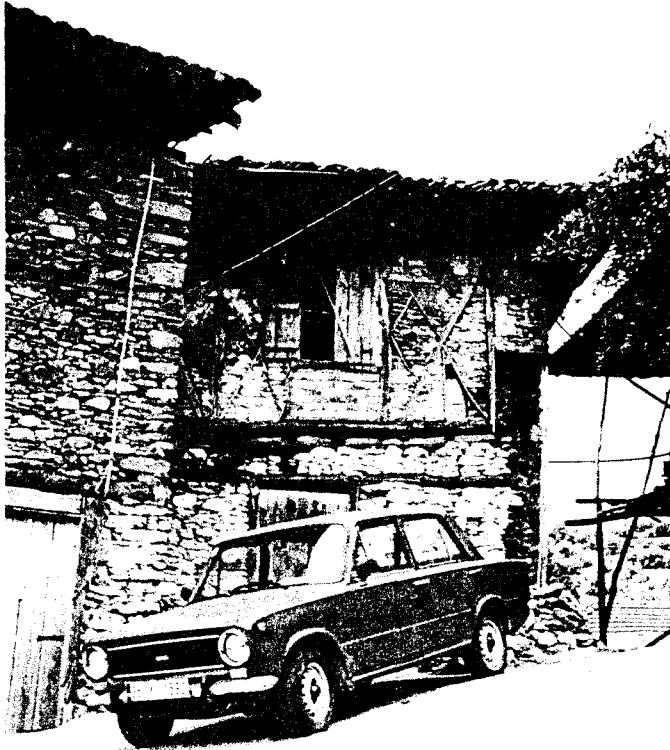
FIG.4.5 AHMET ERGIN HOUSE WHICH
HAVE -BEGAN TO DECAY AT THE
WALL HAFIZAGA ST. NO:59

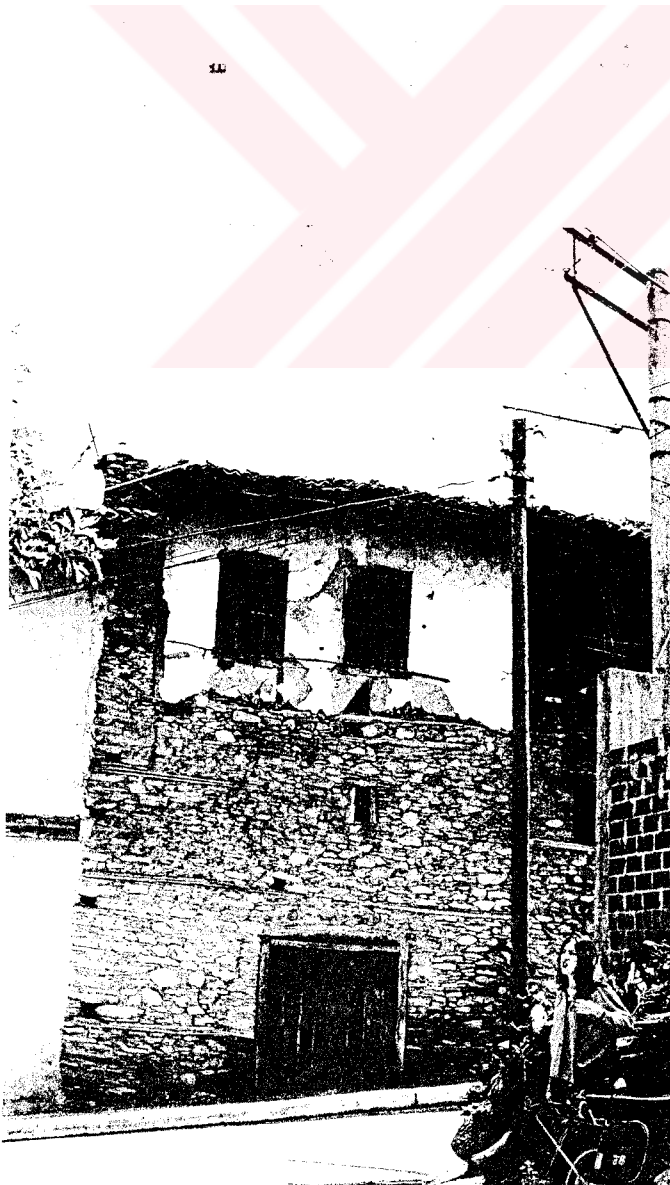
FIG.4.6 MEHMET GIRGIN HOUSE
WHICH HAVE BEGAN TO DECAY
AT THE UPPER PART SATI ST.
