**ENGINEERING GEOLOGY OF THE STATE
HIGHWAY SLOPES BETWEEN BAĞARASI-
FOÇA (İZMİR)**

**A Thesis Submitted to the
Graduate School of Natural and Applied Sciences of Dokuz Eylül University
In Partial Fulfillment of the Requirements for the Degree of Master of
Science in Geological Engineering, Applied Geology Program**

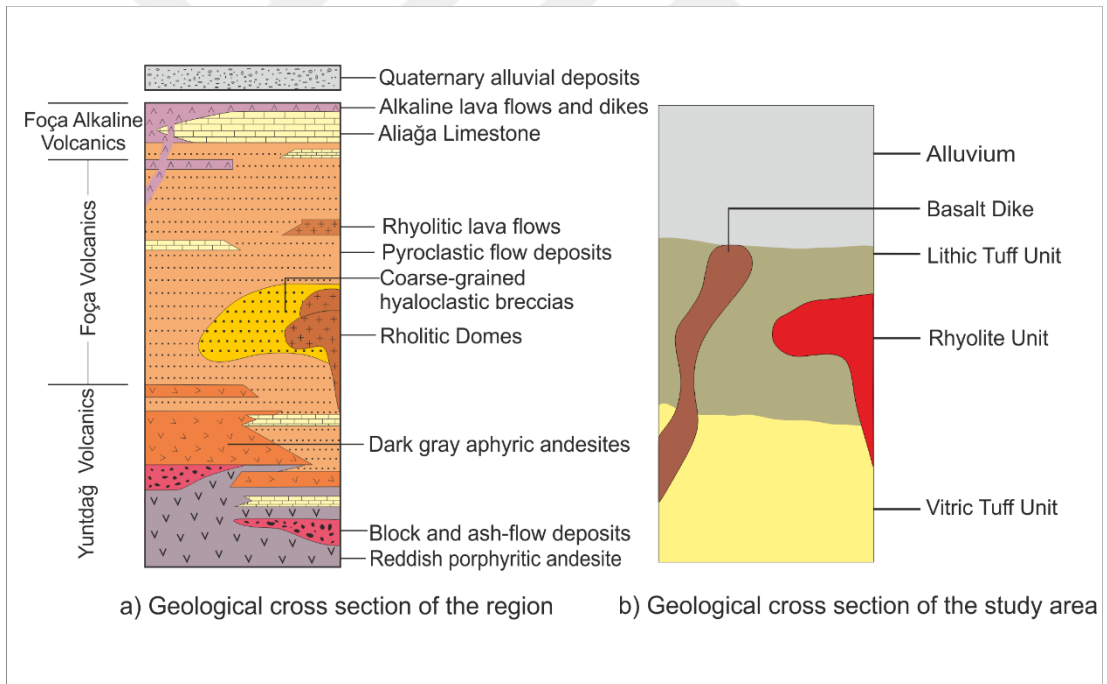
Figure 2.2 a) Geological cross section of the region (Modified after Akay, 2000) and b) Geological cross section of the study area

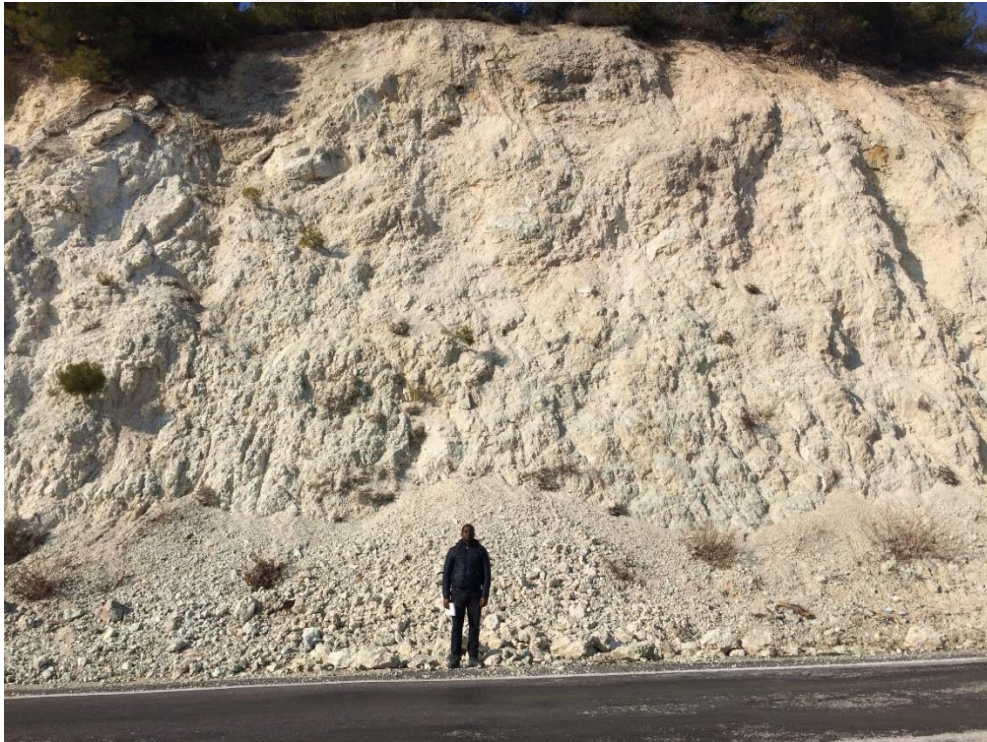
Figure 2.3 Vitric tuff

The oldest lithological unit in the study area is the Vitric Tuff (Figure 2.3). The Vitric Tuff (VT) covers a significant section of the study area and the best outcrops of this rock unit were observed at Sakkali Hill and Boz Hill. The VT varied in colour from creamy-white to whitish gray. The VT was observed to generally have weak strength with significant indentation when struck with a geological hammer.

The vitric tuffs were generally highly fractured with glass fragment size less than 4 mm. The VT was observed to have high weathering degrees. The glass fragments had varied shapes-linear, circular and squares. The VT directly overlies the Yuntdag volcanics.

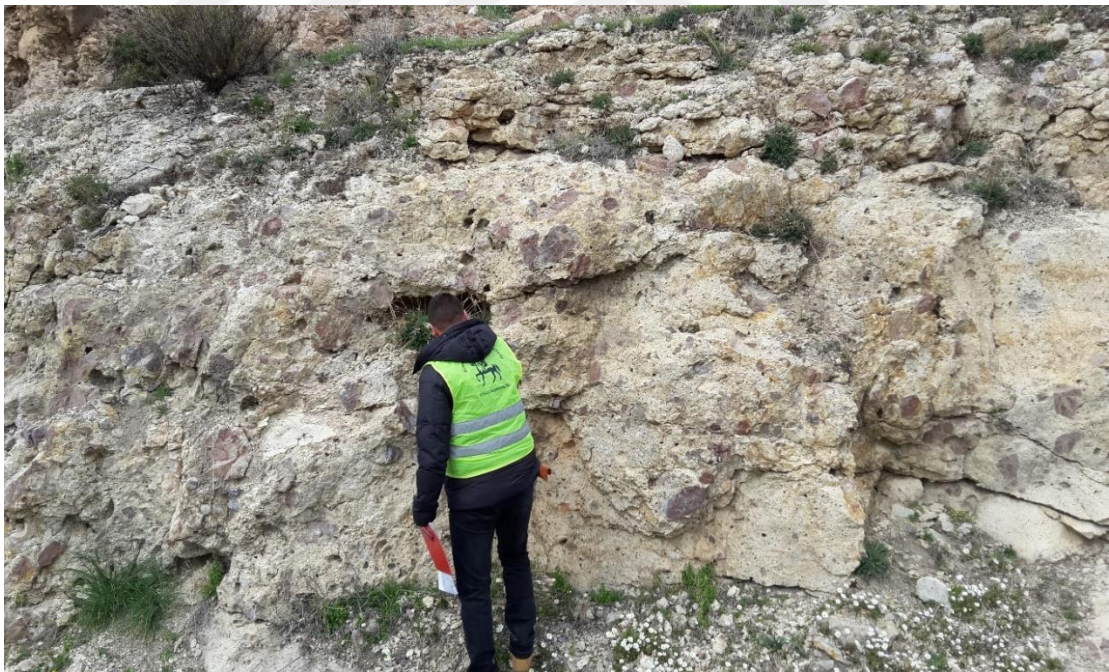
Figure 2.4 Lithic tuff

The Lithic Tuff (LT) unit outcrops predominantly on the hills found at the northern part of the study area with minor extensions towards the southern parts. The LT varies in colour from ash to brown. The LT was found to be of medium strength with little indentation when struck with a geological hammer. The lithic tuffs were formed from a consolidation of volcanic ash and rock fragments. Discontinuities in the LT were fewer in number compared to those observed in VT. The LT also had a generally lower degree of weathering compared to the VT.

Hand specimen examination indicated that the LT consisted mainly of over 60% rock fragments, mineral particles and fine material (volcanic glass). The rock fragments had a particle size range of 1 cm - 5 cm. The LT directly overlies the vitric tuffs. An image of the lithic tuff unit observed in the field is presented in Figure 2.4.

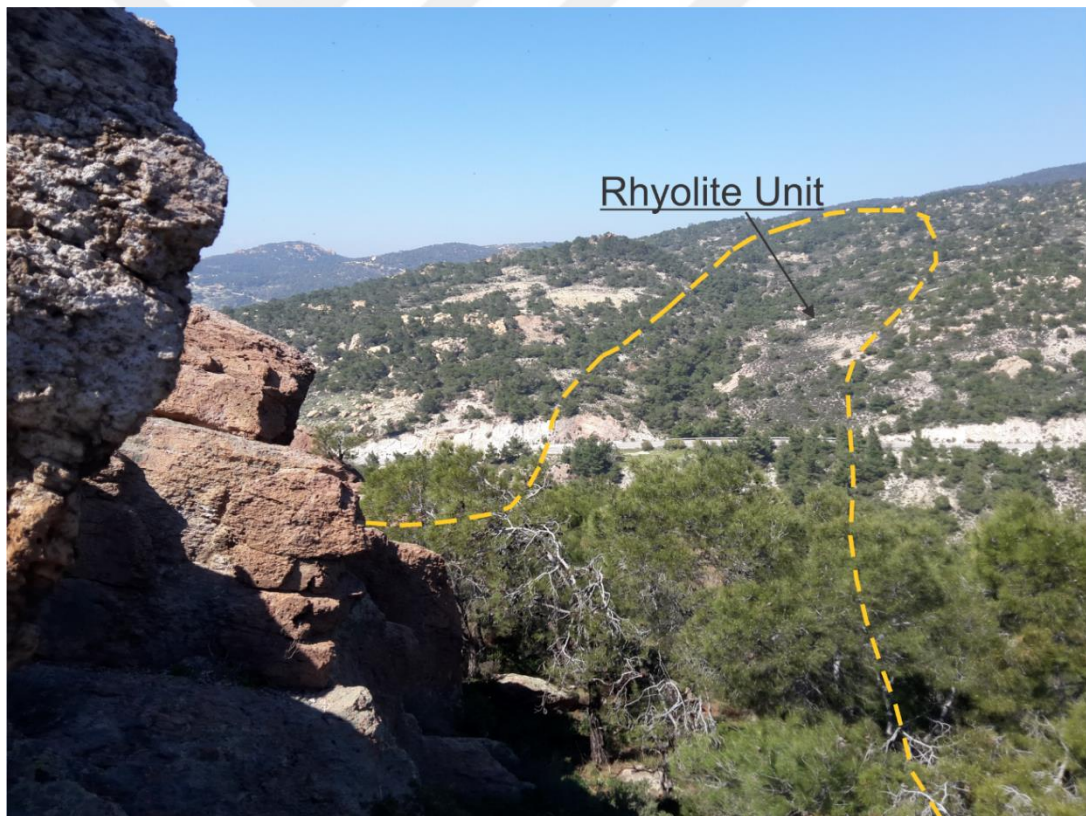
Figure 2.5 Rhyolite unit

The best outcrops of the Rhyolite Unit (RU) were observed on Eskifoça Hill. Both fresh and weathered surface of the RU were pink in colour. The RU was massive and generally slightly weathered. Field tests (blows of geological hammer) of the strength of the RU indicated that it was of high strength.

No flow structure was observed in the rhyolite. Akay (2004) observed that the Rhyolite Unit in the study area had a dome structure. This explains why no flow structure was observed in the RU. Microcrystalline textures were observed in the rhyolite in thin section analysis. An image of the Rhyolite Unit is presented in Figure 2.5.

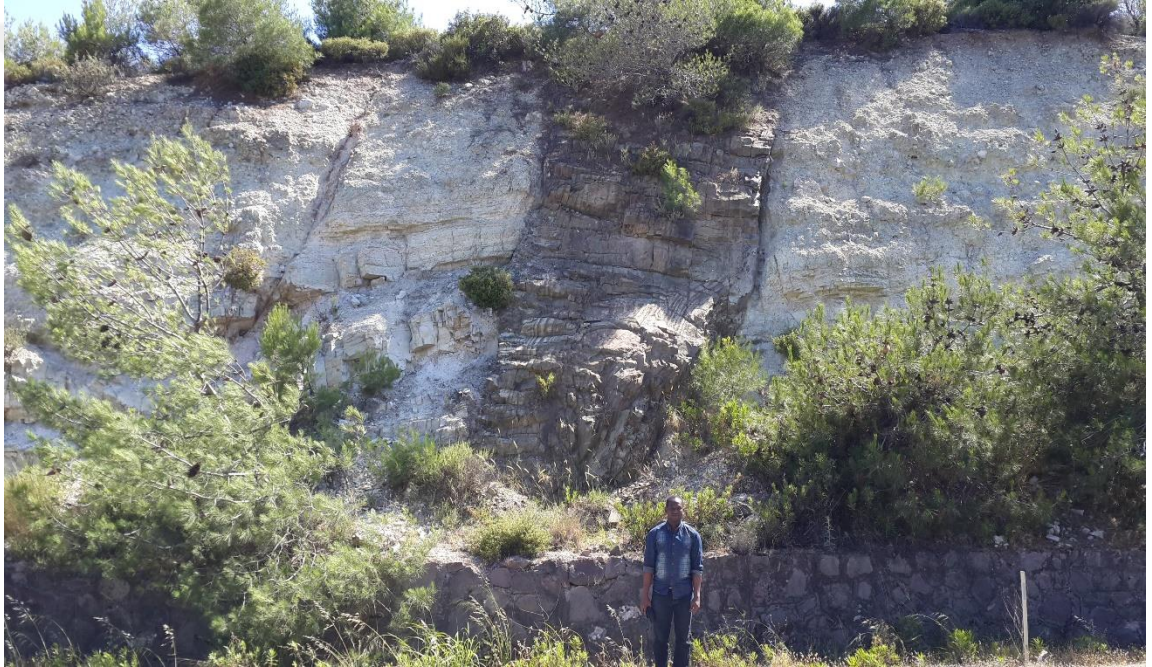
Figure 2.6 Basalt dike

The Basalt Unit (BU) outcrops north-west of the Taşlı Hill. The BU formed as an intrusion (dike) in the volcanic tuffs. The BU has a massive structure with a brownish gray to dark brown colour. Cooling and shrinkage joints were observed in the unit. Flow structures were also observed in the unit. The BU generally had an aphanitic texture. Key mineral components observed in the BU were plagioclase and pyroxene. Plagioclase occurs as both phenocrysts and matrix in basalts (Nakipoğlu, 1994). An image of the BU is presented in Figure 2.6.

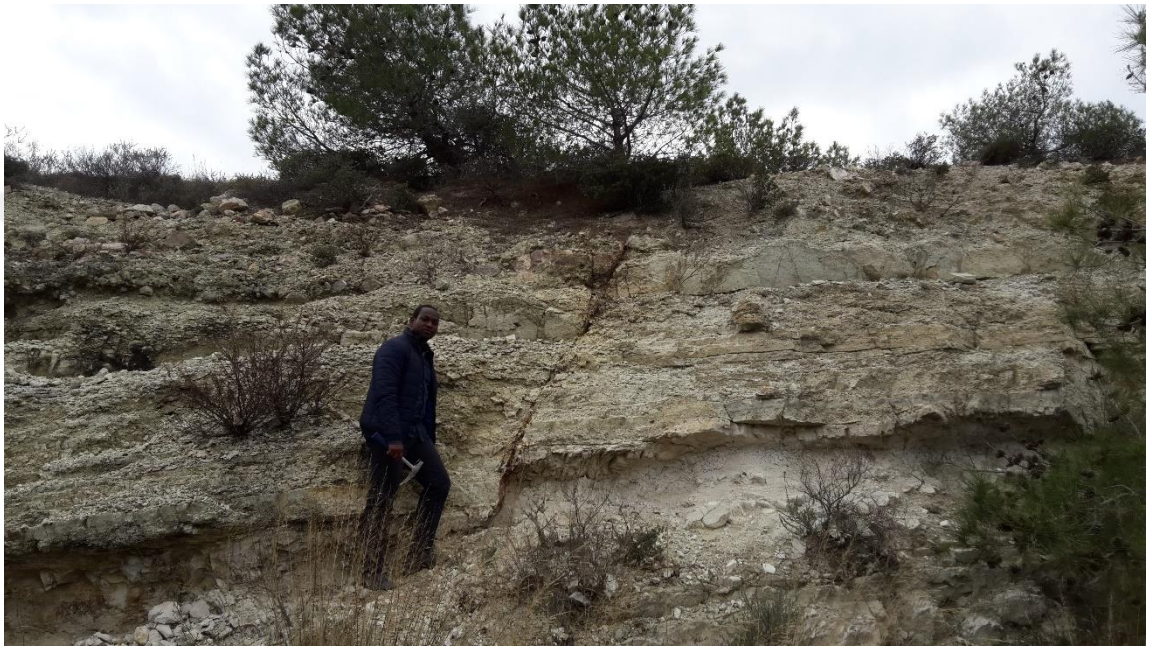
Figure 2.7 Normal fault observed in the study area

The study area is located in the Foça depression, which forms part of the Middle East Aegean Depression. The Foça depression is the product of vertical displacements along the main N-NE trending structural facies (Kaya, 1978). Small scale faults are present in the study area (Figure 2.7).

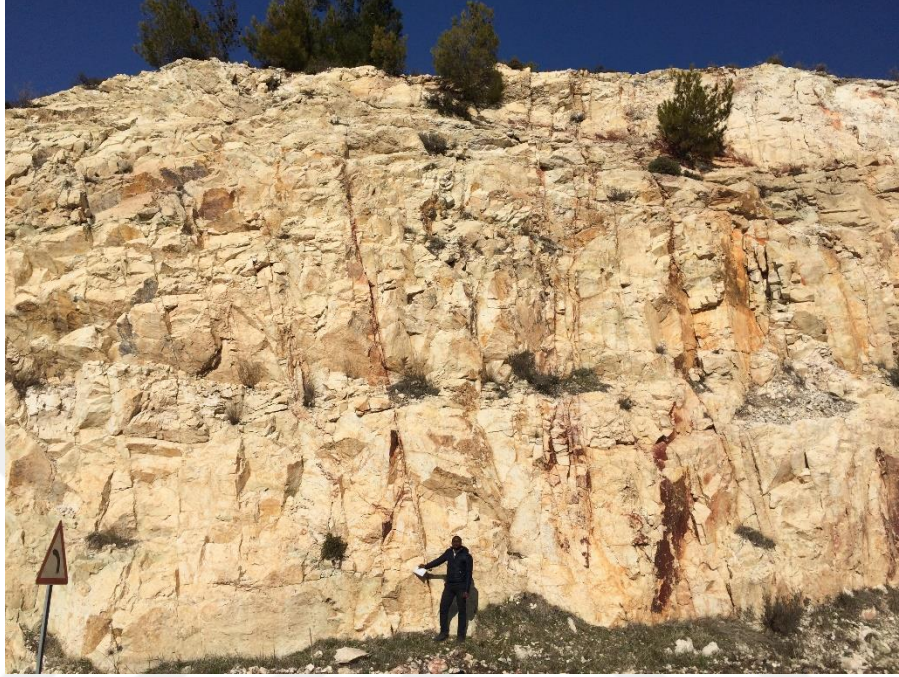
Figure 2.8 Fractures and joints

Flow structures are generally in the NE direction. Cooling fissures are usually associated with the flow structures (Nakipoğlu, 1994). In the study area, fracture and joint systems (Figure 2.8) developed after volcanism.

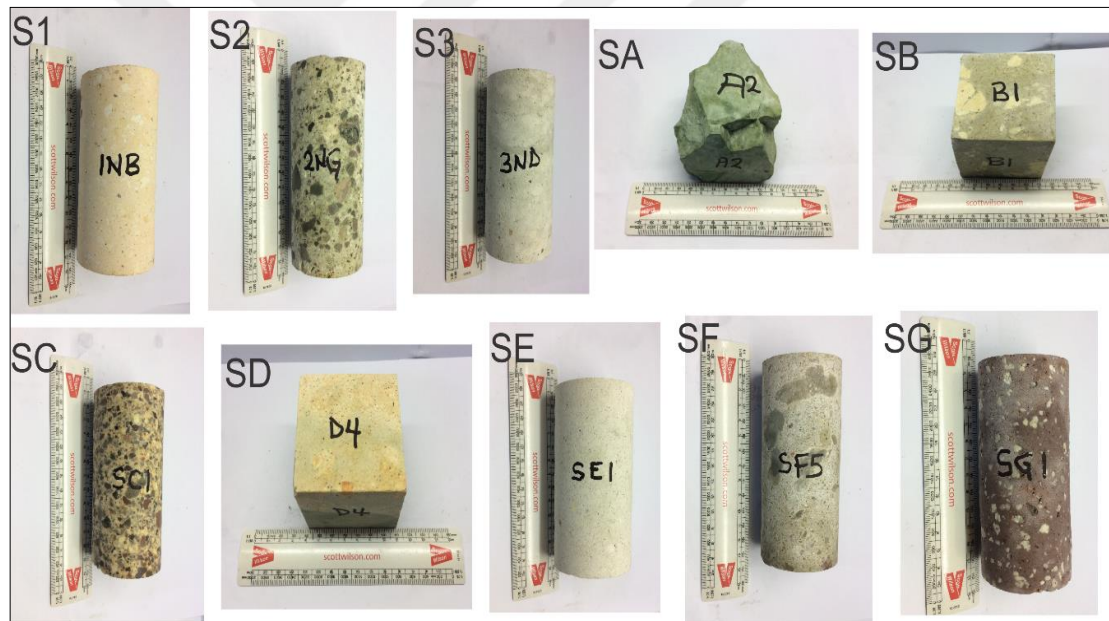
Figure 3.1 Images of rock specimens from the ten slopes

Petrographic studies were conducted on 22 thin sections prepared from samples obtained from ten different locations along the Foca-Bagarasi (Izmir) State highway slope. These locations (slopes) are designated as Slope 1 (S1), Slope 2 (S2), Slope 3 (S3), Slope A (SA), Slope B (SB), Slope C (SC), Slope D (SD), Slope E (SE), Slope F (SF) and Slope G (SG). The samples had different weathering grades (SW-HW). Separate petrographic analyses were conducted for each of the ten sample groups. Images of rock specimens from the ten slopes are presented in Figure 3.1.

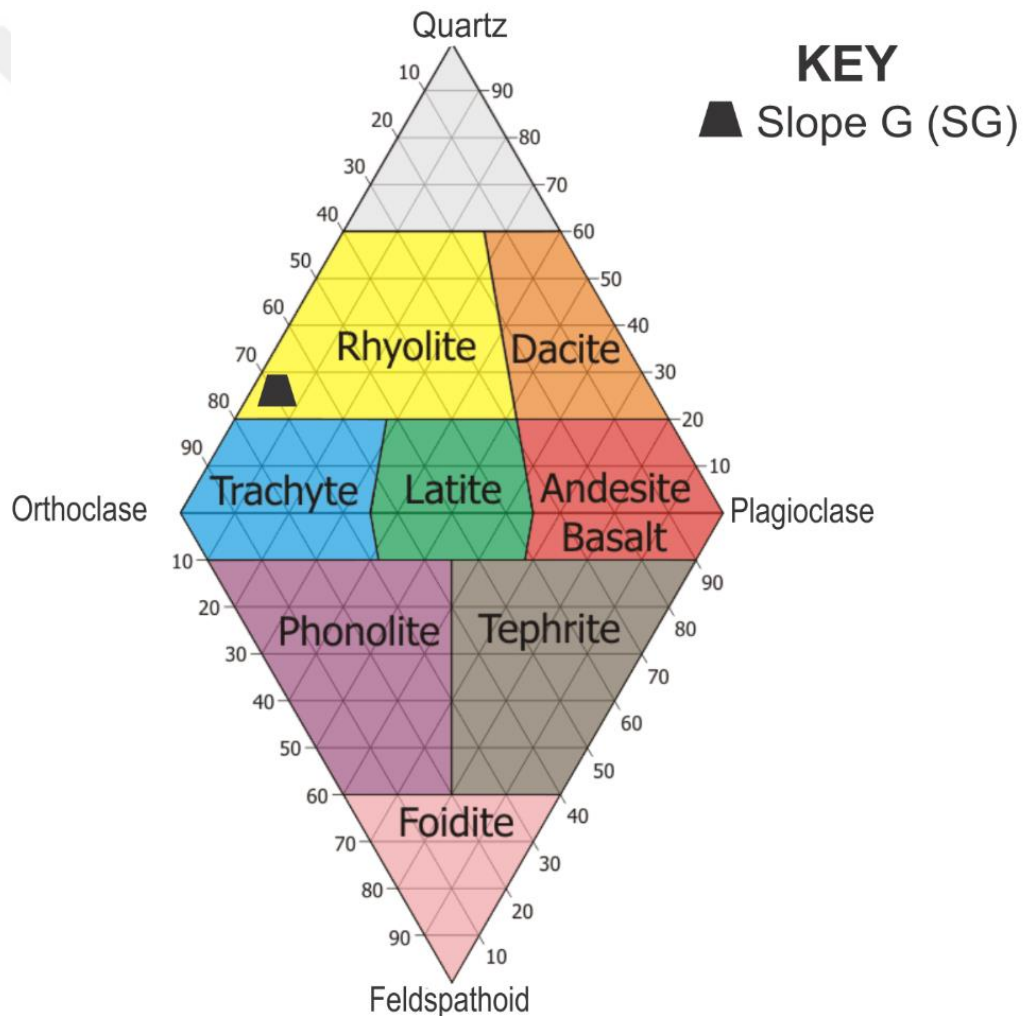
Figure 3.2 IUGS classification of Slope G (SG) (after Streckeisen, 1980)

SG was composed of a large quantity of quartz, a quartz rich matrix, sanidine and biotite. SG was classified as rhyolite using the Quartz-Alkali feldspar-Plagioclase-Feldspathoid (QAPF) diagram developed by IUGS (Streckeisen, 1980) for classifying volcanic rocks (Figure 3.2).

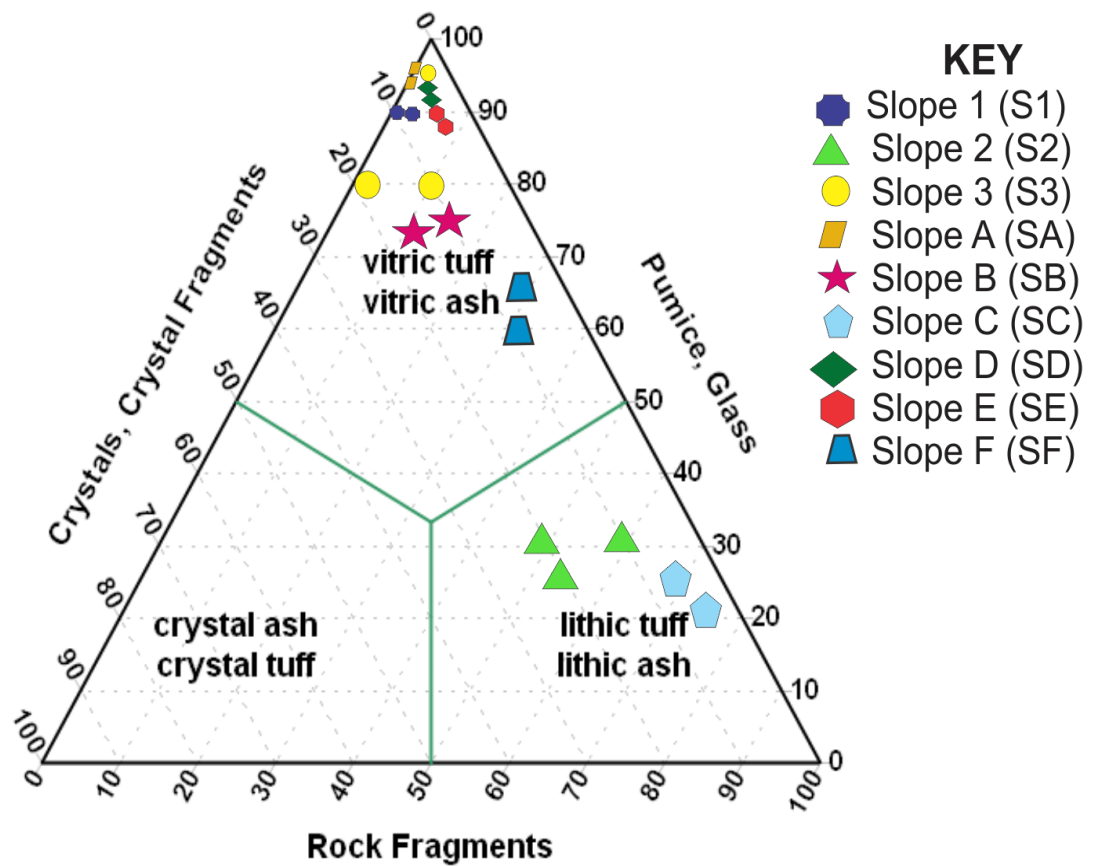
Figure 3.3 relative compositions of Glass, Crystals and Rock fragments (GCR) of the specimens (modified after Pettijohn et al. 1987 and Andreis et al. 2007)

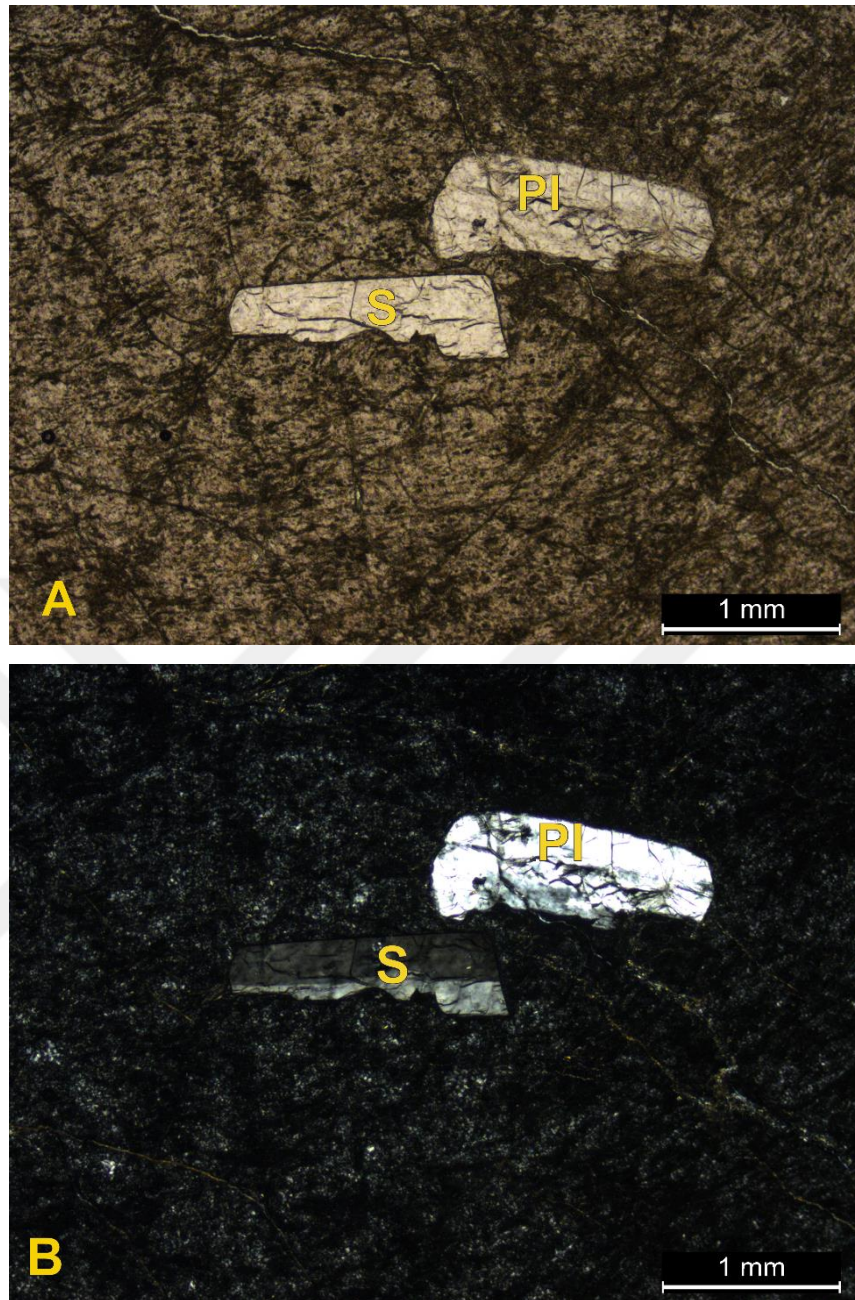
Figure 3.4 SA (HW vitric tuff) -Observations under Plane Polarised light (A) and Cross Polarised Light (B) (Pl-Plagioclase feldspar, F-Feldspar, Px-Pyroxene, Bt-Biotite, Rf-Rock fragment, S-Sanidine, Qtz-Quartz, Ch-Chalcedony formed from devitrified glass, Pm-Pumice)

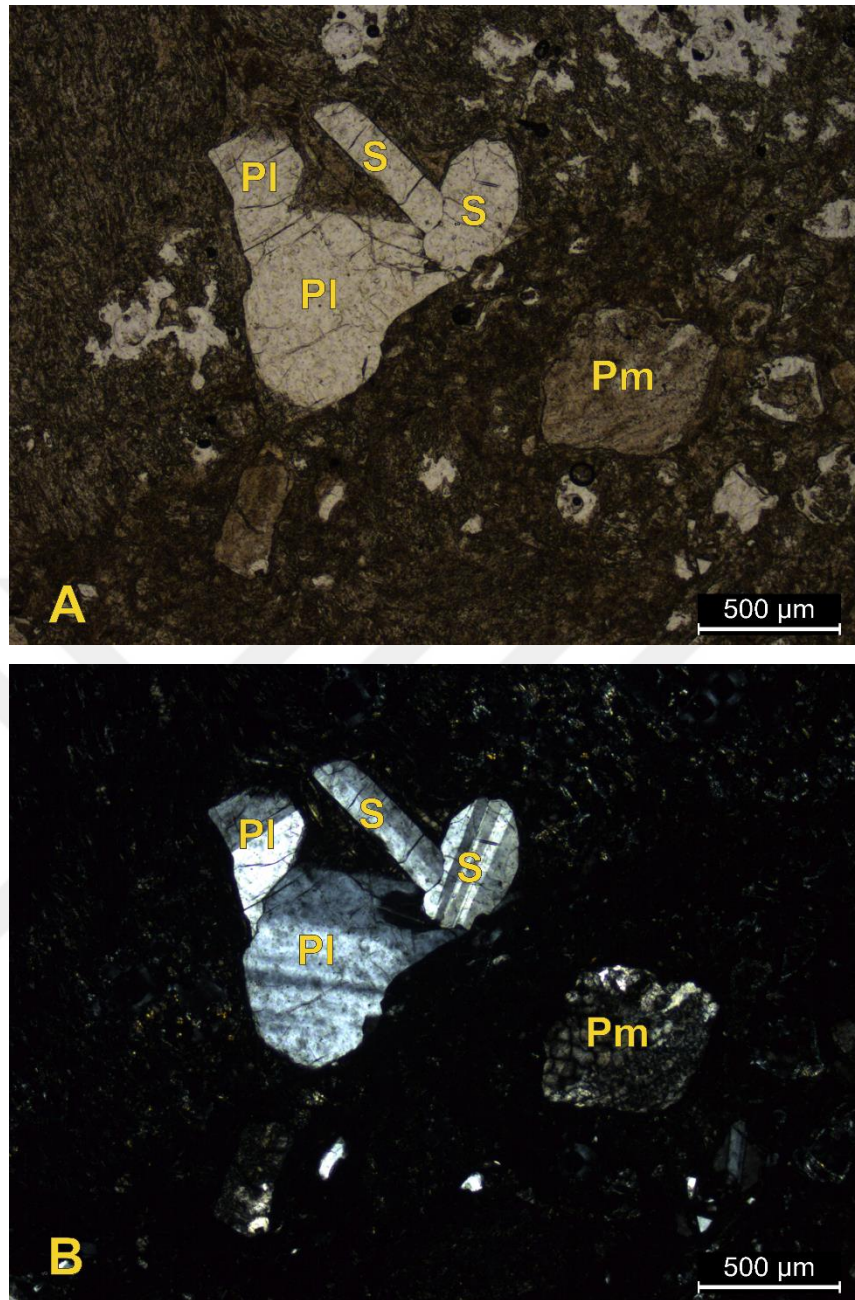
Figure 3.5 SB (MW vitric tuff)-Observations under Plane Polarised light (A) and Cross Polarised Light (B) (Pl-Plagioclase feldspar, F-Feldspar, Px-Pyroxene, Bt-Biotite, Rf-Rock fragment, S-Sanidine, Qtz-Quartz, Ch-Chalcedony formed from devitrified glass, Pm-Pumice)

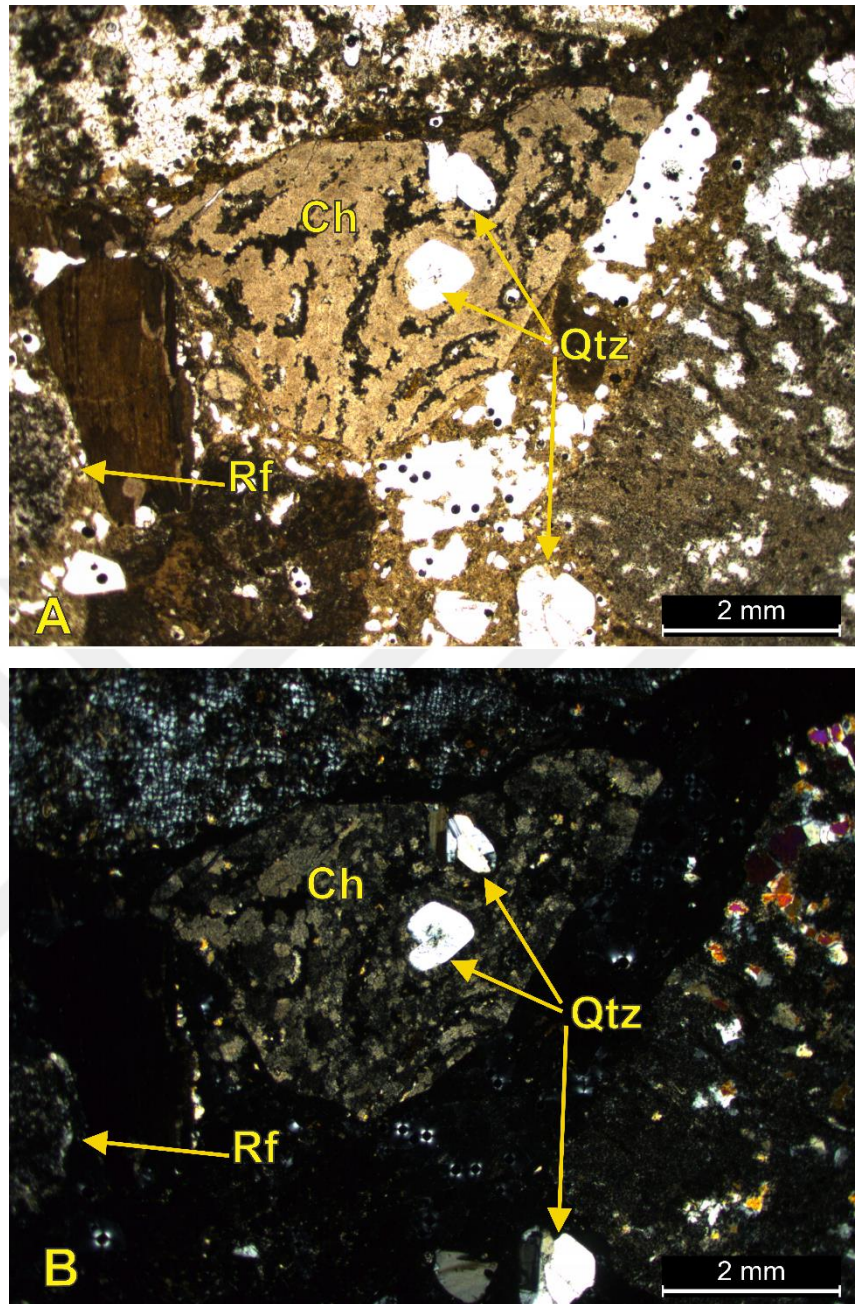
Figure 3.6 SC (SW lithic tuff) -Observations under Plane Polarised light (A) and Cross Polarised Light (B) (Pl-Plagioclase feldspar, F-Feldspar, Px-Pyroxene, Bt-Biotite, Rf-Rock fragment, S-Sanidine, Qtz-Quartz, Ch-Chalcedony formed from devitrified glass, Pm-Pumice)

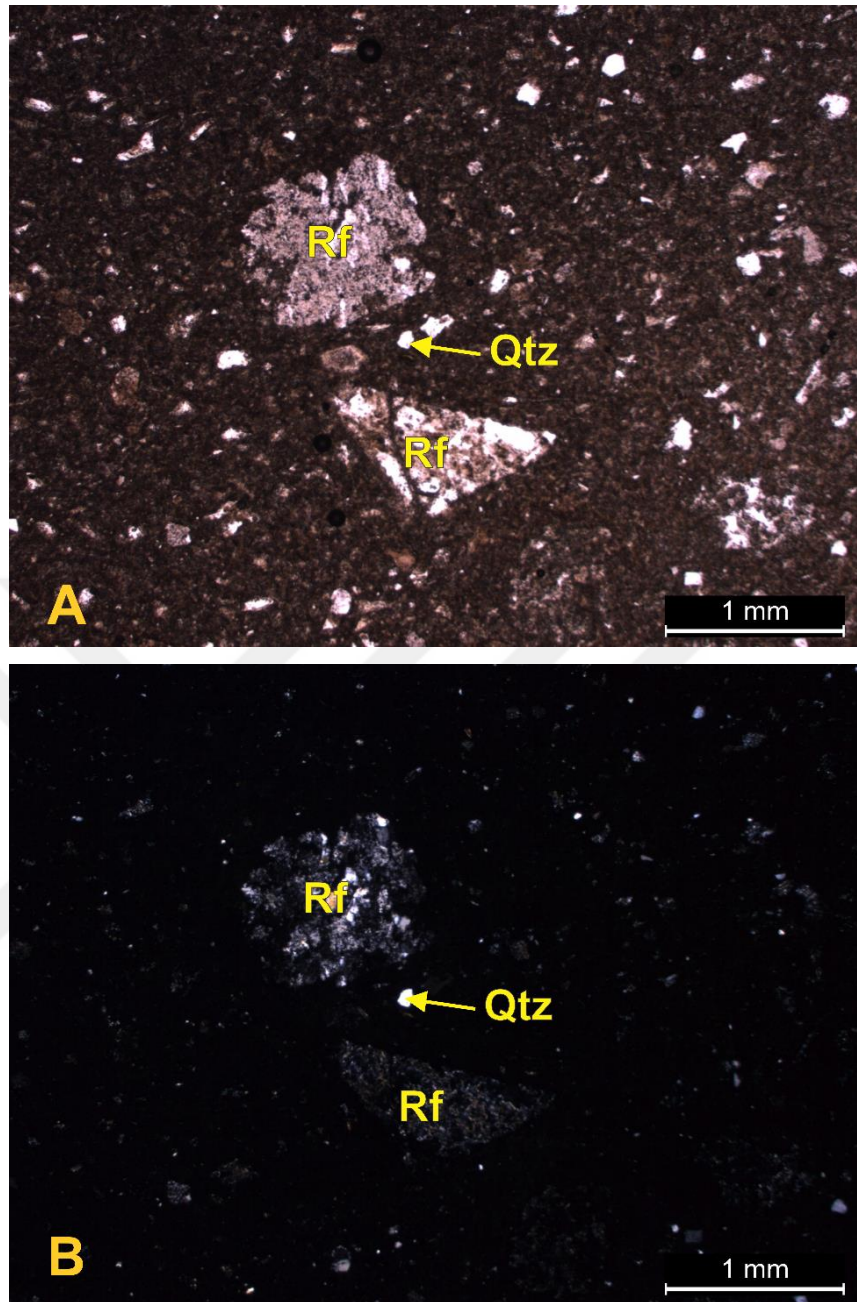
Figure 3.7 SD (HW vitric tuff) -Observations under Plane Polarised light (A) and Cross Polarised Light (B) (Pl-Plagioclase feldspar, F-Feldspar, Px-Pyroxene, Bt-Biotite, Rf-Rock fragment, S-Sanidine, Qtz-Quartz, Ch-Chalcedony formed from devitrified glass, Pm-Pumice)

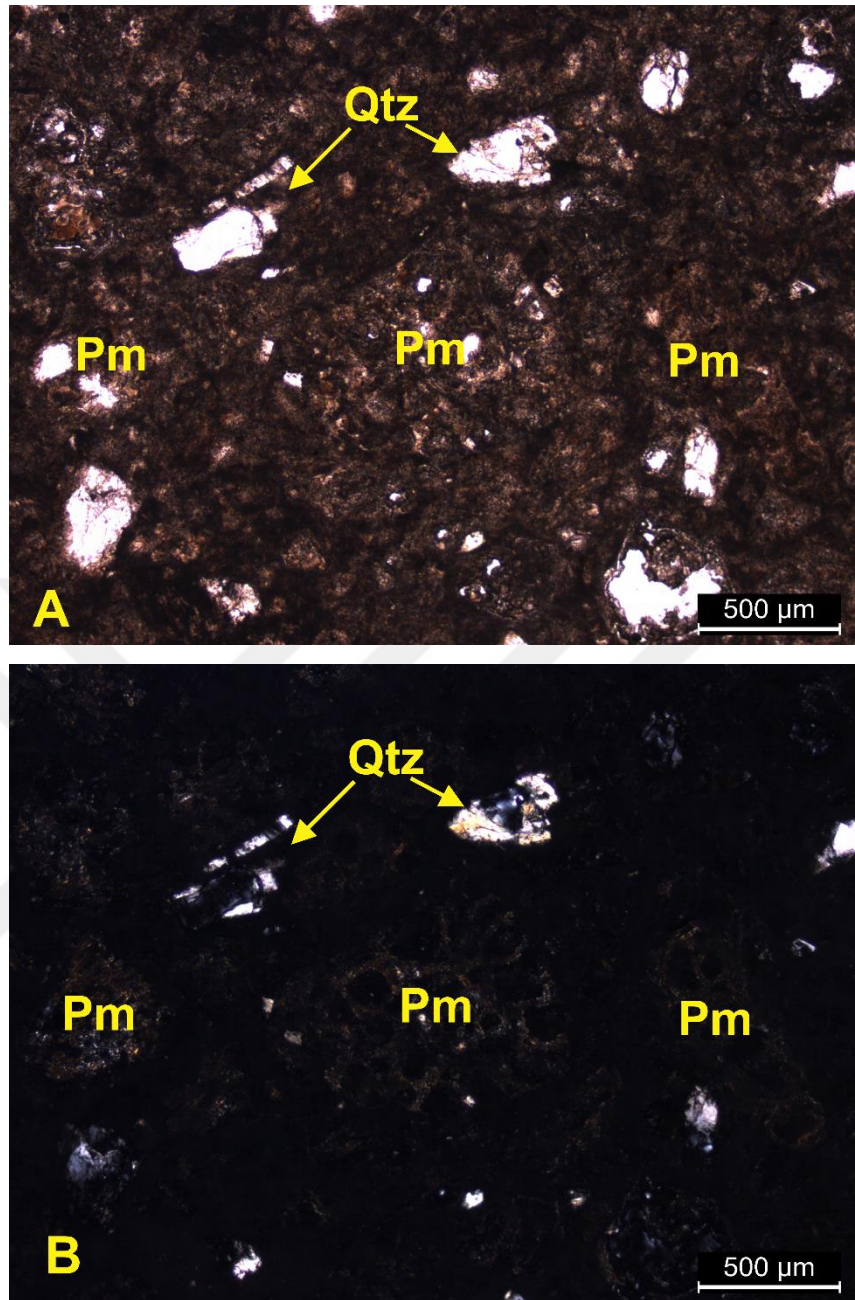
Figure 3.8 SE (MW vitric tuff) -Observations under Plane Polarised light (A) and Cross Polarised Light (B) (Pl-Plagioclase feldspar, F-Feldspar, Px-Pyroxene, Bt-Biotite, Rf-Rock fragment, S-Sanidine, Qtz-Quartz, Ch-Chalcedony formed from devitrified glass, Pm-Pumice)

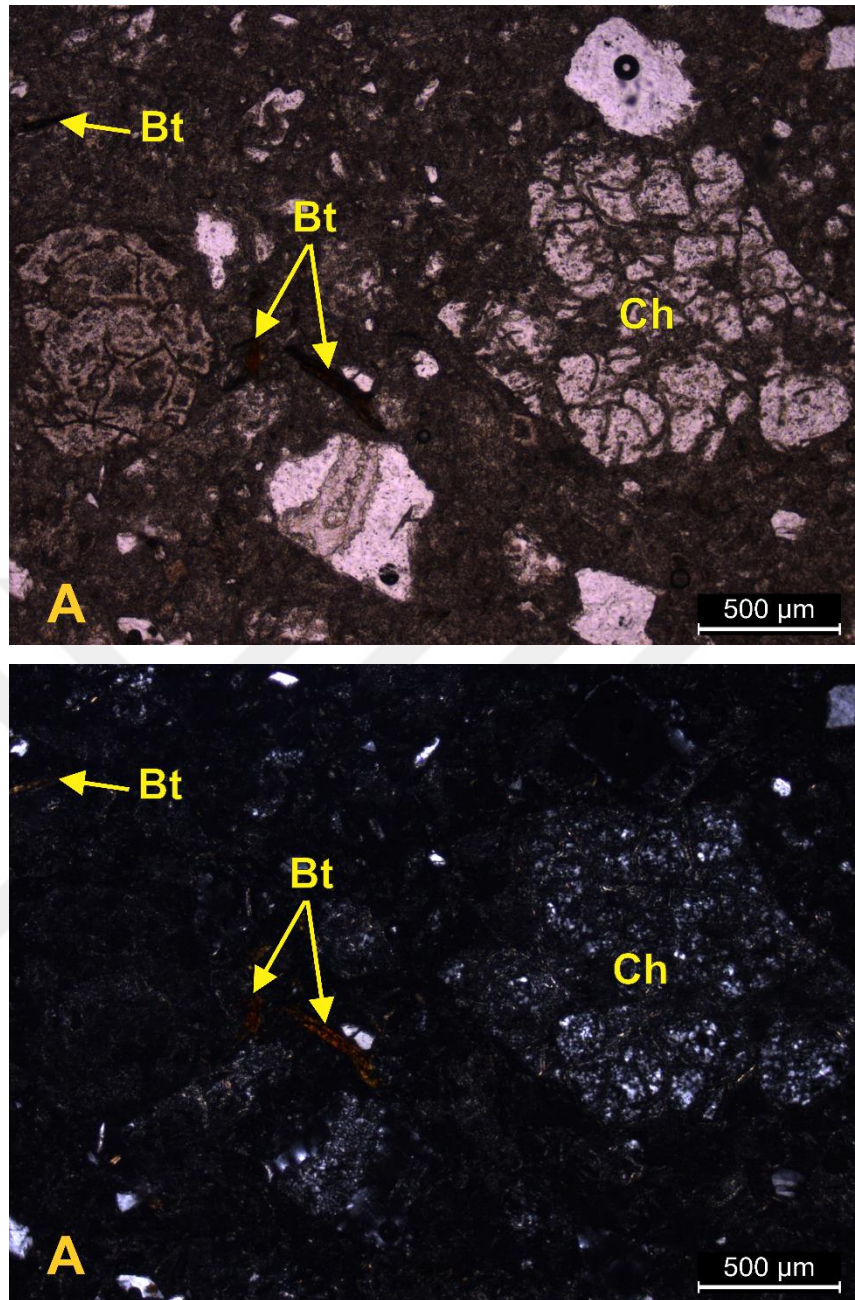
Figure 3.9 SF (MW vitric tuff) -Observations under Plane Polarised light (A) and Cross Polarised Light (B) (Pl-Plagioclase feldspar, F-Feldspar, Px-Pyroxene, Bt-Biotite, Rf-Rock fragment, S-Sanidine, Qtz-Quartz, Ch-Chalcedony formed from devitrified glass, Pm-Pumice)

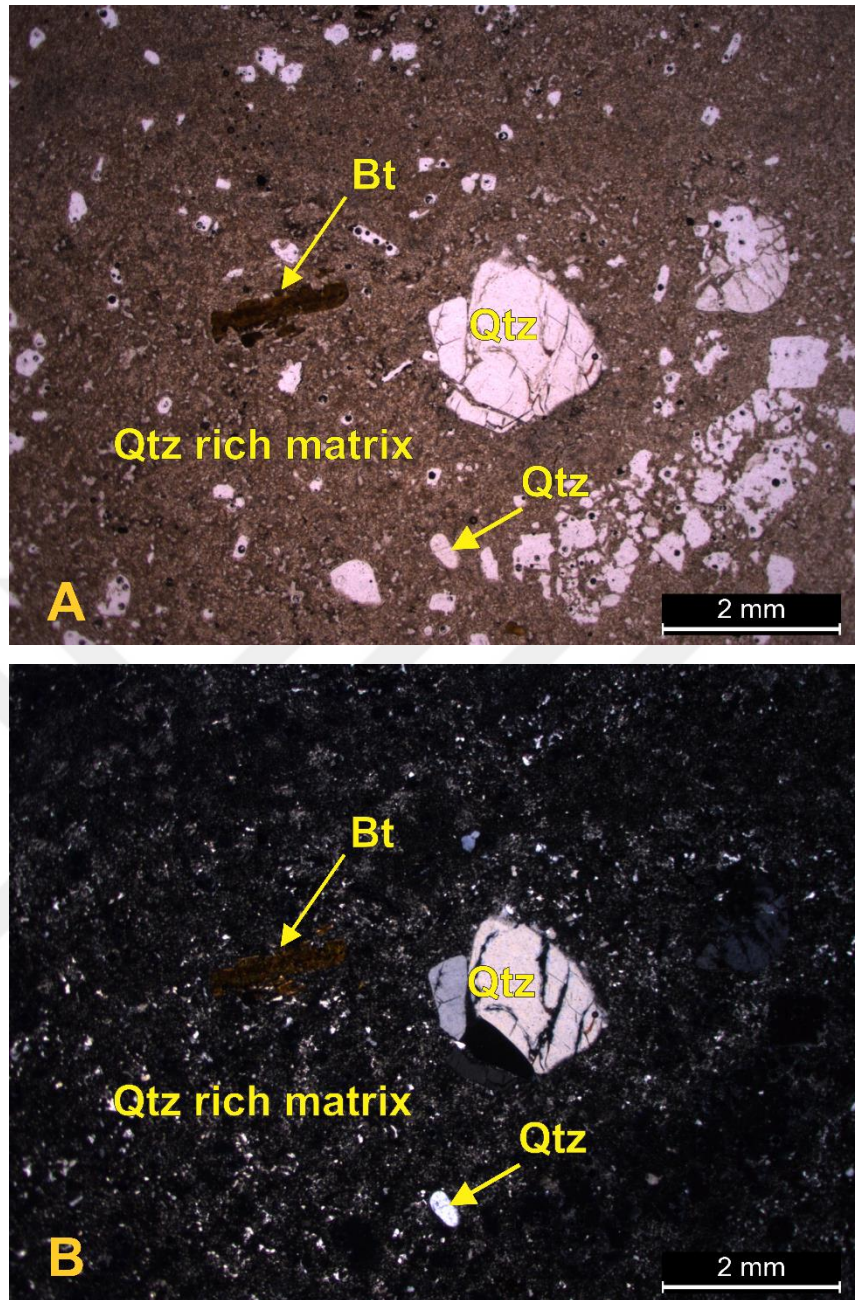
Figure 3.10 SG (Rhyolite)-Observations under Plane Polarised light (A) and Cross Polarised Light (B) (Pl-Plagioclase feldspar, F-Feldspar, Px-Pyroxene, Bt-Biotite, Rf-Rock fragment, S-Sanidine, Qtz-Quartz, Ch-Chalcedony formed from devitrified glass, Pm-Pumice)

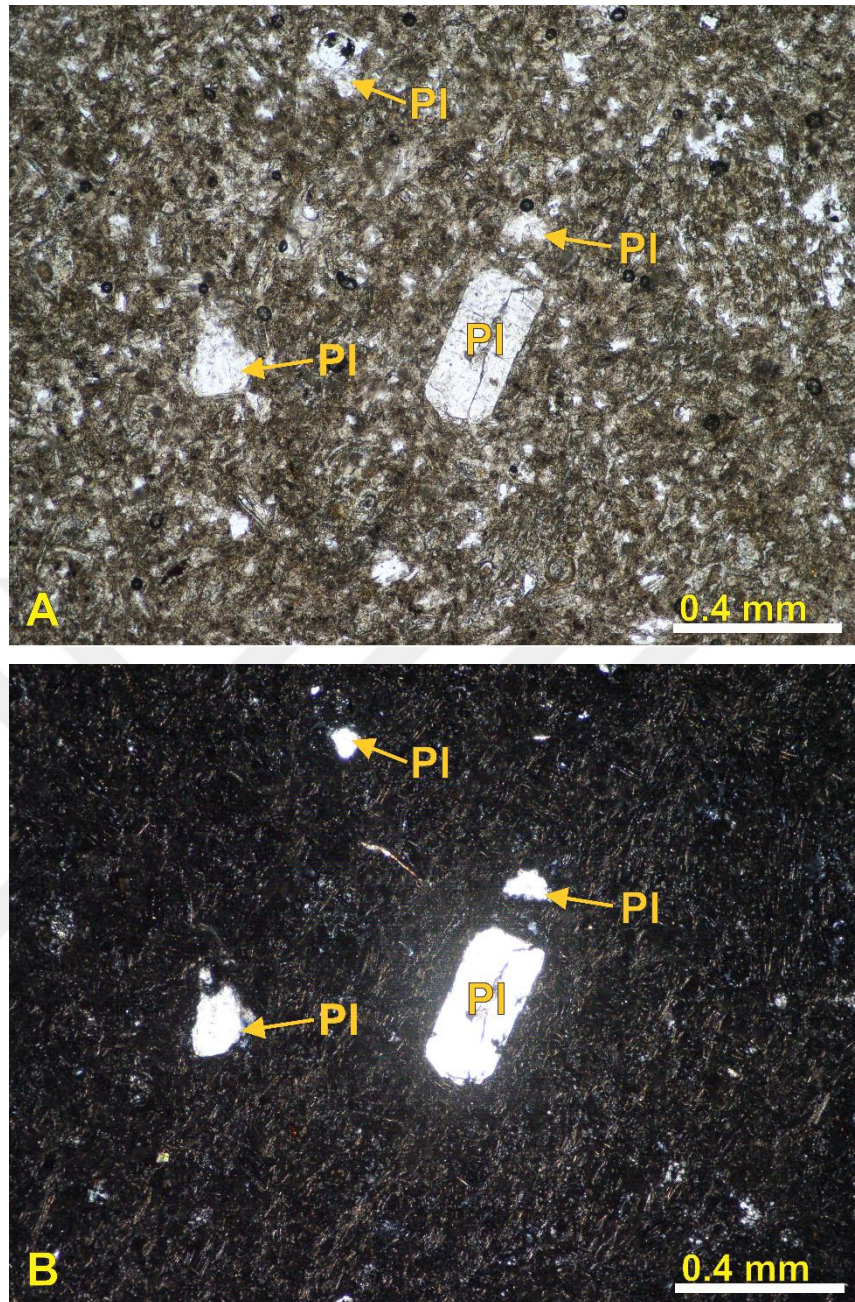
Figure 3.11 S1 (HW vitric tuff)-Observations under Plane Polarised light (A) and Cross Polarised Light (B) (Pl-Plagioclase feldspar, F-Feldspar, Px-Pyroxene, Bt-Biotite, Rf-Rock fragment, S-Sanidine, Qtz-Quartz, Ch-Chalcedony formed from devitrified glass, Pm-Pumice)

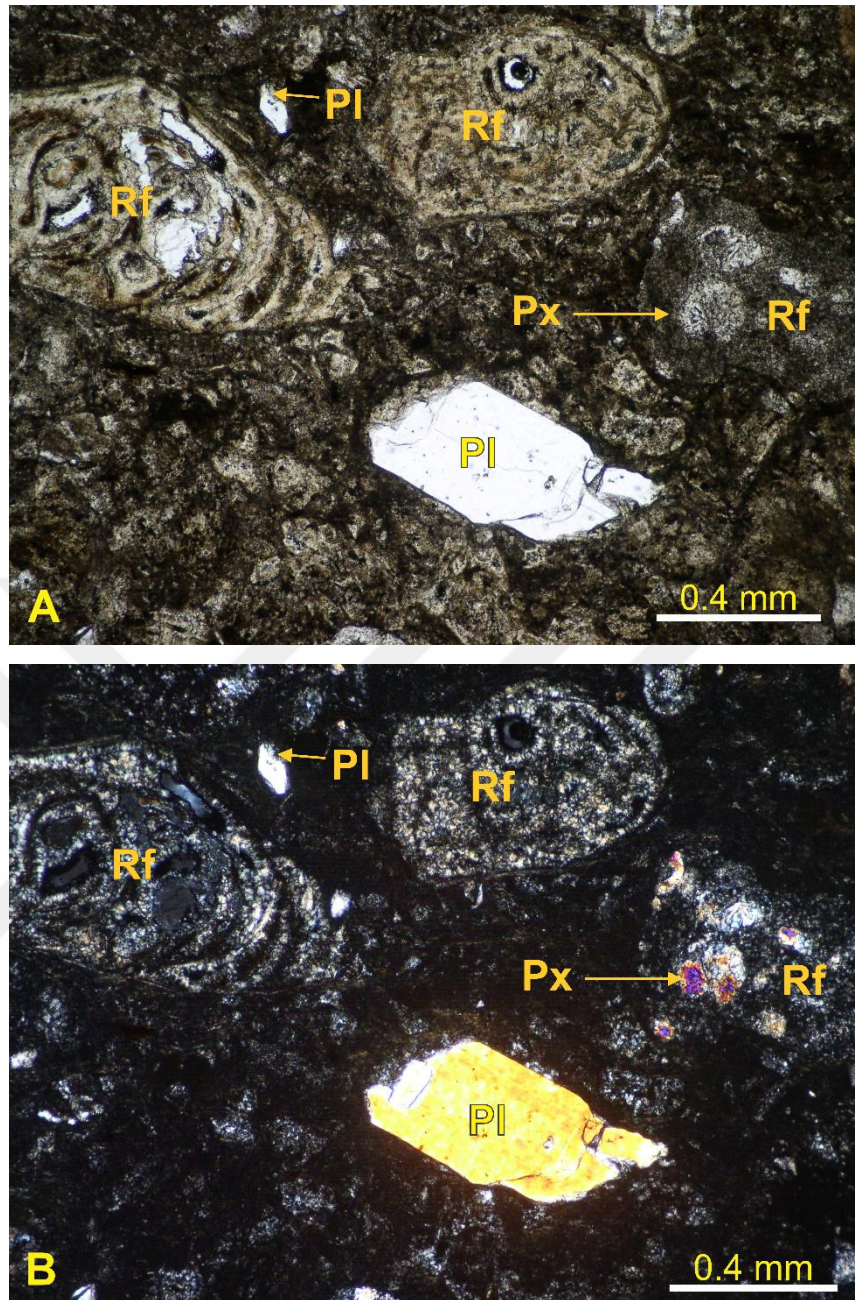
Figure 3.12 S2 (SW lithic tuff)-Observations under Plane Polarised light (A) and Cross Polarised Light (B) (Pl-Plagioclase feldspar, F-Feldspar, Px-Pyroxene, Bt-Biotite, Rf-Rock fragment, S-Sanidine, Qtz-Quartz, Ch-Chalcedony formed from devitrified glass, Pm-Pumice)

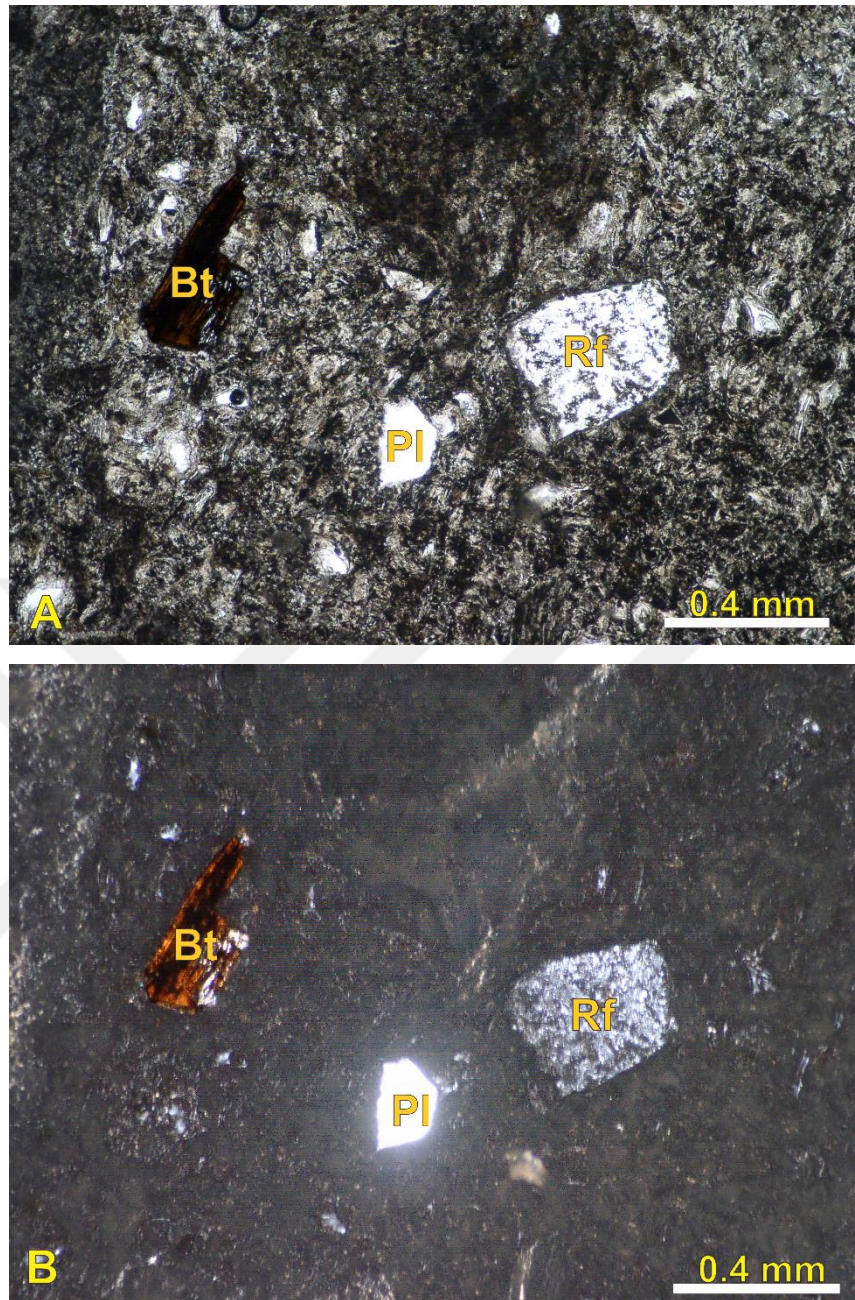
Figure 3.13 S3 (HW vitric tuff)-Observations under Plane Polarised light (A) and Cross Polarised Light (B) (Pl-Plagioclase feldspar, F-Feldspar, Px-Pyroxene, Bt-Biotite, Rf-Rock fragment, S-Sanidine, Qtz-Quartz, Ch-Chalcedony formed from devitrified glass, Pm-Pumice)

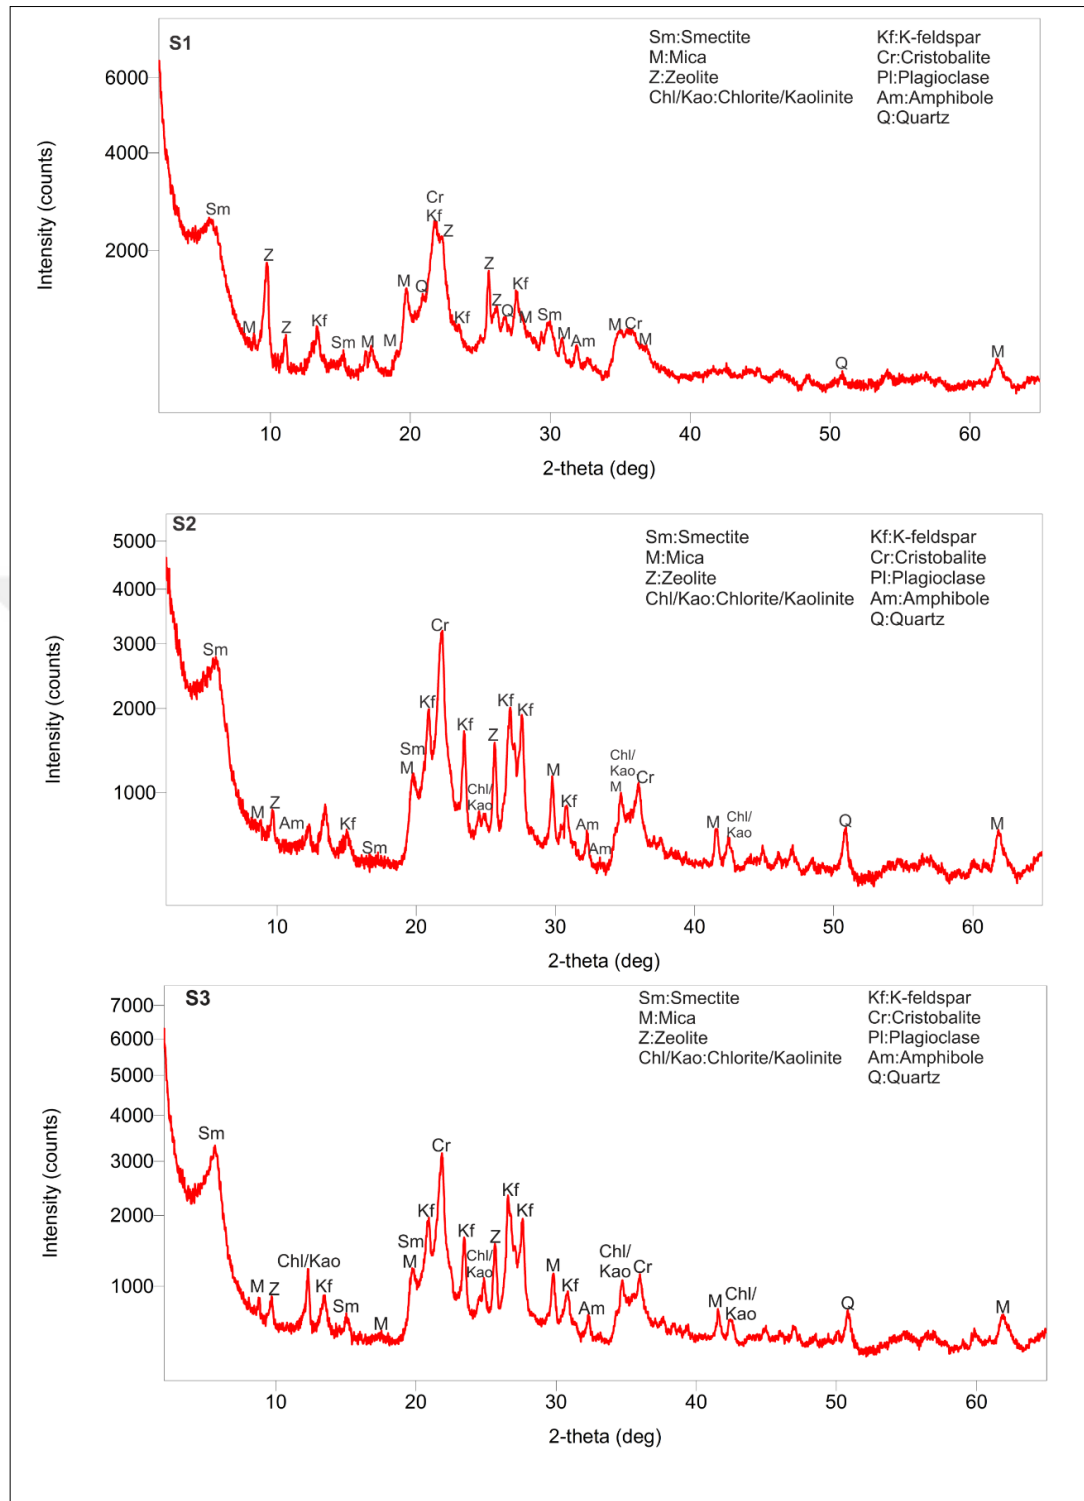
Figure 3.14 X-Ray diffraction diagrams of S1, S2 and S3

Infill materials (clay samples) were obtained from discontinuities of the ten slopes (sample groups) along the Bağarası-Foça (Izmir) State Highway. X-Ray Diffractometer (XRD) analyses were conducted on the clay samples obtained from the field. Separate XRD analyses were conducted for each of the ten slopes. The dominant mineral identified from the XRD analyses was smectite, a clay mineral with a high swell potential. Very high quantities of smectite were found in all the samples.

As high as 8000 counts of smectite was recorded in SF and SG. Other minerals identified from the XRD analyses were zeolite, mica, chlorite, kaolinite, K-feldspar, plagioclase, amphibole, cristobalite and quartz. X-Ray diffraction diagrams of the ten slopes are presented in Figure 3.14, 3.15, 3.16 and 3.17.
