**ENGINEERING GEOLOGY OF THE STATE
HIGHWAY SLOPES BETWEEN BAĞARASI-
FOÇA (İZMİR)**

**A Thesis Submitted to the
Graduate School of Natural and Applied Sciences of Dokuz Eylül University
In Partial Fulfillment of the Requirements for the Degree of Master of
Science in Geological Engineering, Applied Geology Program**

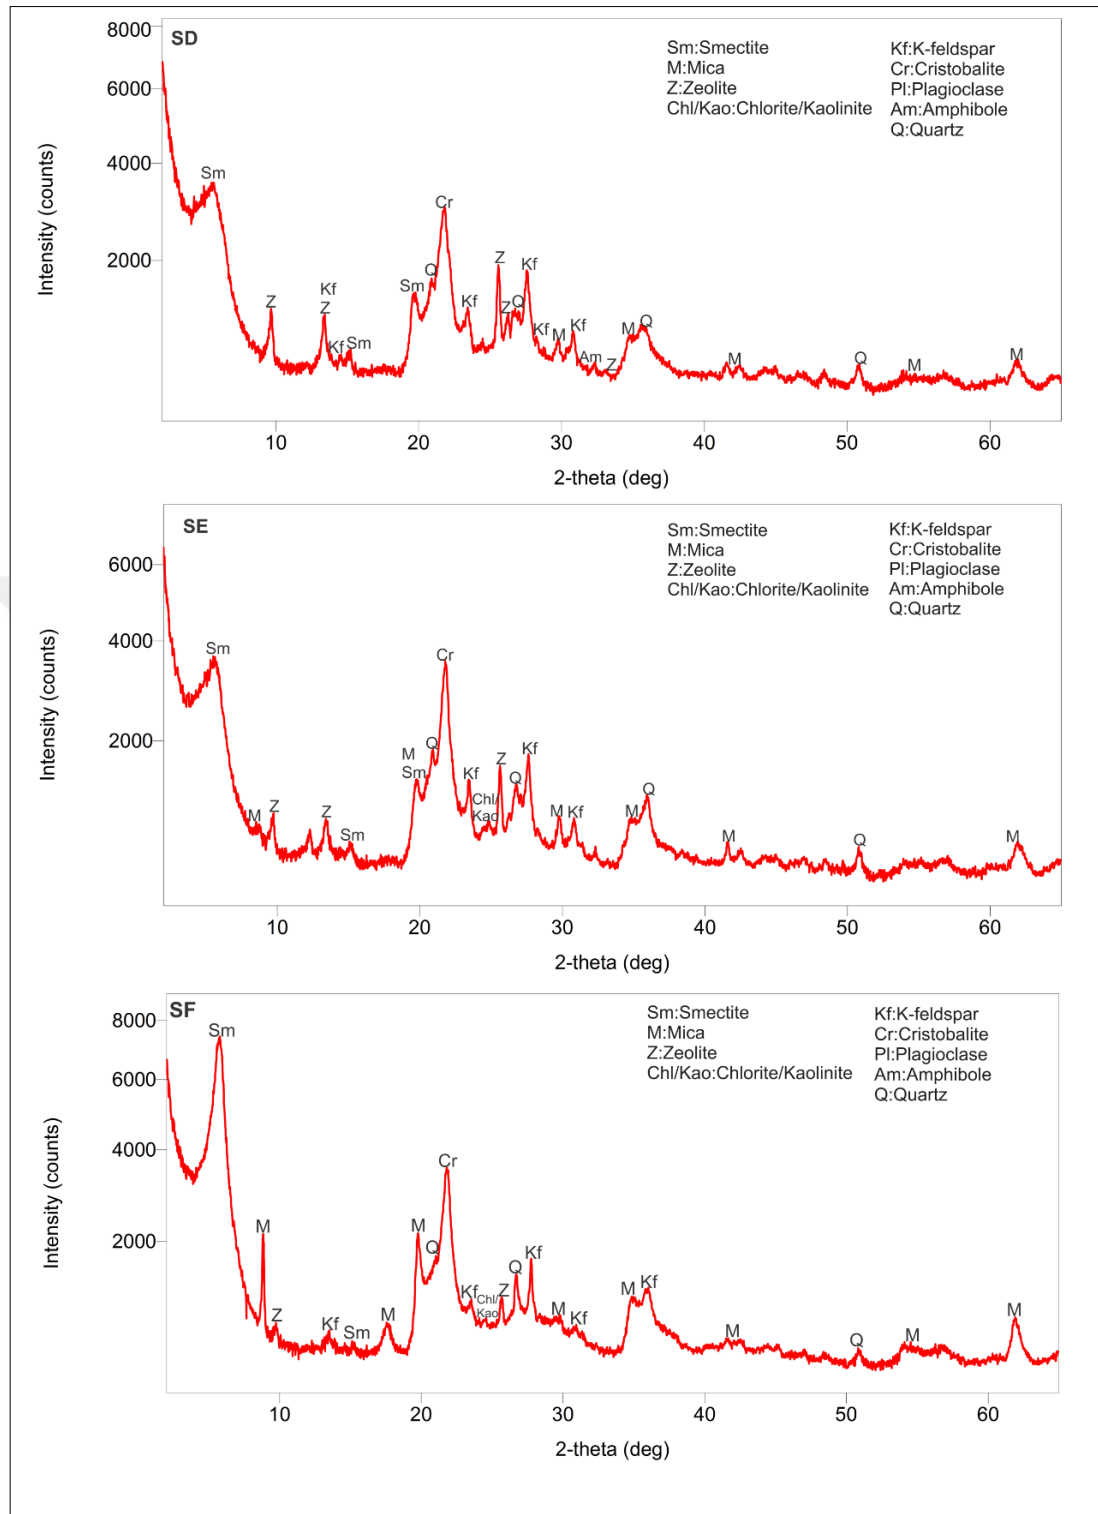
Figure 3.16 X-Ray diffraction diagrams of SD, SE and SF

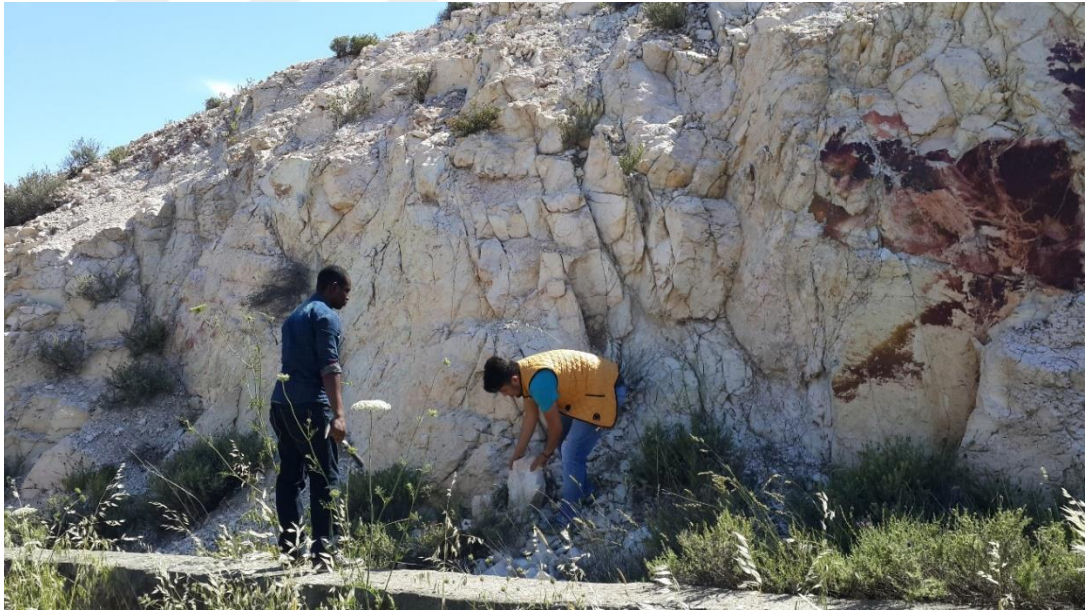
Figure 4.1 Block sample collection from one of the slopes in the study area

Block samples (Figure 4.1) of slightly weathered (SW), moderately weathered (MW) and highly weathered (HW) volcanic tuffs were obtained from ten locations (S1, S2, S3, SA, SB, SC, SD, SE, SF and SG) along the Bagarasi-Foca (Izmir) State Highway. Core specimens were prepared from the block samples in the Rock Mechanics Laboratory (Geological Engineering Department of Dokuz Eylül University). The samples were cut into a length to diameter ratio of 2:1. However, due to the weak nature of the rock samples, core specimen preparation was difficult and some of the specimens could not meet this criterion.

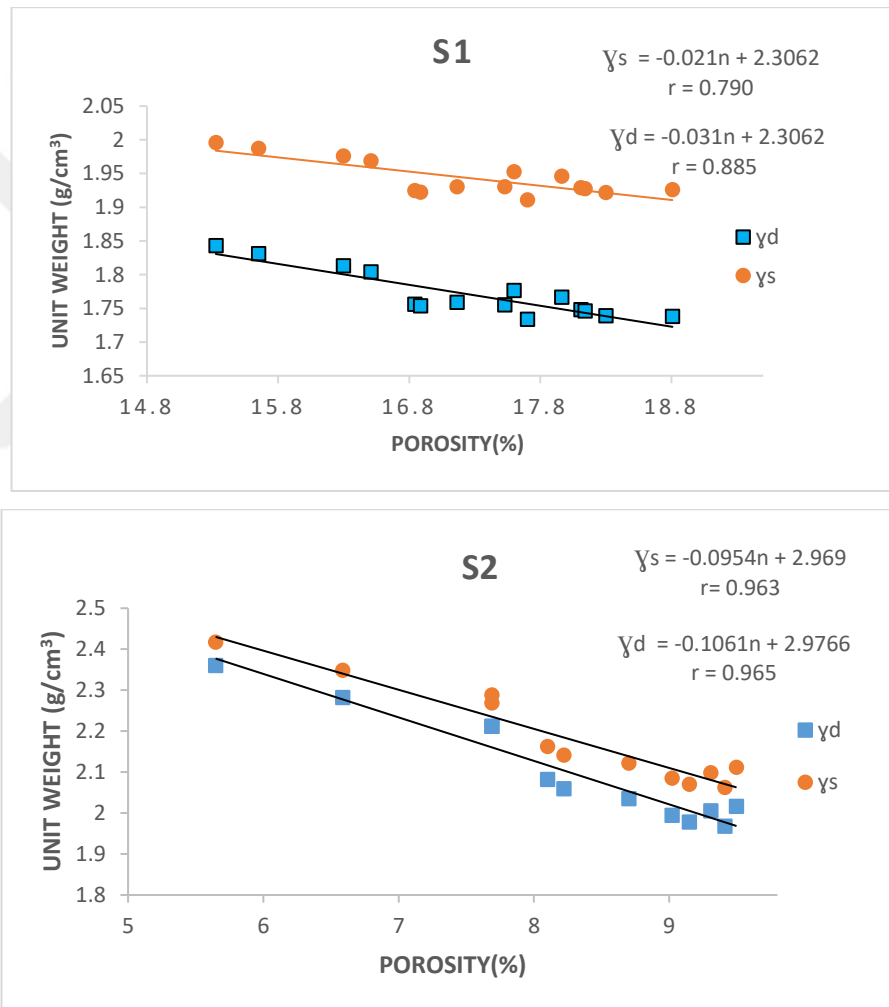
Figure 4.2 Relations between unit weight and porosity (S1 and S2)

The relation between porosity, saturated unit weight and dry unit weight was analyzed. An inverse linear relation was observed between saturated unit weight and porosity and between dry unit weight and porosity for all the specimen groups. Strong linear regression values were obtained for these data sets. Thus, the regression linear equations of these lines are reliable. The graphs and regression equations for these relations are presented below.

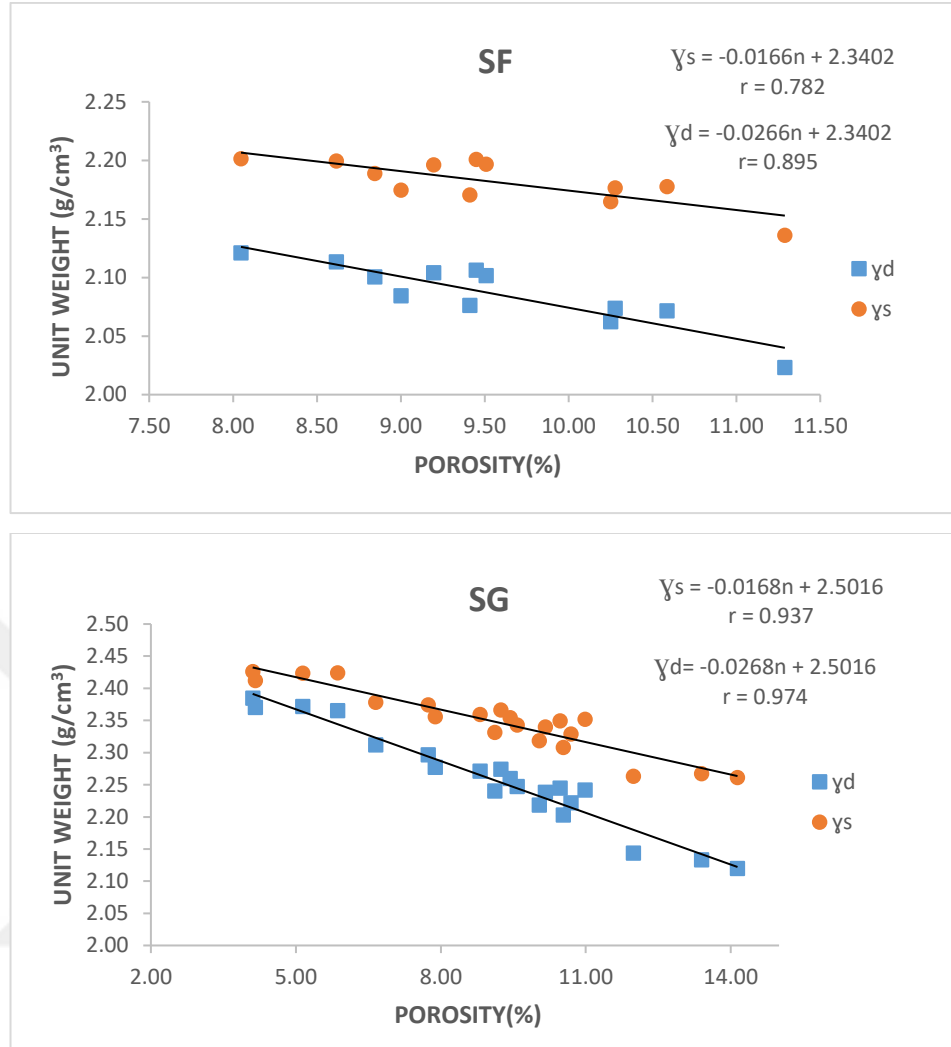
Figure 4.5 Relations between unit weight and porosity (SF and SG)

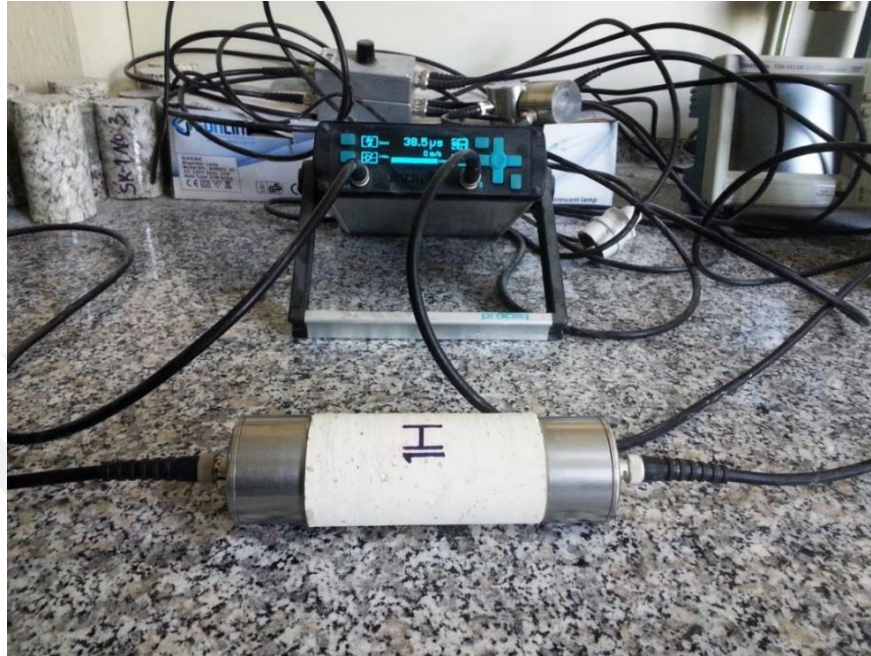
Figure 4.6 A Pundit device in operation

The Pundit Lab (Figure 4.6), an ultrasonic pulse velocity instrument, was used for this test. The data and results of the P-wave velocity tests are presented in Table 4.2. P-wave velocity classification (after IAEG, 1979) is presented in Table 4.3.

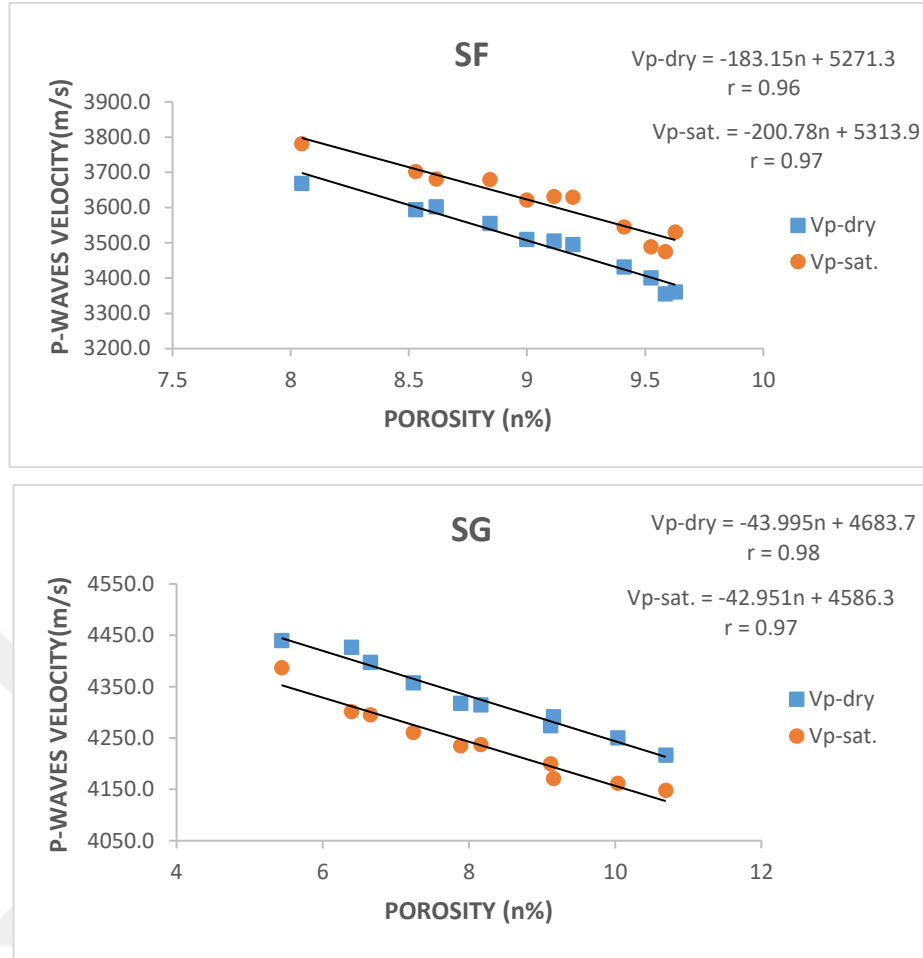
Figure 4.9 Relations between P-wave velocity (Vp-dry, Vp-sat.) and porosity (SF and SG)

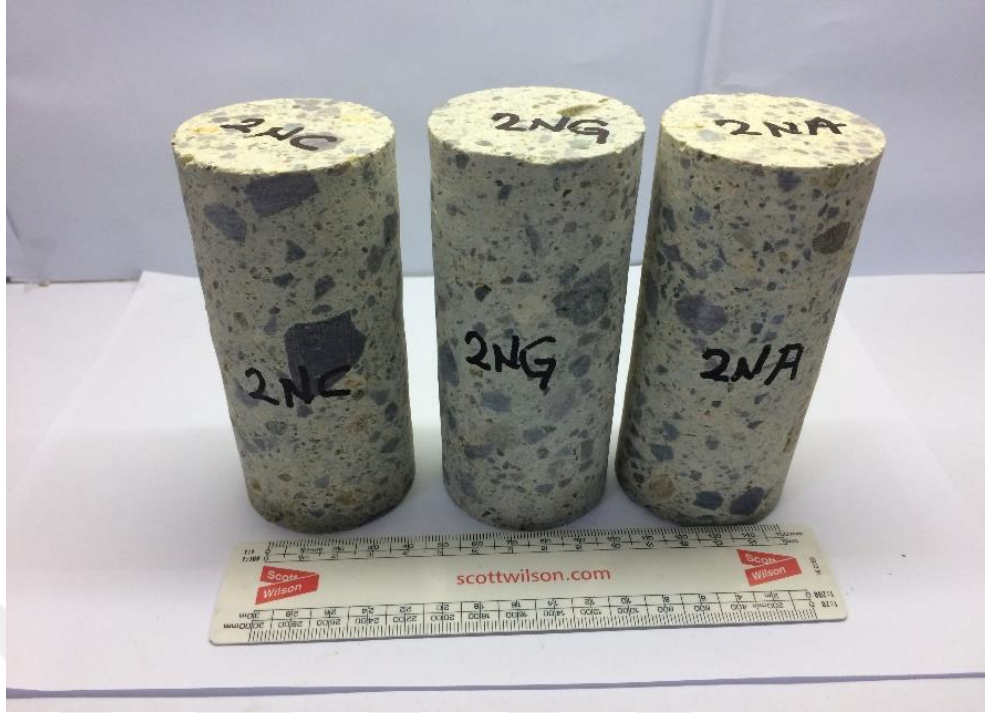
Figure 4.10 Specimens prepared for UCS test

Uniaxial Compressive Strength (UCS) tests were conducted on 111 core specimens from S1, S2, S3, SC, SE, SF, SG and 15 cube specimens from SD. The tests were conducted according to ASTM D7012-14. UCS tests were conducted on both saturated (sat.) and dry specimens. As prescribed by ASTM (2014), the core specimens were cut to recommended lengths and the ends were flattened with a diamond-cutting blade. UCS is useful in determining the strength of intact rock. An image of some of the specimens prepared for the UCS test is presented in Figure 4.10. UCS tests could not be conducted for SA and SB due to their weathered nature and the presence of multiple joints.

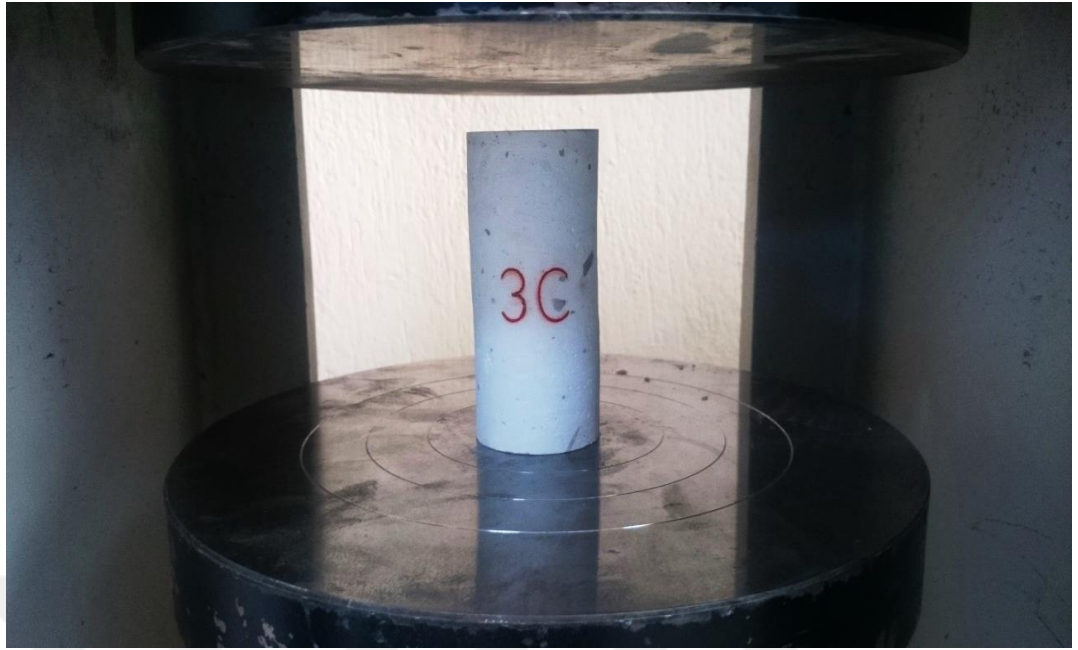
Figure 4.11 Core specimen in a loading chamber

An image of one of the specimens in a loading chamber is presented in Figure 4.11 while an image of some of the specimens at failure is presented in Figure 4.12. The calculated UCS values are presented in Table 4.4.

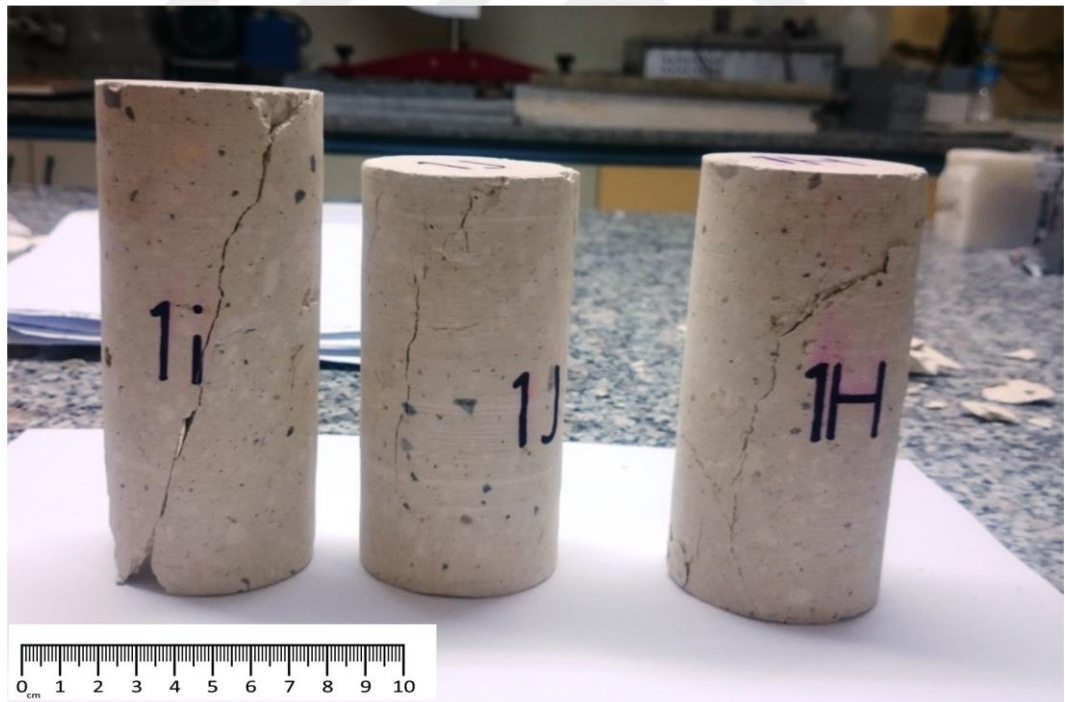
Figure 4.12 Core specimens at failure

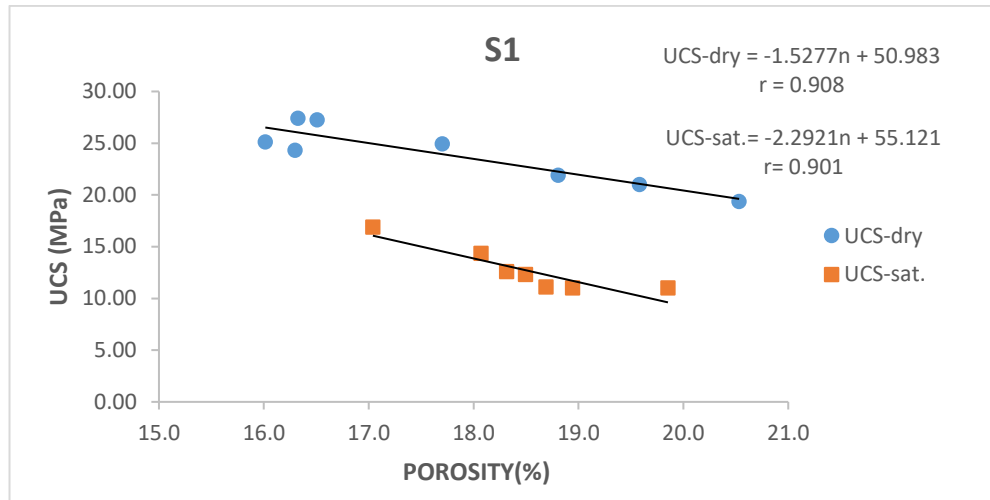
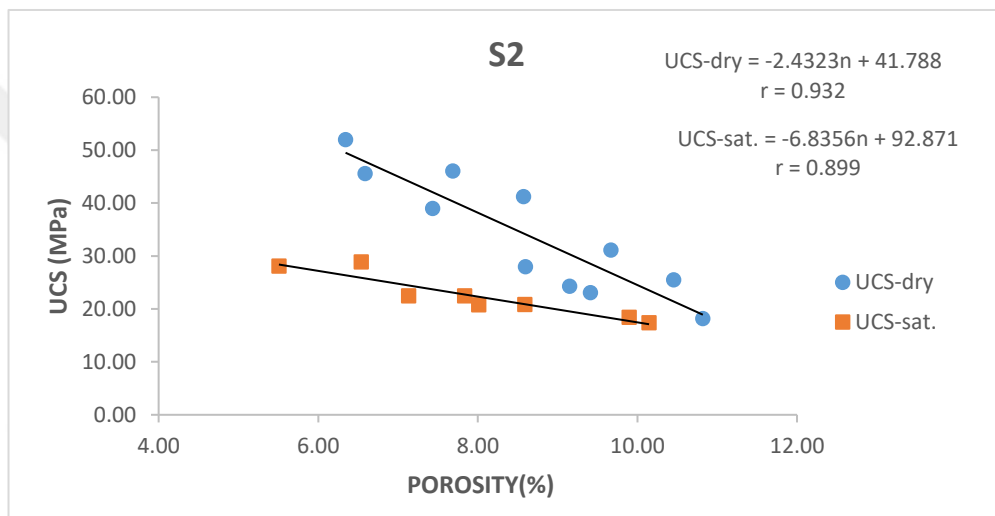
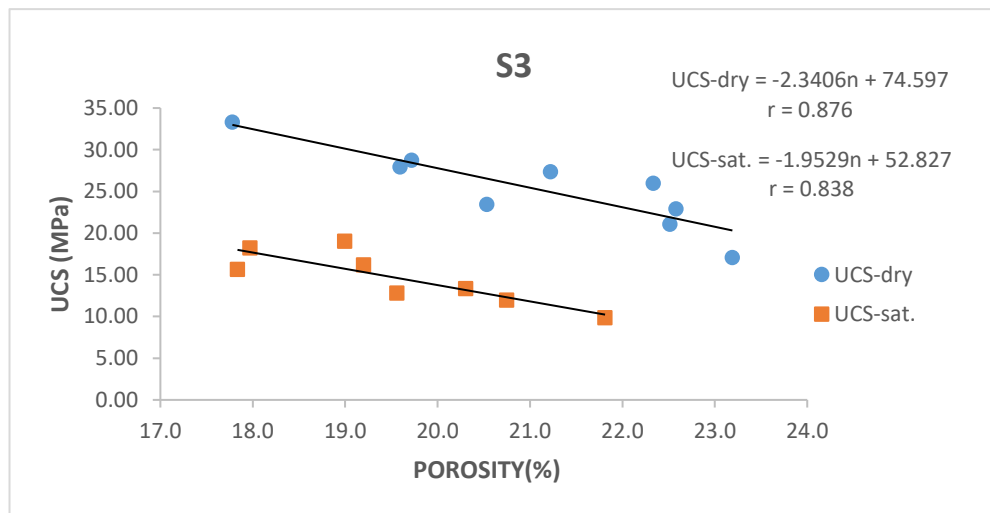
Figure 4.13 Relations between UCS and porosity (S1, S2 and S3)

Analyses were conducted to determine the relations between UCS and porosity. An inverse linear relation was found to exist between the two index properties in each case. The graphs and regression equations for these relations are presented below.

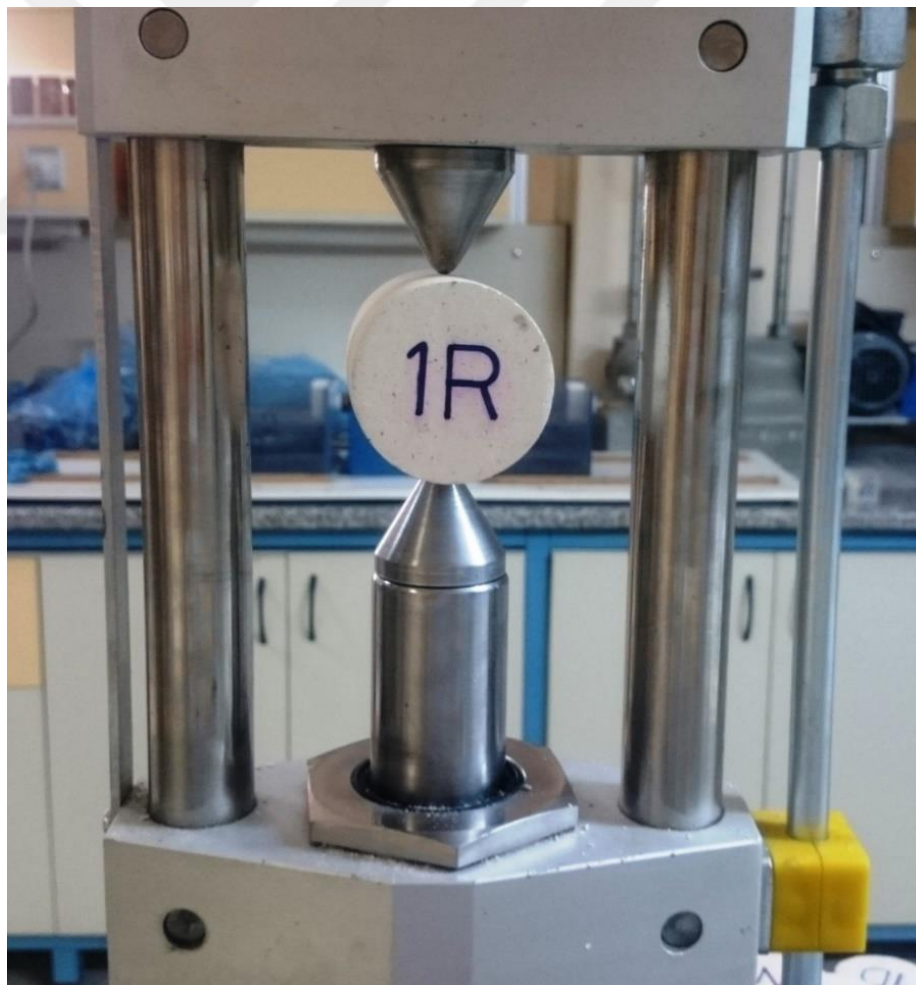
Figure 4.16. Point Load Test- specimen in a loading frame

The test was conducted according to ASTM D5731-16. According to ASTM (2008), Point Load Index test can be conducted both in the laboratory and in the field on rock cores, blocks or irregular lumps with a diameter between 30-85 mm and is suitable for estimating the uniaxial compressive strength of a rock within a short time interval. An image of a specimen being tested in a loading frame is presented in Figure 4.16.

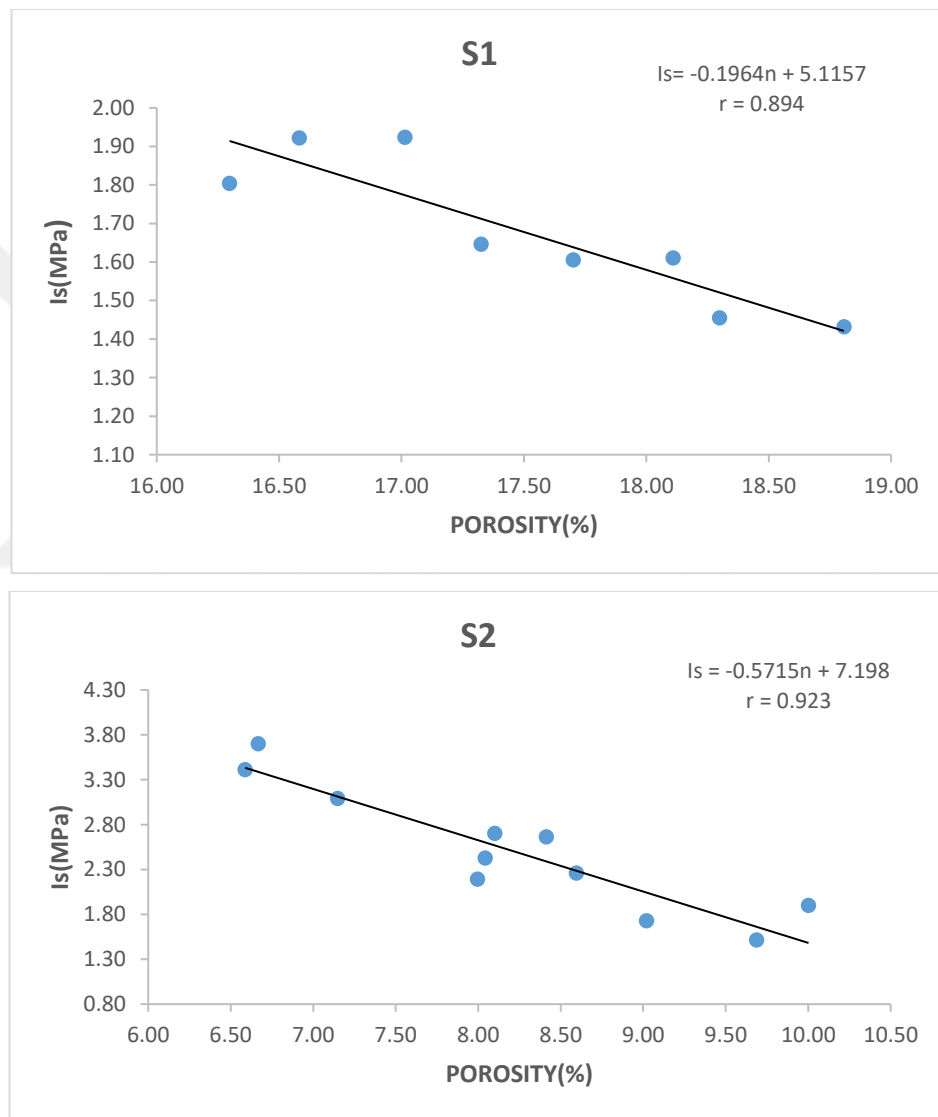
Figure 4.17 Relations between point load index and porosity (S1 and S2)

Analyses were conducted to determine the relation between Point Load Index, and Porosity. An inverse linear relation was found to exist between the two properties in all the ten specimen groups. The graphs and regression equations for these relations are presented below.

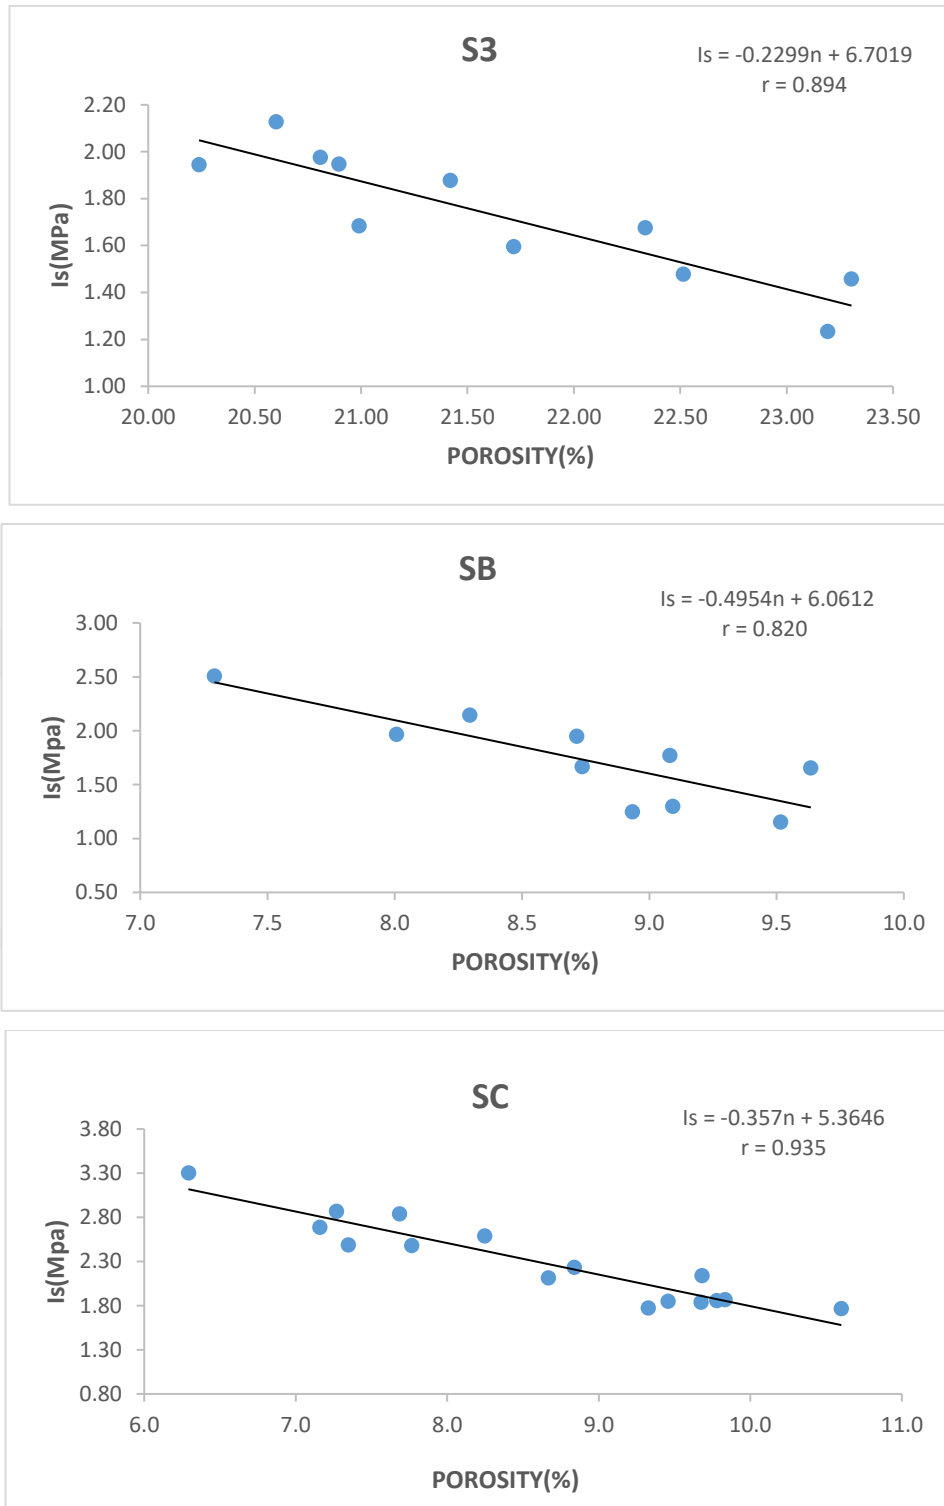
Figure 4.18 Relations between point load index and porosity (S3, SB and SC)

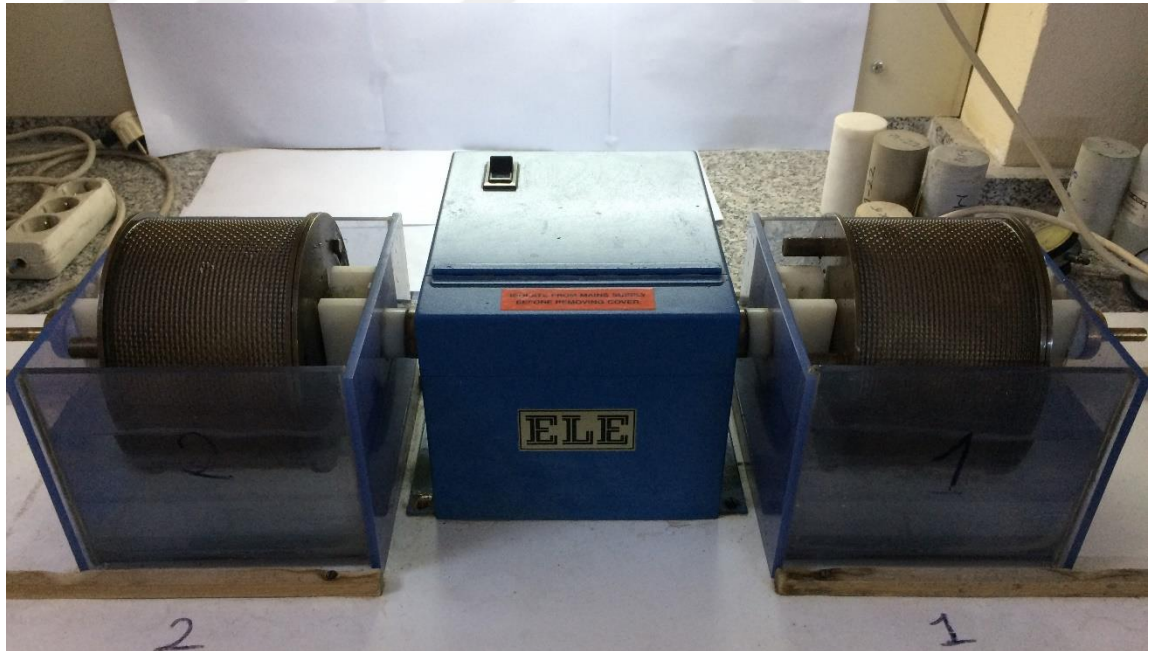
Figure 4.23 Slake Durability Index test device

Id Index tests were conducted according to ASTM standard (D4644-16). The tests were conducted on ten samples from the ten different locations (S1, S2, S3, SA, SB, SC, SD, SE, SF, and SG) with different weathering grades (SW-HW). The samples were oven-dried prior to conducting the test. Ten (10) spherical rock samples of 40-60 g each, with a total mass of 450-550 g were prepared. For each cycle, a rotation speed of 20 rpm was used for 10 minutes. The samples were dried for 12 hours at 105 °C after each cycle. The tests were conducted for five cycles (Id₅) per each sample group. An image of the slake durability index testing device is presented in Figure 4.23.

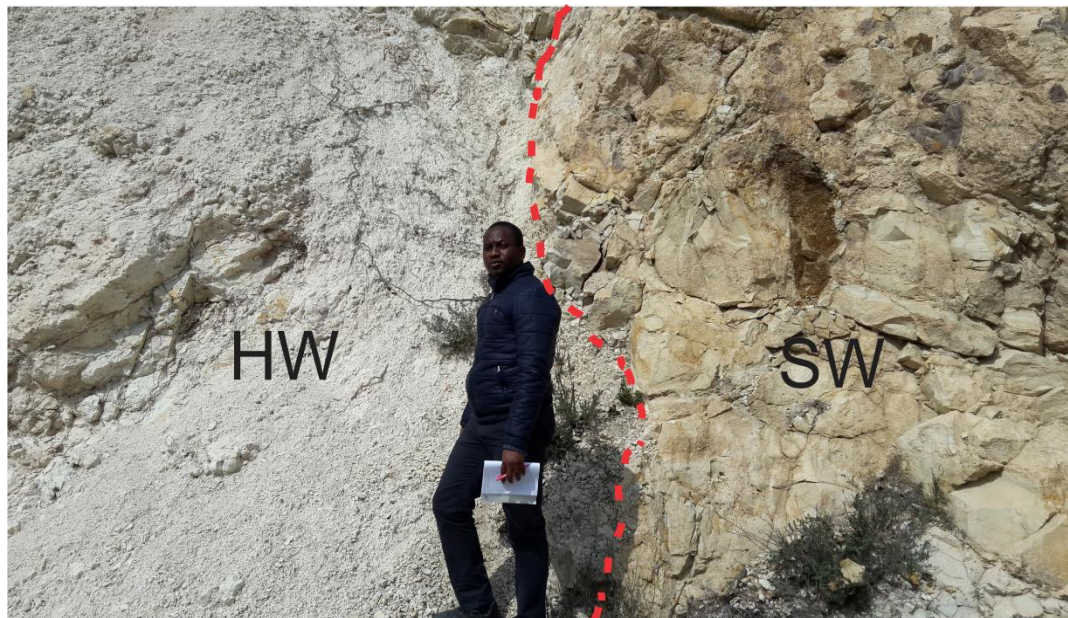
Figure 4.24 Differential weathering observed in the field

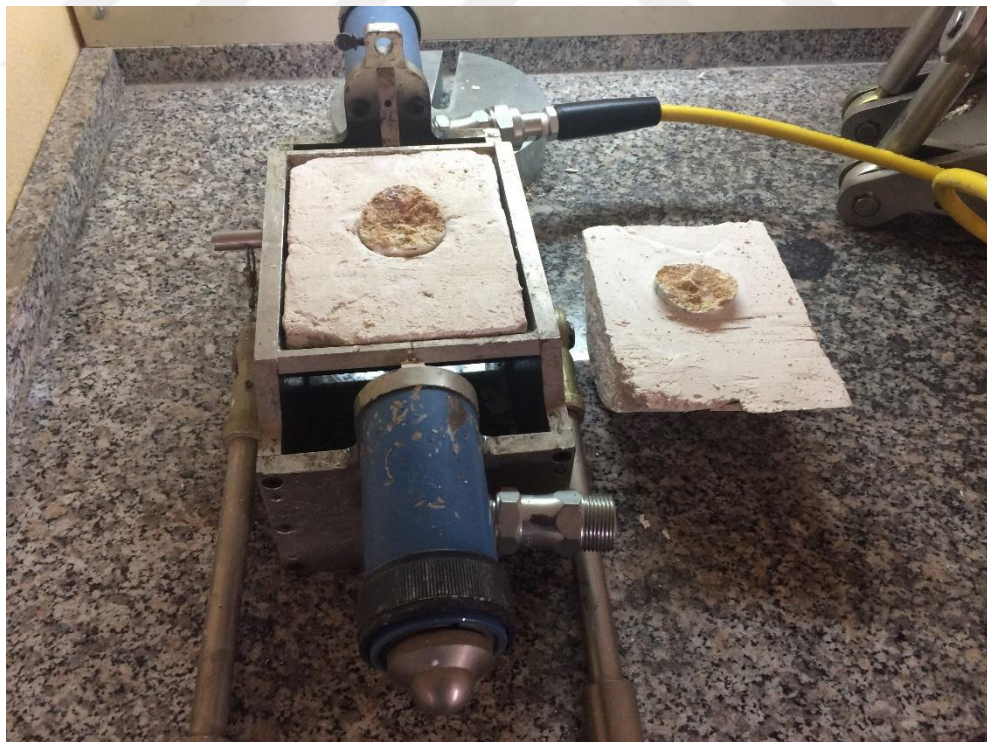
Figure 4.25 Specimen in shear box device

The specimens were mounted in the shear box (Figure 4.25) and an increasing external shear force was applied along the shear plane under a constant normal force. Normal loads of 0.36, 0.72 and 1.07 kN were used for the test. The normal and shear displacements were recorded. The test data sheets and results are presented in Appendix 4. Peak friction angles obtained were 33.52° and 29.59° . There was no cohesion between the joints.

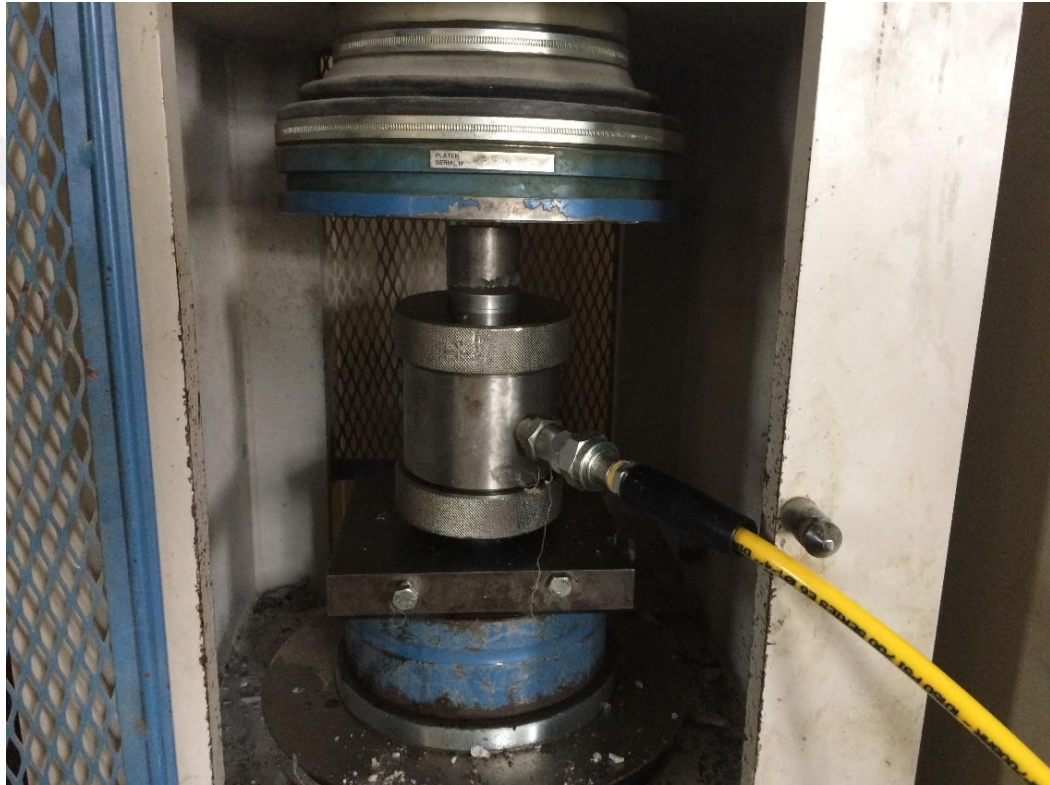
Figure 4.26 Triaxial compression test

Triaxial Compressive strength tests were conducted on 15 (SW-HW) Vitric Tuffs (VT) and Lithic Tuffs (LT). The tests were conducted according to ASTM D7012-14. The specimens had an average length to diameter ratio of 2:1. The specimens were placed in a flexible membrane within a confining chamber. The specimens were then subjected to lateral fluid pressure (3, 4, 6 and 9 MPa) and axial loading (Figure 4.26).

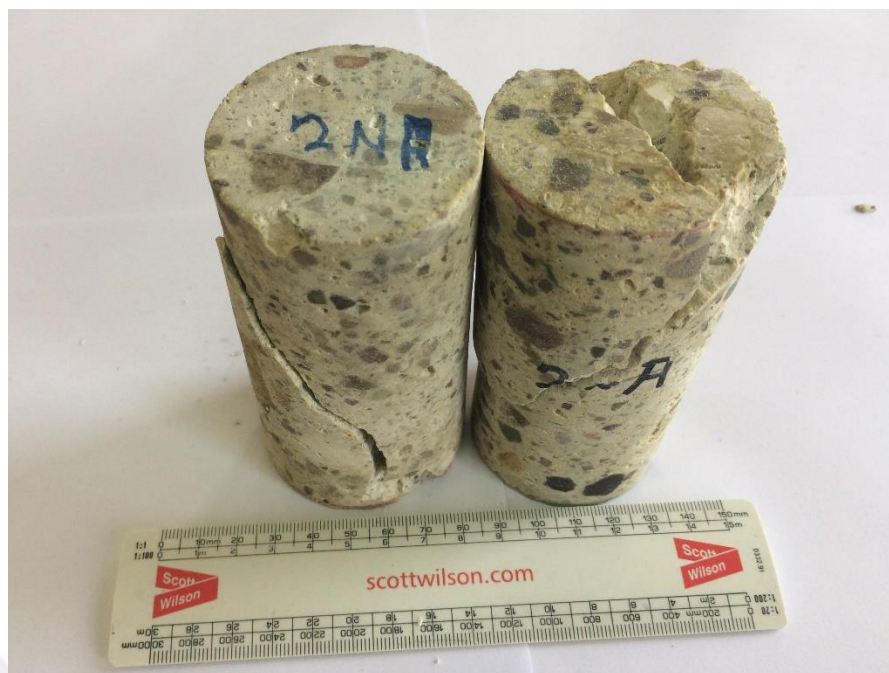
Figure 4.27 Specimens at failure

An image of specimens at failure is presented in Figure 4.27. Test data and results are presented in Table 4.10. Mohr-coulomb parameters -friction angle (Φ) and cohesion values (C) - were calculated using the lateral stress (σ_3) and axial stress (σ_1) values. The parameters were calculated with the aid of Roclab software, by Rocscience (Figure 4.28). The calculated values are presented in Table 4.11.

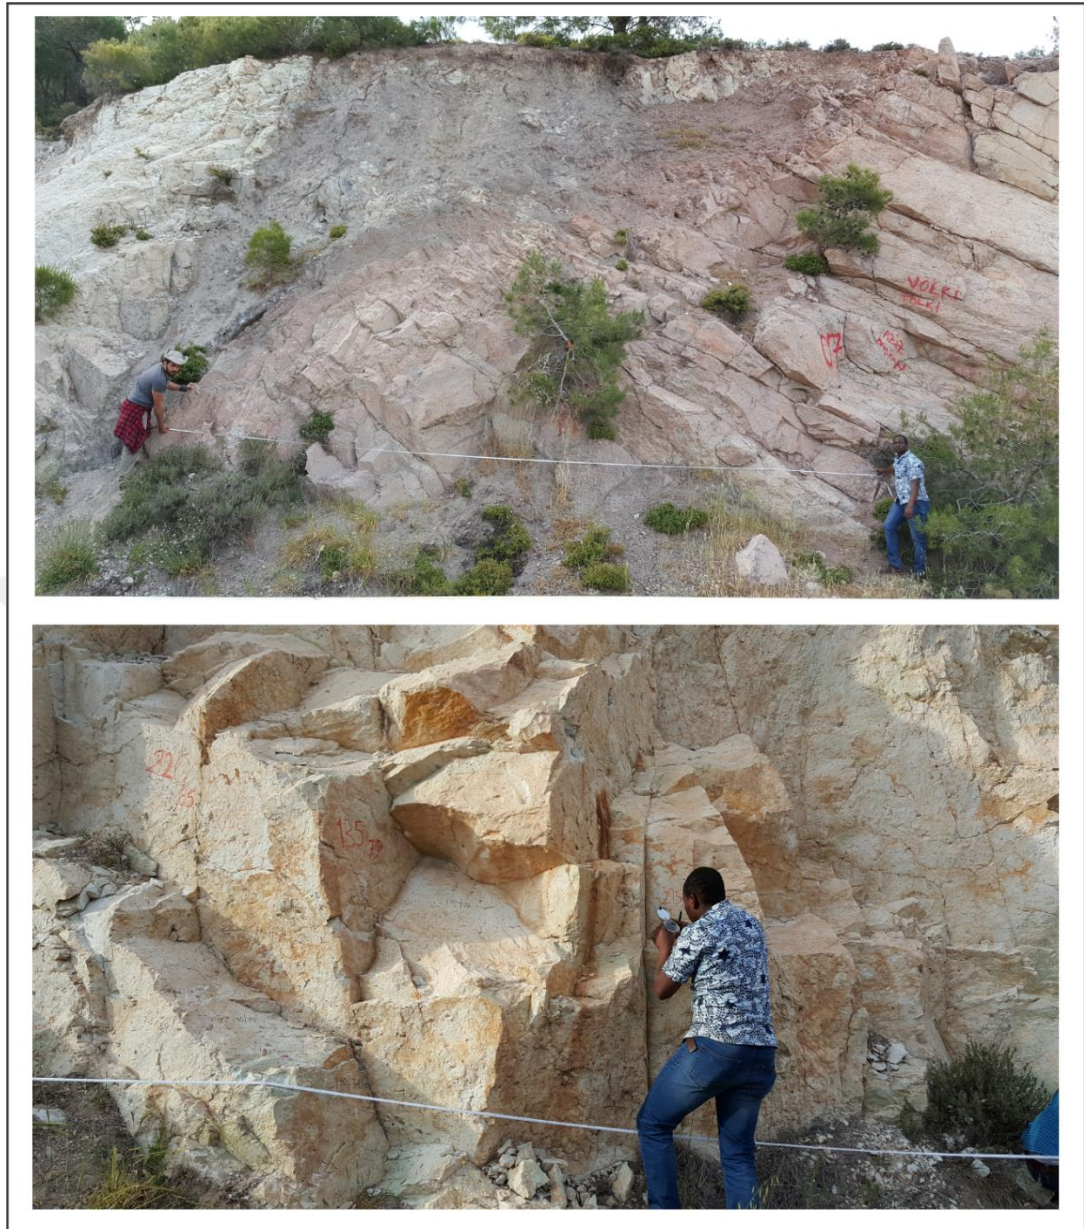
Figure 4.30 Images from the scanline mapping

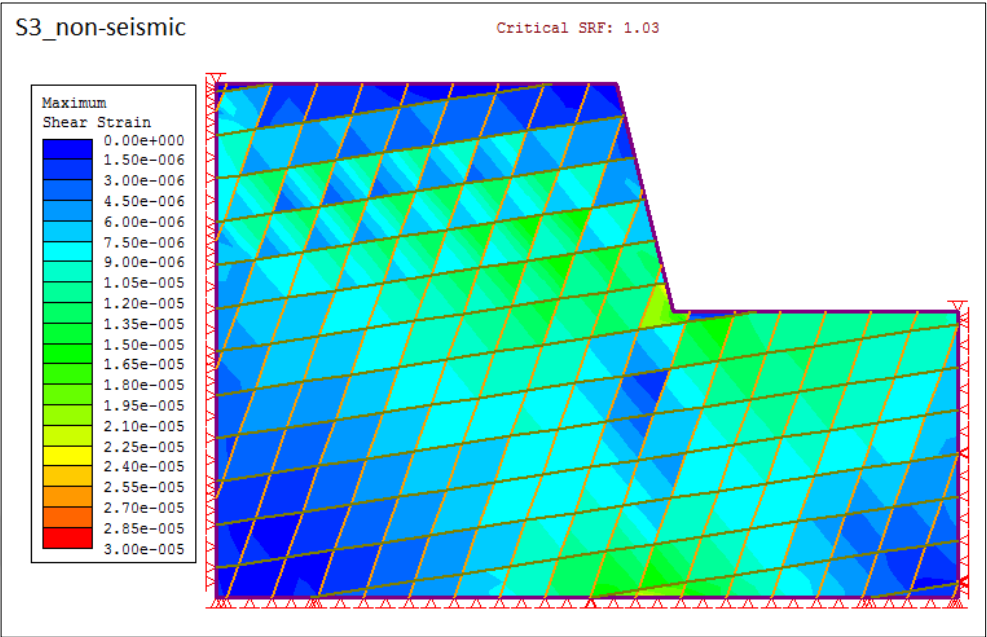
Figure 4.40 SRF-dry condition (S3)

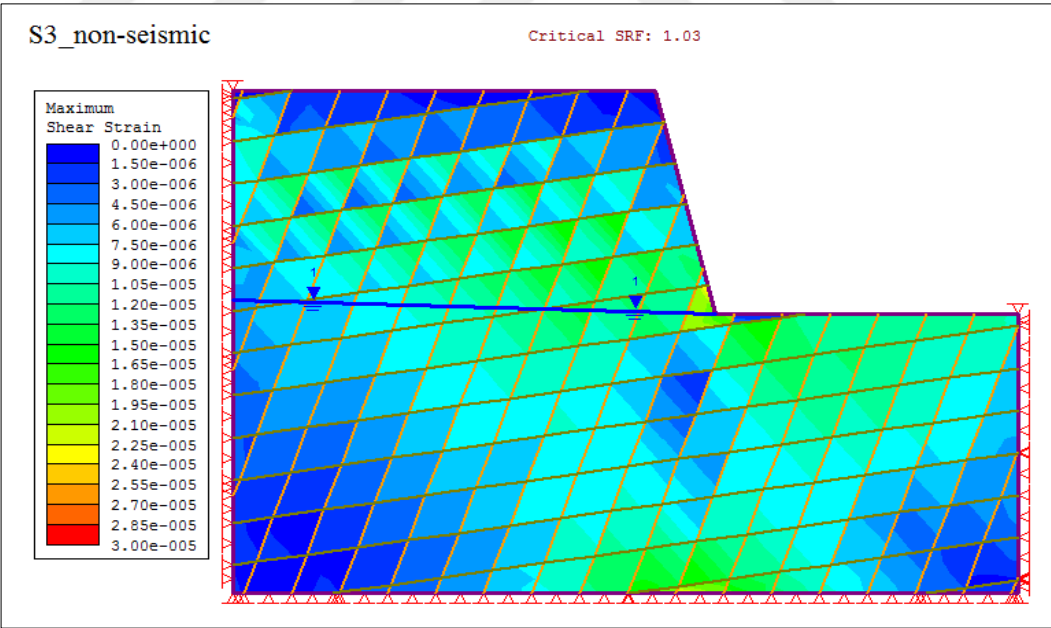
Figure 4.41 SRF-Piezometric line at toe of slope (S3)

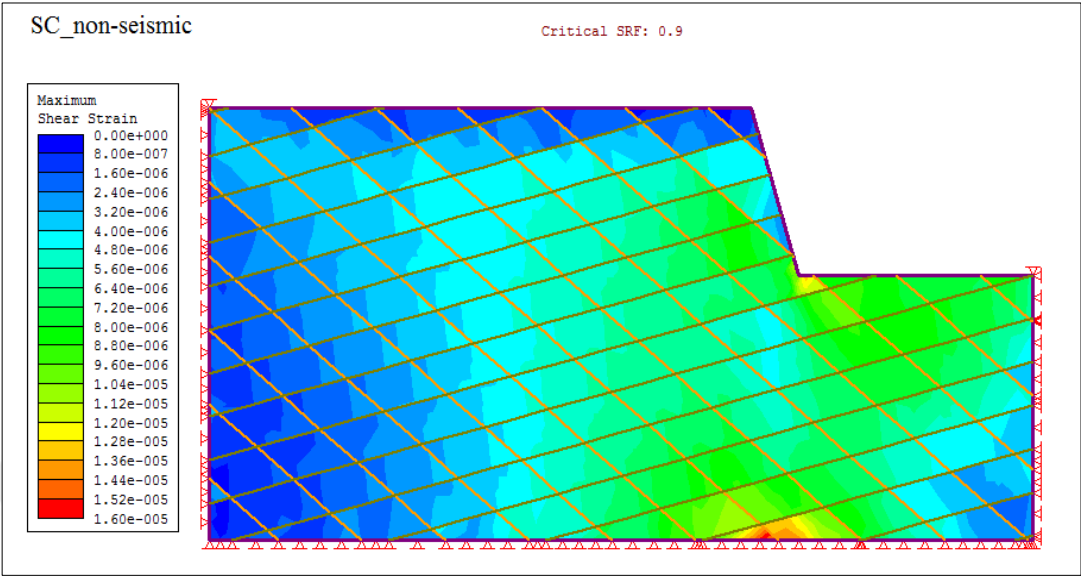
Figure 4.43 SRF-dry condition (SC)

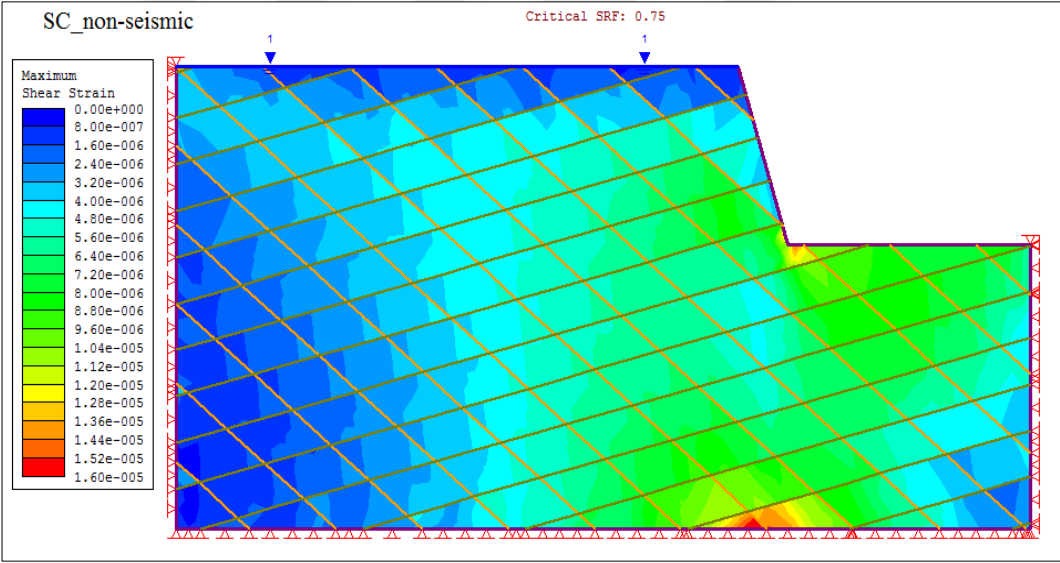
Figure 4.44 SRF-Piezometric line at top of slope (SC)

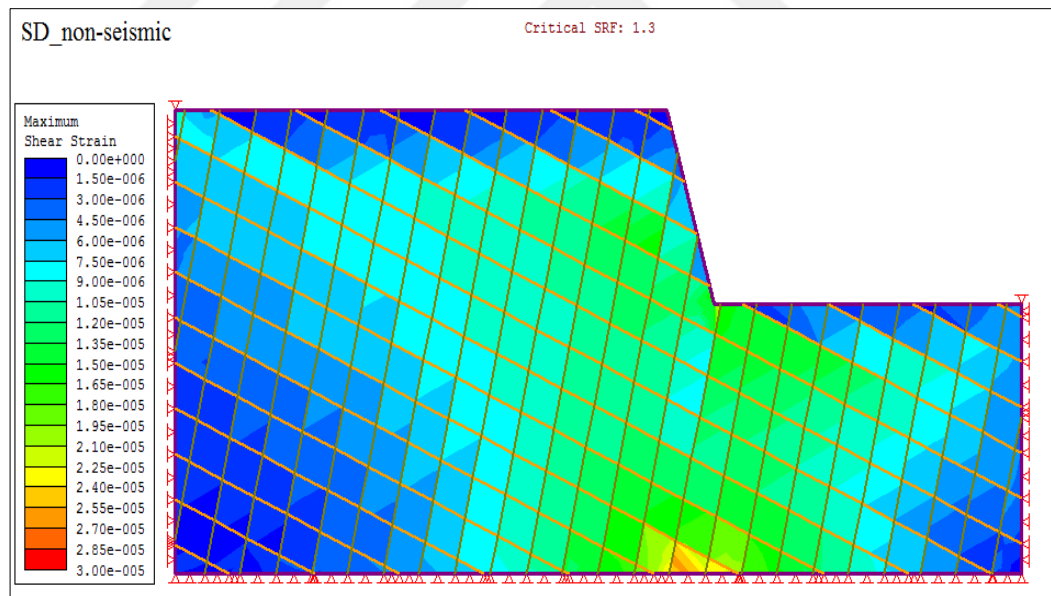
Figure 4.45 SRF-dry condition (SD)

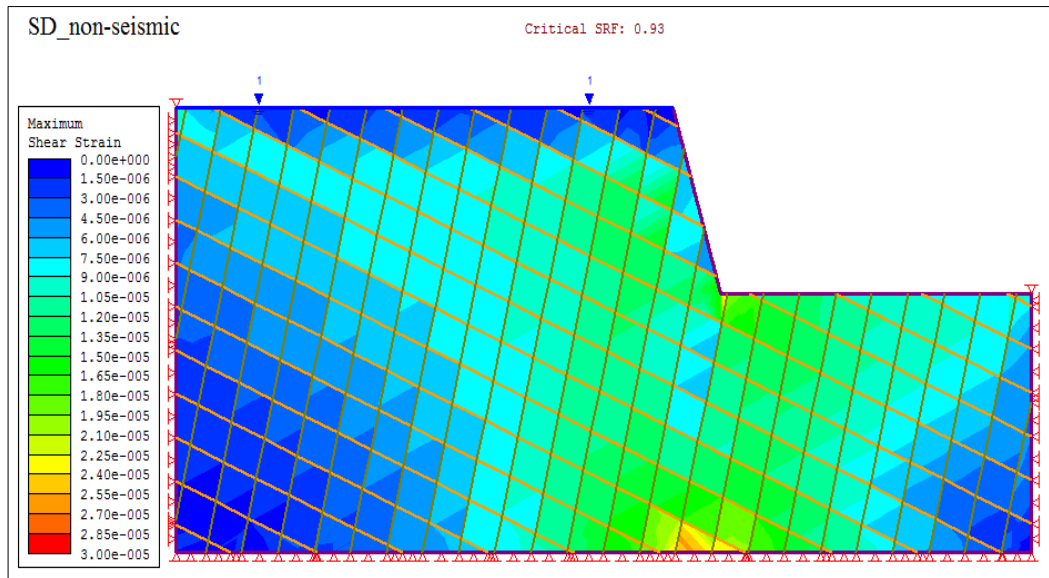
Figure 4.46 SRF-Piezometric line at top of slope (SD)
