**ENGINEERING GEOLOGY OF THE STATE
HIGHWAY SLOPES BETWEEN BAĞARASI-
FOÇA (İZMİR)**

**A Thesis Submitted to the
Graduate School of Natural and Applied Sciences of Dokuz Eylül University
In Partial Fulfillment of the Requirements for the Degree of Master of
Science in Geological Engineering, Applied Geology Program**

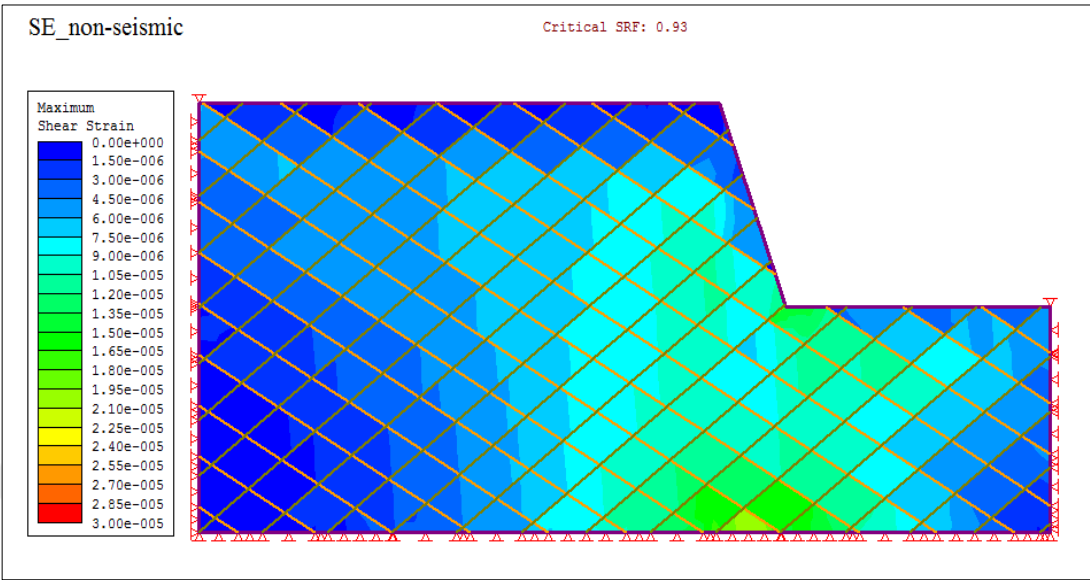
Figure 4.47 SRF-dry condition (SE)

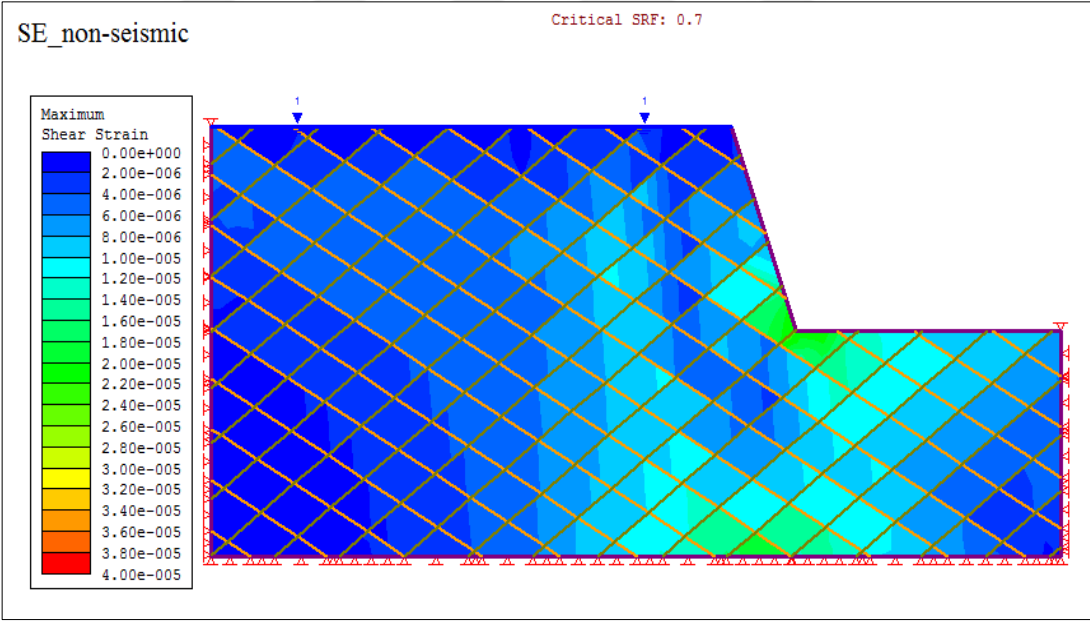
Figure 4.48 SRF-Piezometric line at top of slope (SE)

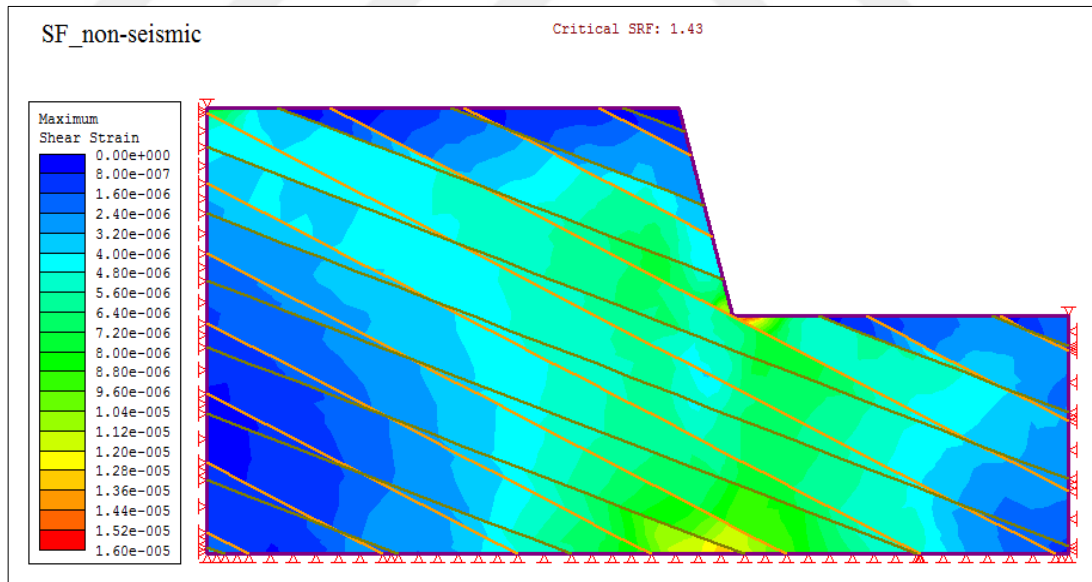
Figure 4.49 SRF-dry condition (SF)

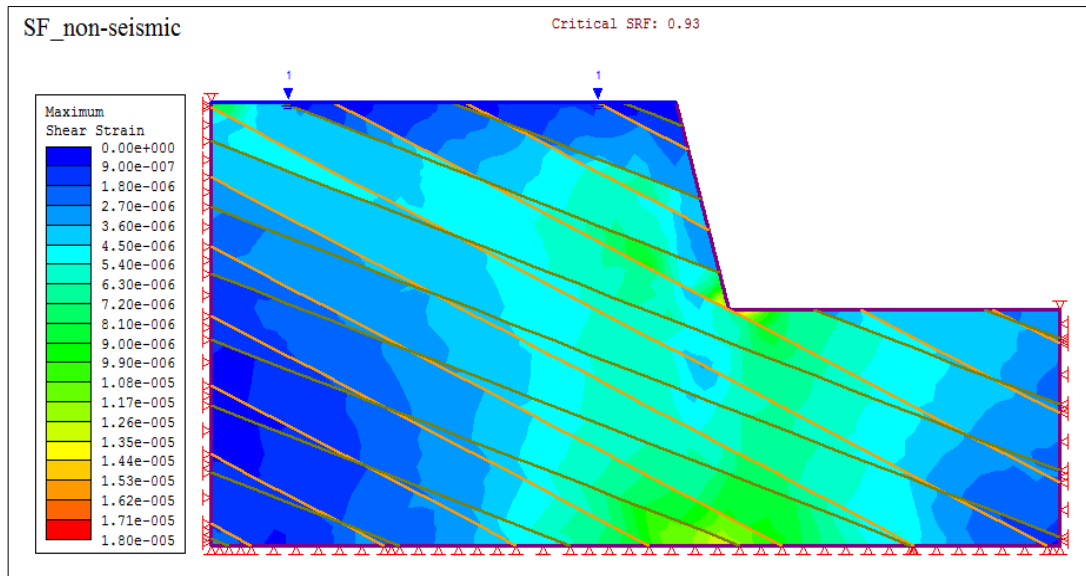
Figure 4.50 SRF-Piezometric line at top of slope (SF)

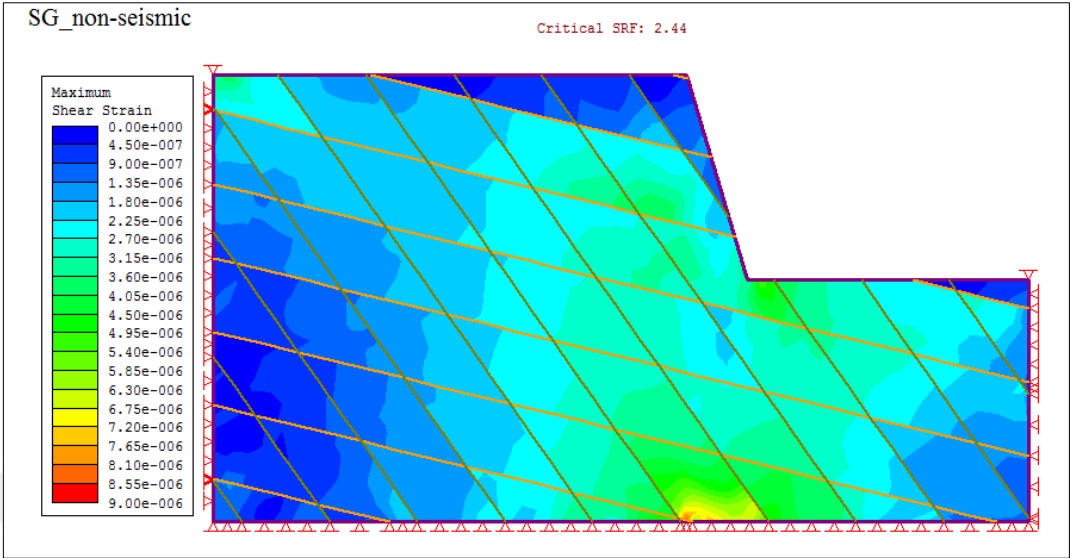
Figure 4.51 SRF-dry condition (SG)

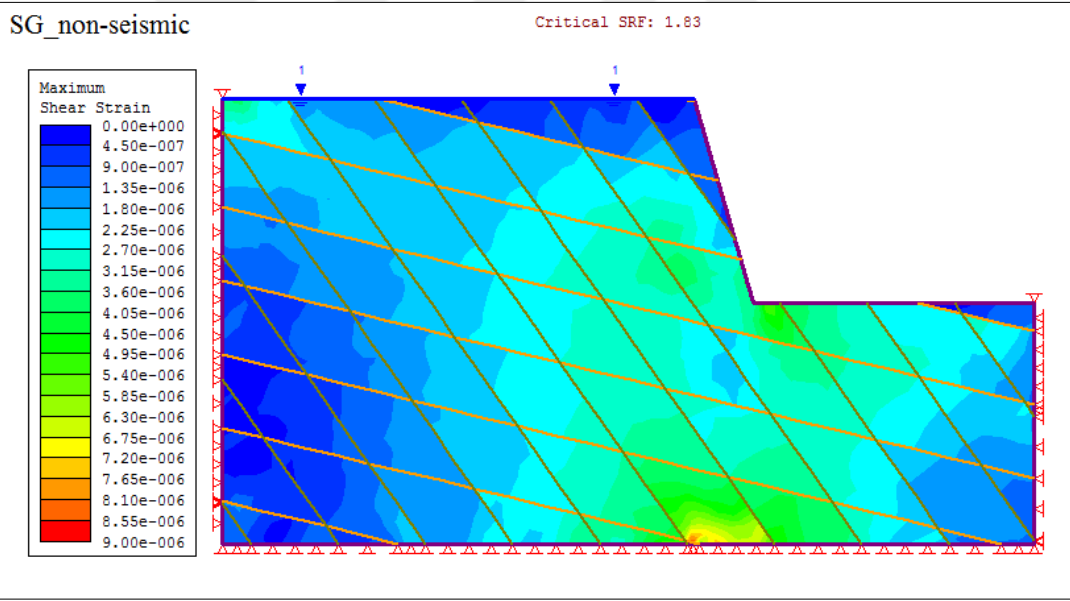
Figure 4.52 SRF-Piezometric line at top of slope (SG)
