**MONITORING AND NUMERICAL ANALYSIS OF
OPEN PIT MINE SLOPES IN GNEISSES**

August, 2021

**A Thesis Submitted to the
Graduate School of Natural and Applied Sciences of Dokuz Eylül University
In Partial Fulfillment of the Requirements for the Degree of Master of
Science in Geological Engineering, Applied Geology Program**

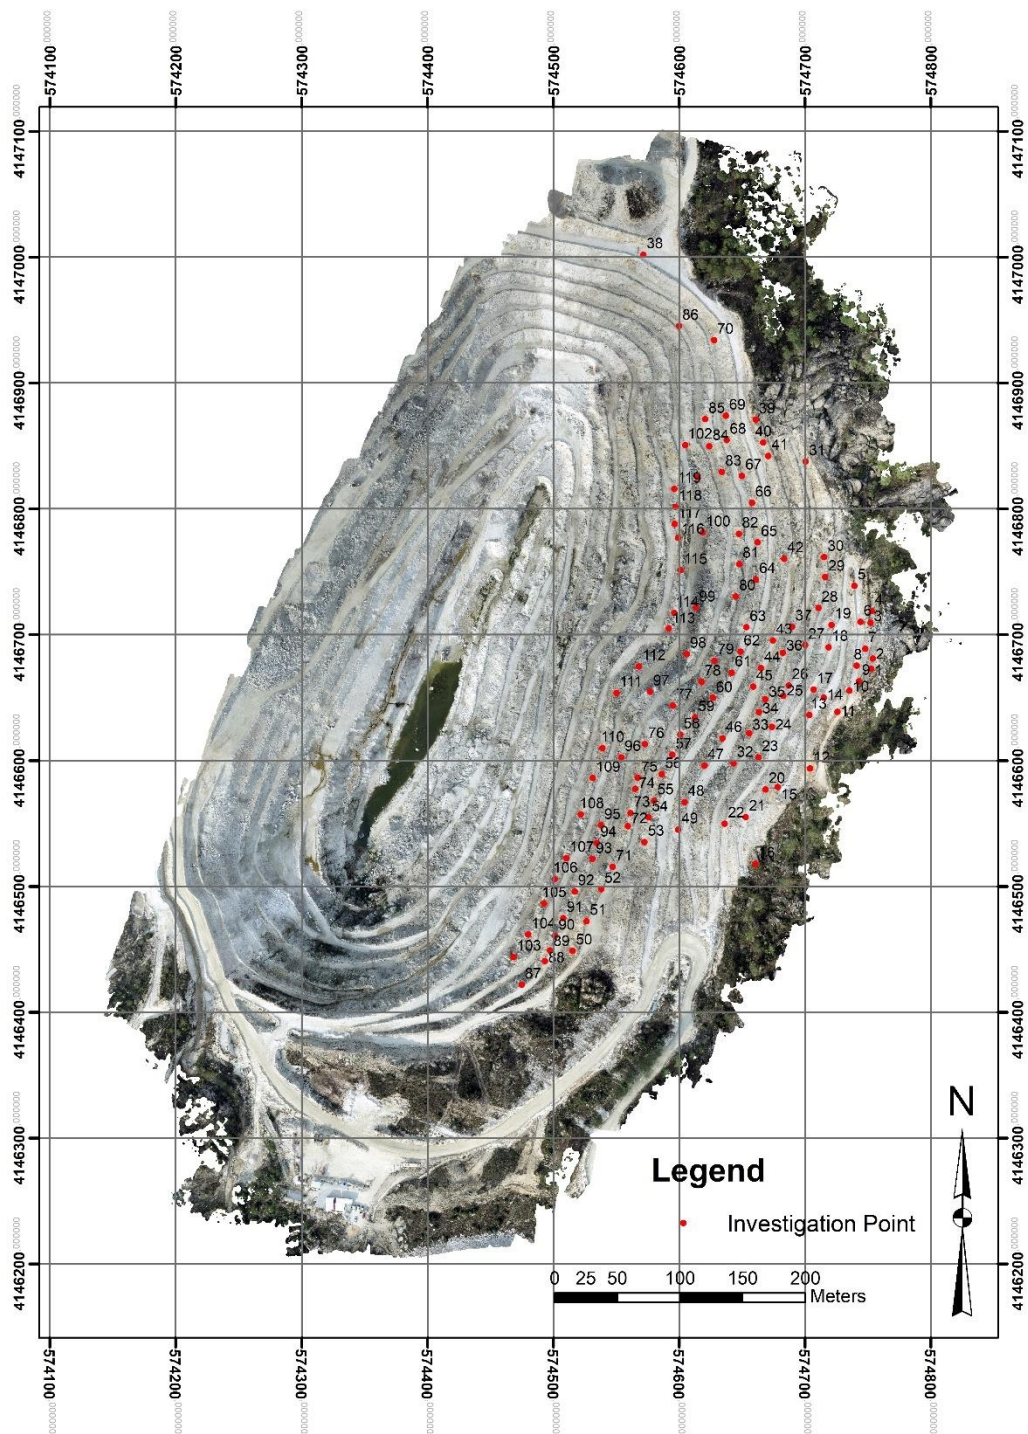
Figure 3.3 Observation points where discontinuity measurements were made on the eastern side of the albite operation

The line survey method was used to determine the characteristics of the discontinuities in the slopes located in the eastern part of the mine site. The line survey method is a method that allows examining the rock mass and taking measurements from discontinuities. In this study, the methods recommended by ISRM (2007) were used. For the line study method, which is an effective method in collecting data on the properties of discontinuities, in this study, the properties of discontinuities were revealed by taking 1619 measurements of approximately 1000 m in length. Observations were made only on the eastern slopes of the mine site (Figure 3.3). With the line survey studies, features such as orientation of the discontinuities, spacing, continuity, surface roughness and waviness, degree of degradation, the characteristics of the filling material and the water state on their surfaces have been determined. The orientation of the discontinuities was determined with the Brunton brand geologist compass, the roughness of the discontinuity surfaces with the Barton roughness comb, the spacing and spacing of the discontinuities were determined with a tape measure and digital caliper.

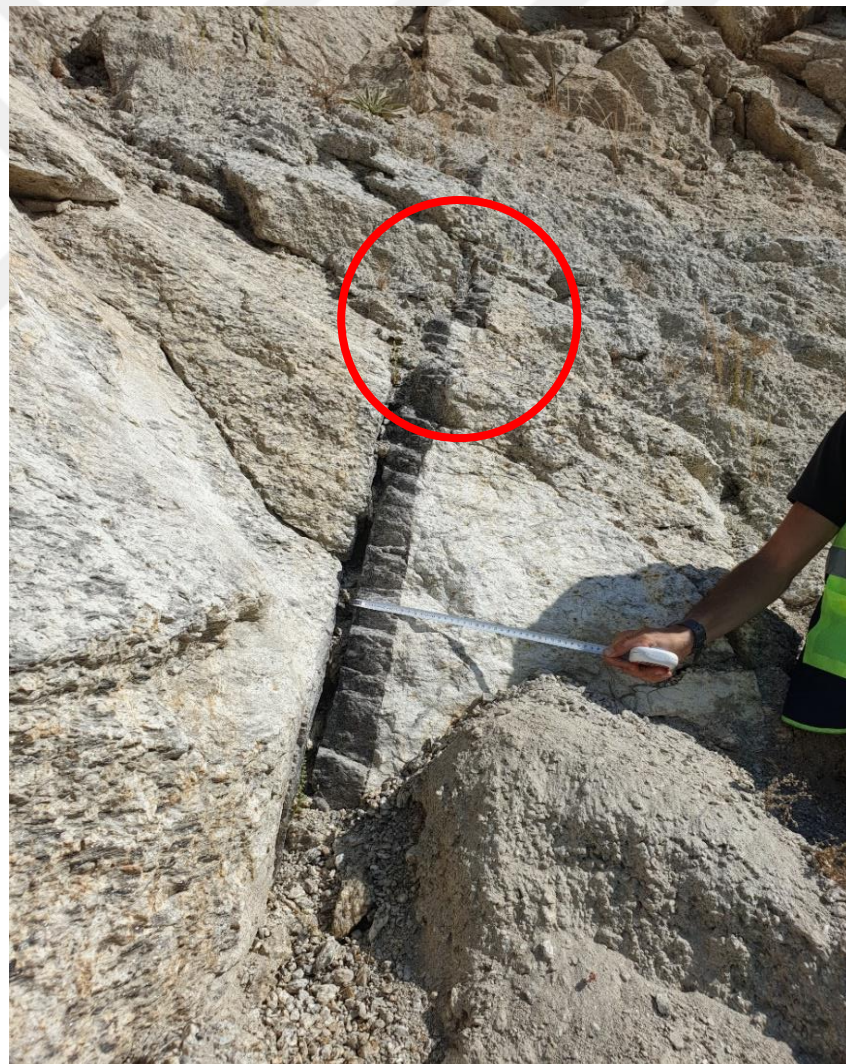
Figure 3.4 The fault causing the quartz vein observed in the study area to slip by approximately 10cm (Personal archive, 2020)

1. *Fault*- If the displacement is visible to the naked eye, such discontinuities can be called faults (Figure 3.4).

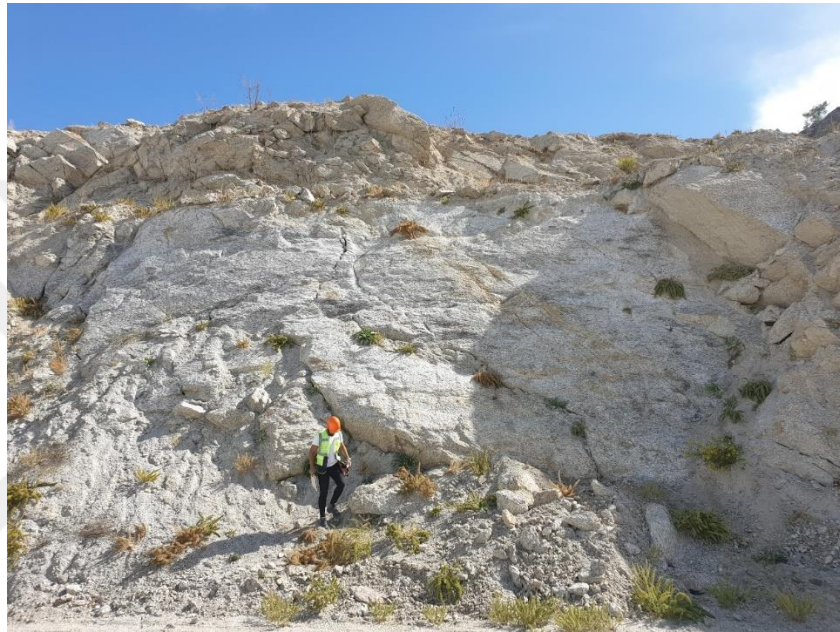
Figure 3.5 Foliation planes causing planar shifts in the study area (Personal archive, 2020)

2. Bedding—Parallel-surfaced structures that accumulate over geological time with or without a physical formation.
3. Foliation- These are the structures where minerals develop parallel to each other after being exposed to different temperatures and pressures after their formation (Figure 3.5).

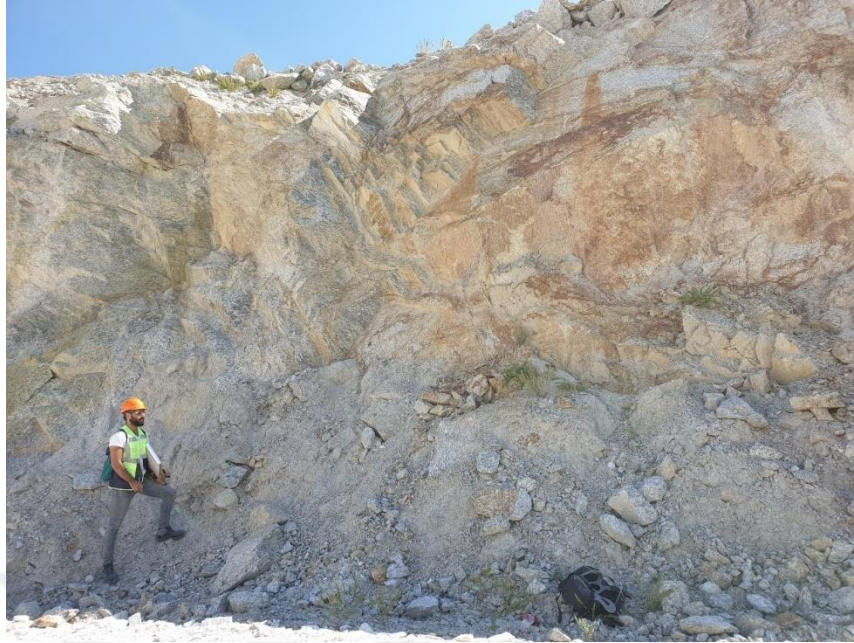
Figure 3.6 Joints and joint sets in slope steps (Personal archive, 2020)

4. Joint—Fractures or cracks in discontinuities where no movement is observed. They are usually cut by other geological structures (flow bands, foliation, etc.). Joints can develop parallel to each other or at an angle to each other (Hoek & Bray, 2004) (Figure 3.6).

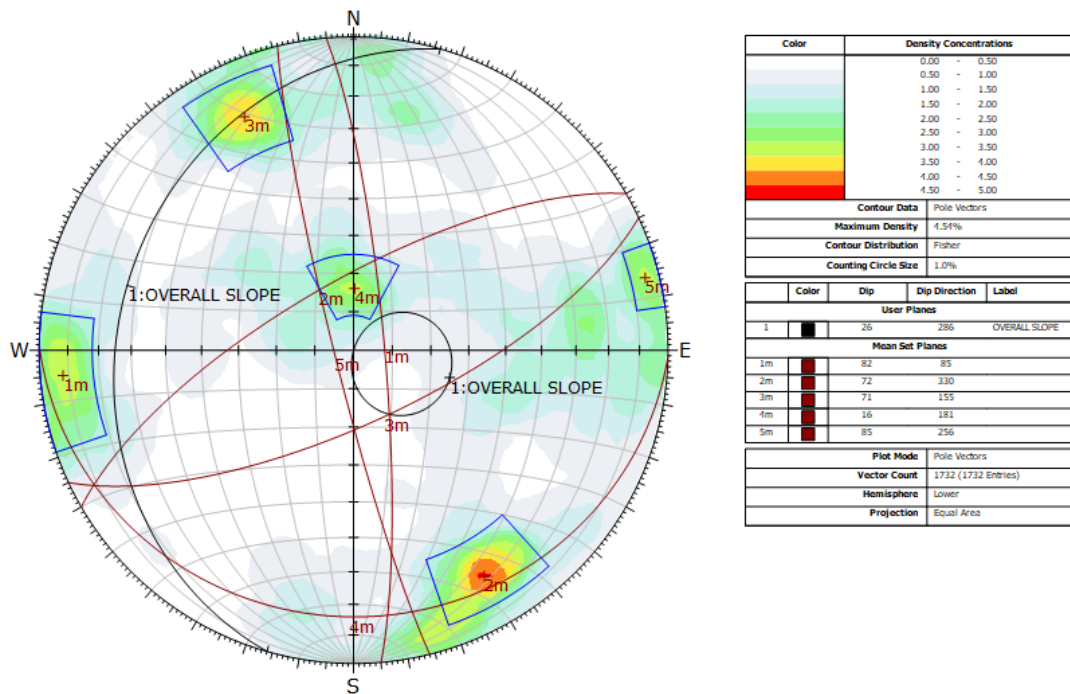
Figure 3.8 Concentration points in the dips program of 1613 discontinuities taken from the field

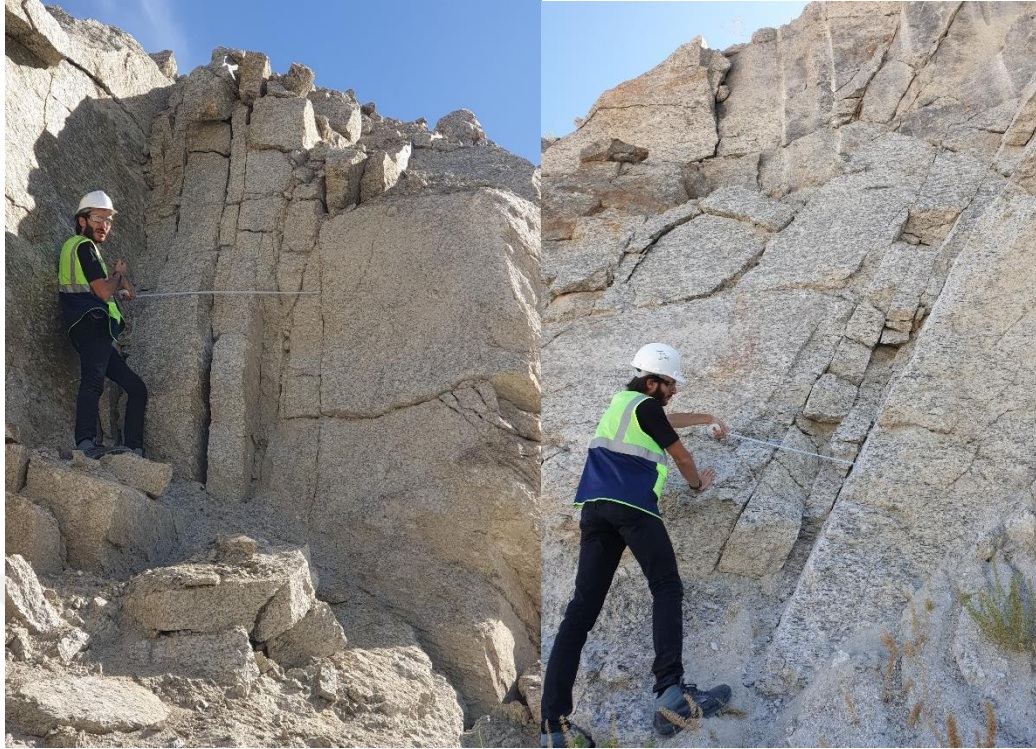
Figure 3.9 Measurement of discontinuity spacing (Personal archive, 2020)

A scan-line work of approximately 1000 m in length was carried out from the operation site (Figure 3.9). These line studies were taken almost perpendicular to the discontinuities on the slope surfaces, almost perpendicular. Based on these conditions, 1619 discontinuities taken from the eastern slopes of the field were classified according to ISRM (2007). Within the scope of this study, the discontinuous spacing of the dominant joint sets in the eastern part of the quarry was evaluated separately and presented in table 3.2. The discontinuity spacing of the joint sets measured on the slopes is presented in Appendix-2.

According to the results obtained, the distance between the discontinuities of the dominant discontinuity sets in the mining operation was calculated as 2m at most (belonging to the J3 joint set), and the lowest as 0.05m. According to the classification system, all of the joint teams in the field were determined as "moderate spacing" (Table 3.3).

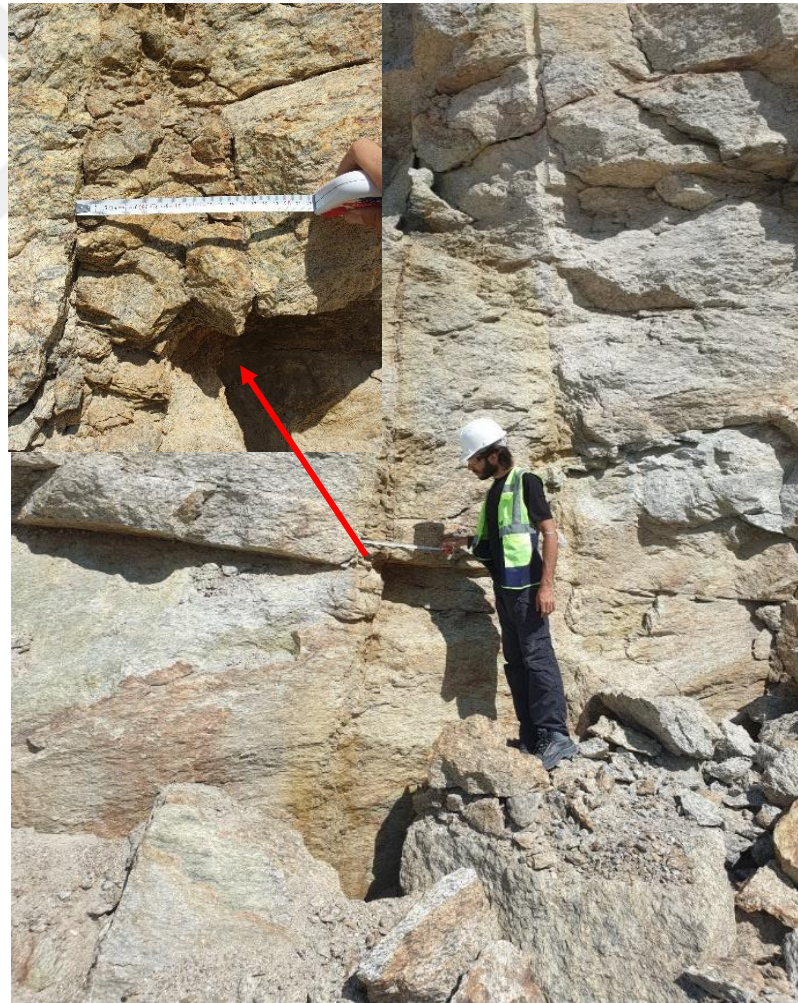
Figure 3.10 Filling material observed in some joint sets (Personal archive, 2020)

Based on the explanations above, the opening and filling of the discontinuities taken from the field are evaluated separately in the table according to ISRM (2007) standards (Table 3.4). Accordingly, the opening of the joint kits is “0.25-0.5 mm: Partly open/Closed Feature and/or 0.5-2.5 mm: Open/Gapped Feature” and the filling is “Geometry: wall roughness, Filling type: weathering grade”.

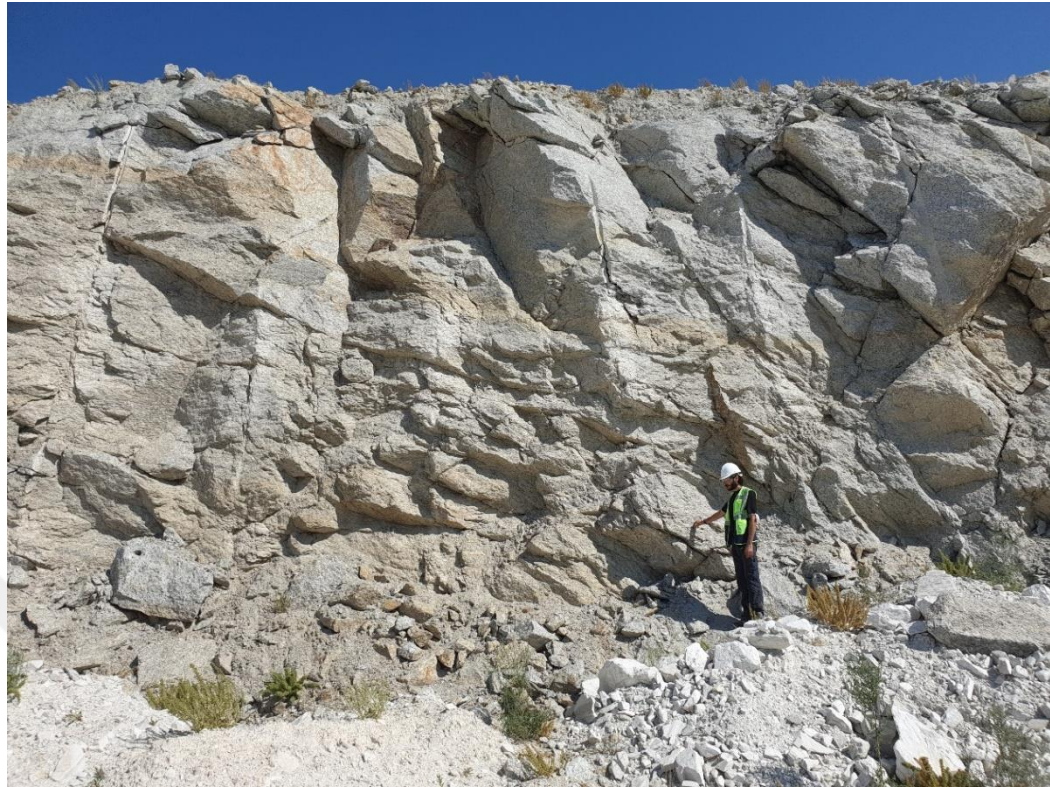
Figure 3.11 Continuity of J1, one of the dominant joint sets observed on the eastern slopes (Personal archive, 2020)

Continuity class of 5 dominant discontinuity sets according to ISRM (2007) standards for measurements taken from the field is presented in the table 3.5. Accordingly, the continuity of the dominant joint sets was determined in field studies as the shortest 2 and the longest 12m (Table 3.6).

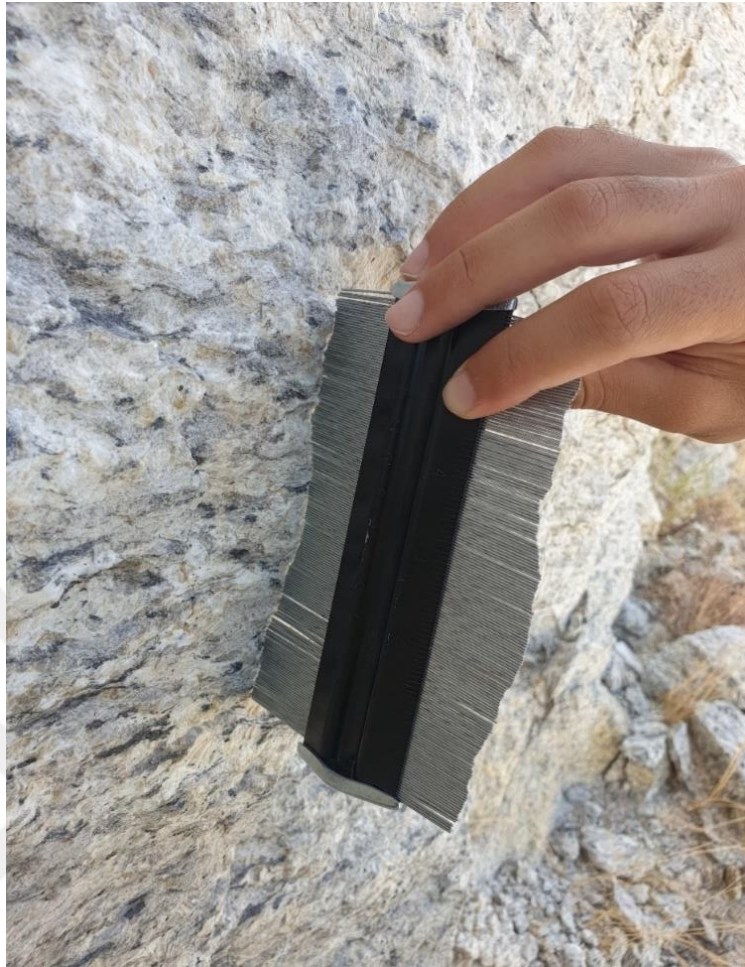
Figure 3.13 Measurement of roughness in joint sets in gneiss units with a comb (Personal archive, 2020)

Within the scope of the study, roughness measurements were taken from the discontinuity surfaces in the field with the help of a comb, as suggested by ISRM (2007) (Figure 3.13). According to these measurements, the roughness classification of the dominant 5 discontinuity sets in the field, again based on the standards developed by ISRM (2007), is given in the table 3.7. Some of these measurements are presented under this topic for illustrative purposes (Figure 3.14).

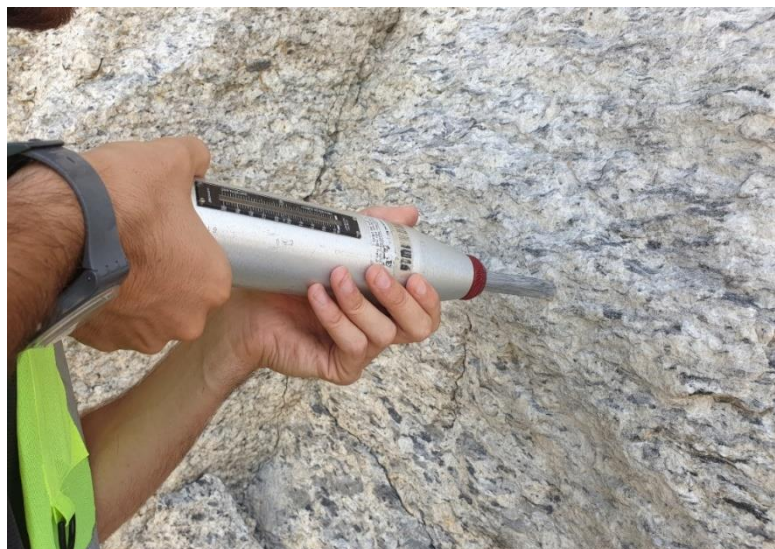
Figure 3.15 The schmidt hammer test according to ISRM standards (Personal archive, 2020)

Within the scope of this study, the measurements of the dominant 5 discontinuity sets were carried out by means of a schmidt hammer. Measurements were made according to ISRM (2007) standards for each observation point (Figure 3.15).

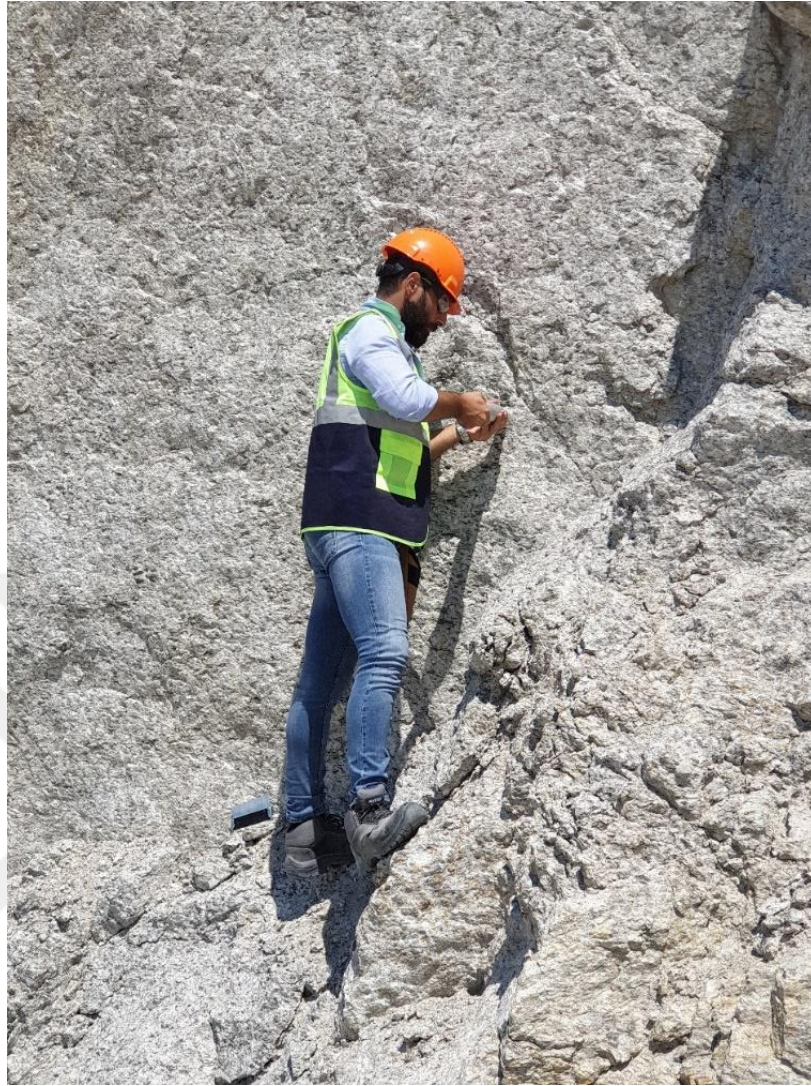
Figure 3.16 The construction of the swirl hammer test to determine the UCS value from the slope steps (Personal archive, 2020)

Number of Test	Highest-lowest Rebound	Mean Rebound	Standard Deviation	Mean log(JCS)	Mean UCS (MPa)	Grade	Description
119	10-56	26.45043	8.872203	1.497	32.9	R3	Medium Strong Rock

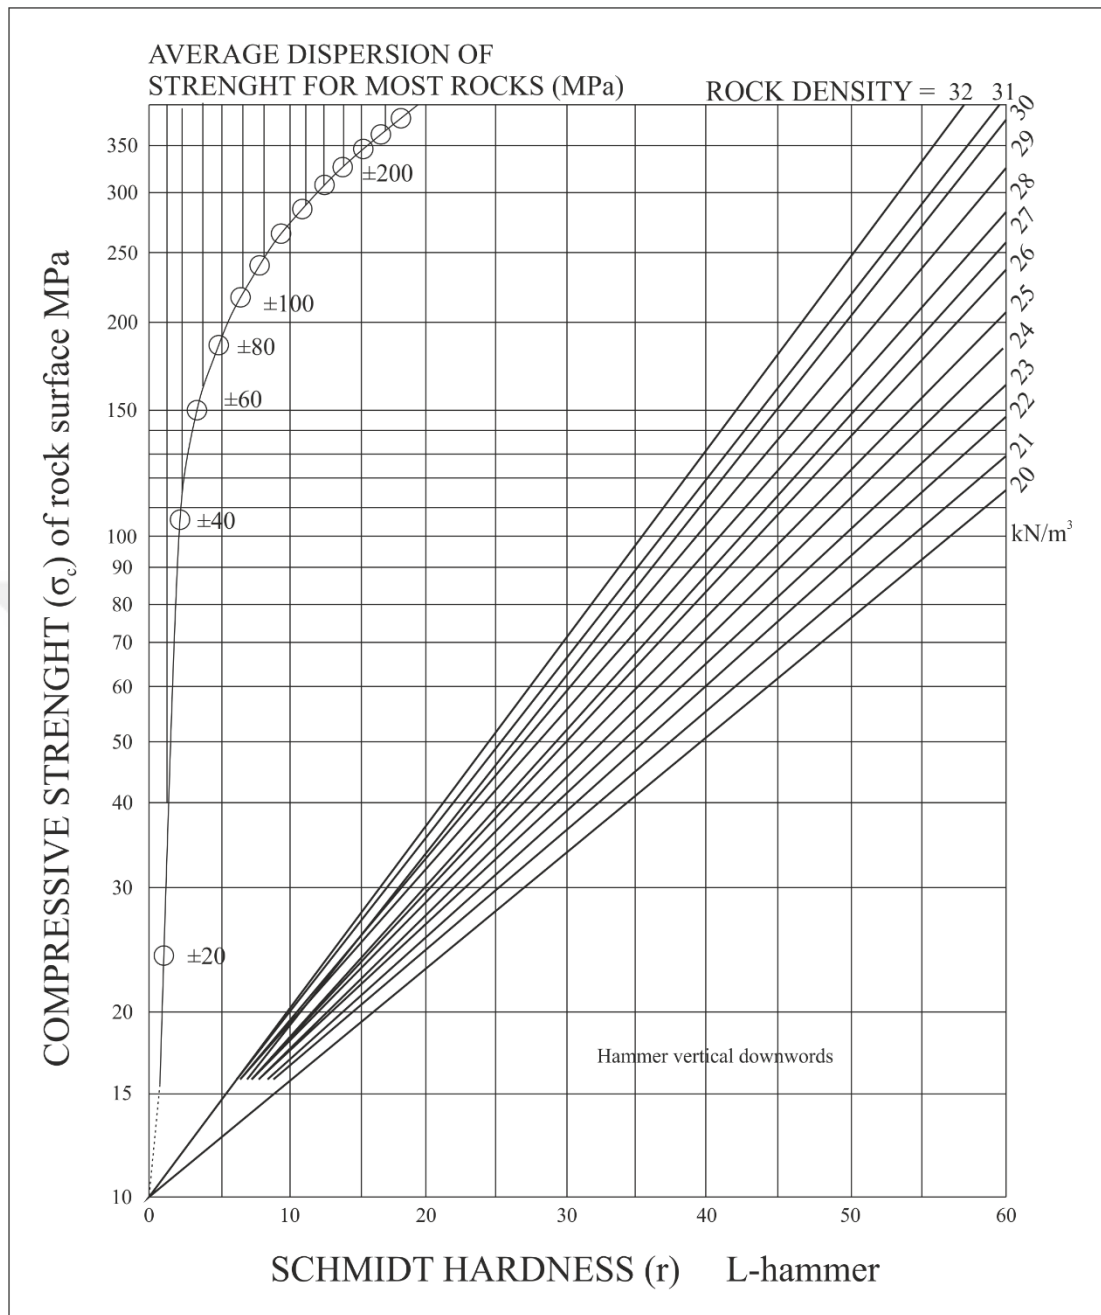
Figure 3.17 The relationship between the Schmidt rebound hardness value and the compressive strength of the rock surface

Another determination of the UCS value belongs to Deere & Miller (1966), first and most comprehensively. For this purpose, the chart in the Figure 3.17 was developed by the researchers for the estimation of the uniaxial pressure value. According to this chart, when the rebound values obtained from the shim hammer and the unit volume weight of the rock material are combined at one point, it is possible to estimate the UCS value. According to this chart, the results obtained are similar to the results obtained within the scope of the article. The UCS value was found to be approximately 32 ± 5 in the results obtained by both the chart and the formula.

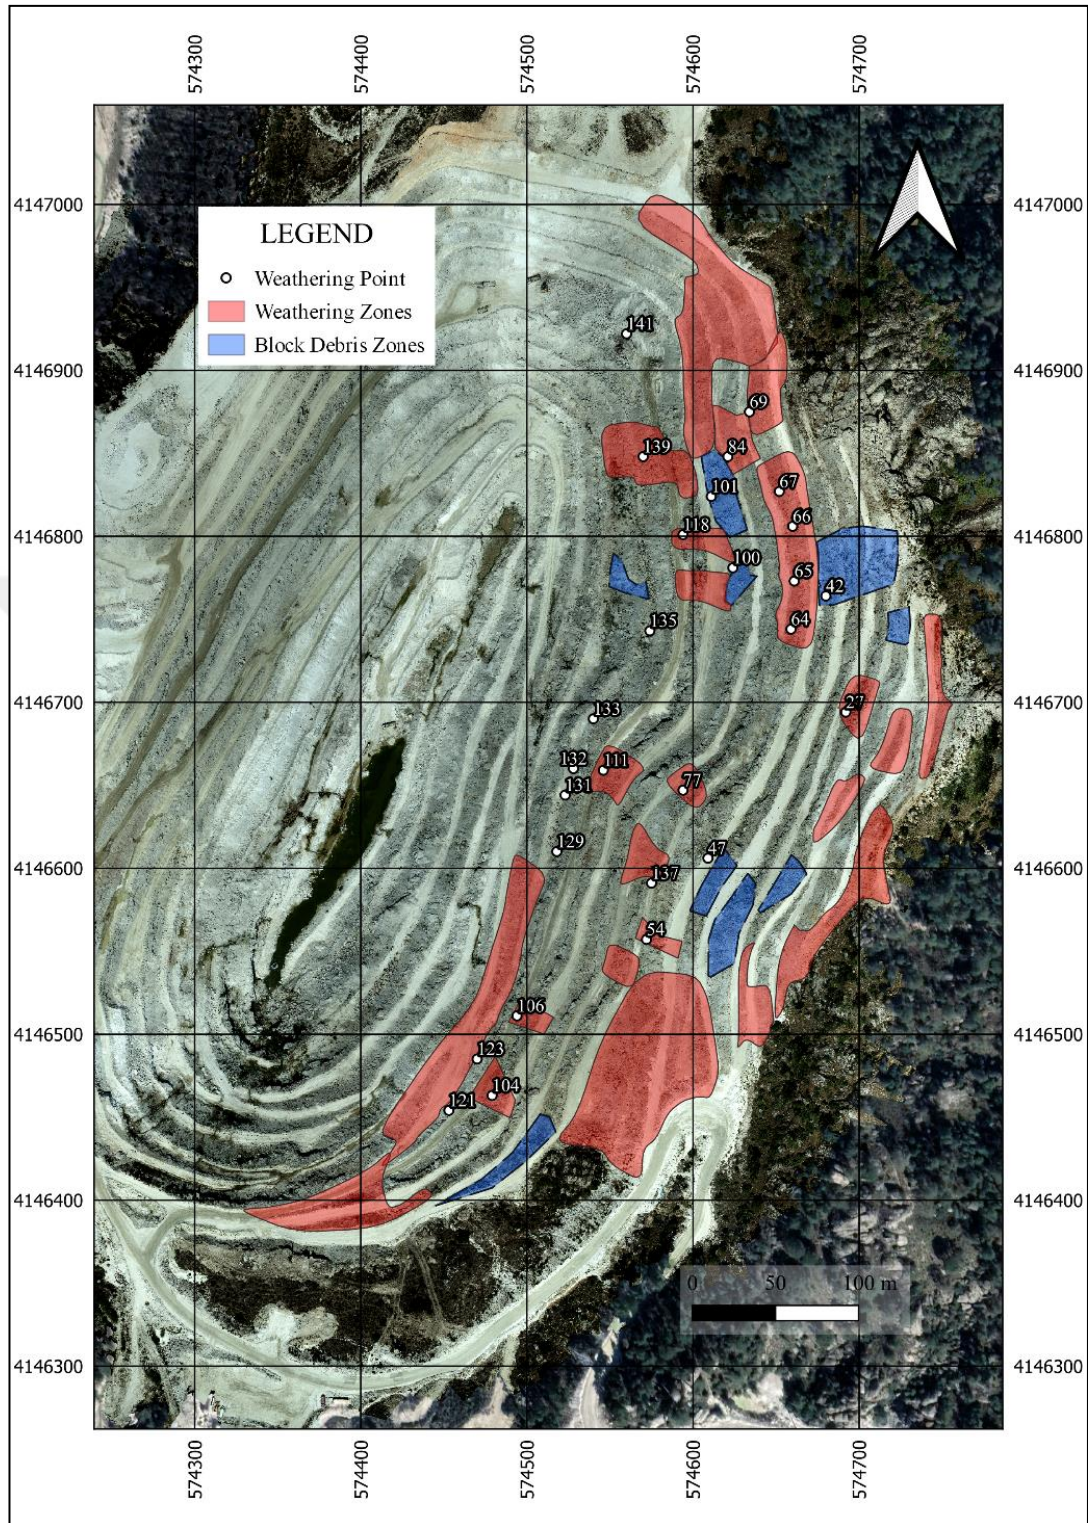
Figure 3.18 Map of the study area showing the weathering zones and block debris

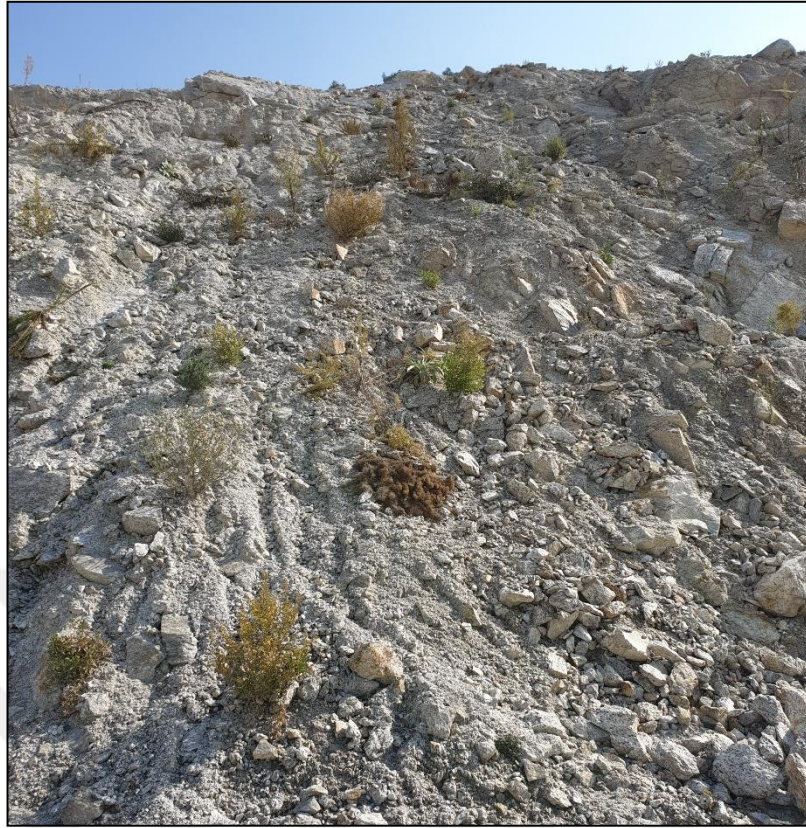
Figure 3.19 The weathering and loss of rock feature observed on the slope at the 111th Observation Point (Personal archive, 2020)

Weathering can be defined as the change in the appearance and/or structure of a rock by exposure to physical or chemical effects. There are serious changes in the strength of the rock mass, which undergoes weathering under the influence of various environmental factors, and this change may result in instability problems. Various parameters such as climate, groundwater level and chemistry are the parameters that cause weathering. With the effect of these environmental factors, the open pit has decreased the strength of the rock mass and caused stability problems. The location of the enterprise in many creek bed regions and the excessive rainfall in winter due to the climate effect reduced the strength of these rocks and adversely affected them. Likewise, due to the excavations made due to production and the corrections made in the stages during the slope design stage, as a result of the pressure release, the rocks underwent physical weathering and reduced their mechanical properties and lost their rock properties. The impact areas of these observed weathering states were determined and the map in Figure 3.18 is shown. Due to the decreasing rock strength due to weathering, block debris and slips of different sizes can be seen clearly in the quarry (Figure 3.19 and 3.20).

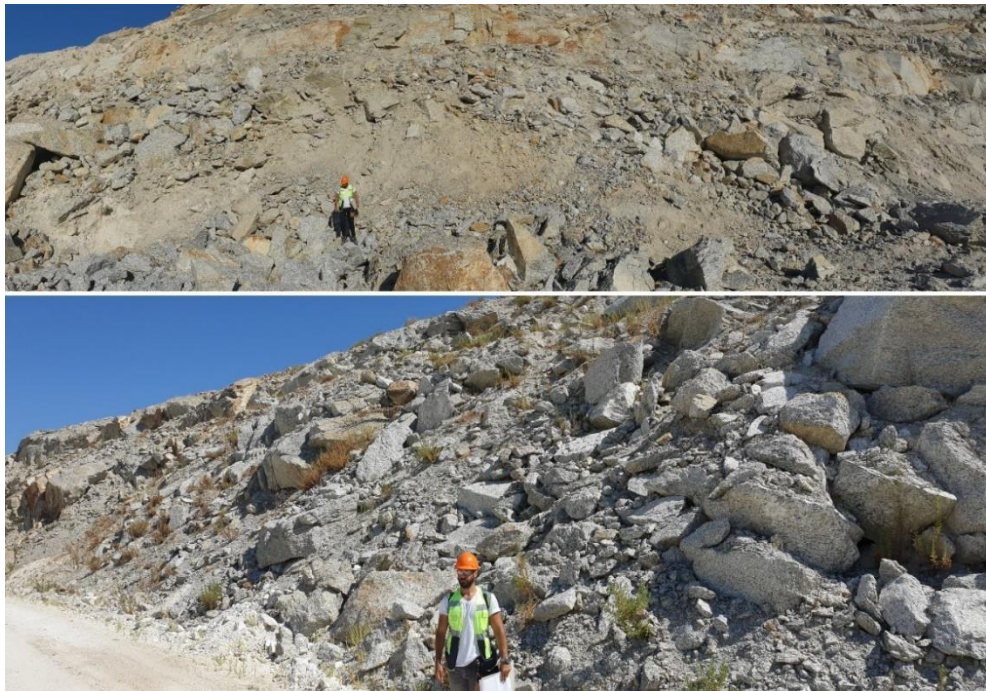
Figure 3.20 Block debris due to weathering seen at observation points 47 and 101 (Personal archive, 2020)

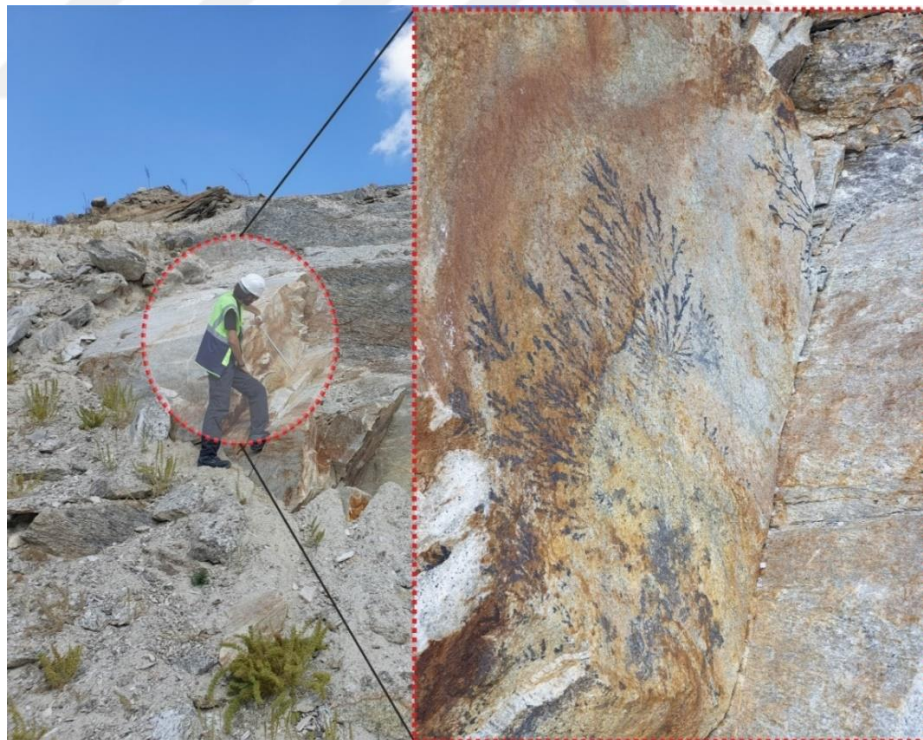
Figure 3.21 Dendritic traces formed by the hydrothermal fluid located in the alteration zone and exposed due to faulting (Personal archive, 2020)

In the mine in this study, the effects of physical weathering can be clearly seen, and alterations due to chemical weathering processes can easily be seen. As a result of the interaction of hydrothermal fluids with the rock mass, which developed due to faulting, oxidation occurred on the rock surface and it was observed that the strength of the rock increased. The fact that the UCS values obtained from the Schmidt hammer experiments in these regions are also high supports this statement. The presence of hydrothermal fluids released due to faulting is supported by the dendritic structure formed in the rock wall in the image in figure 3.21.

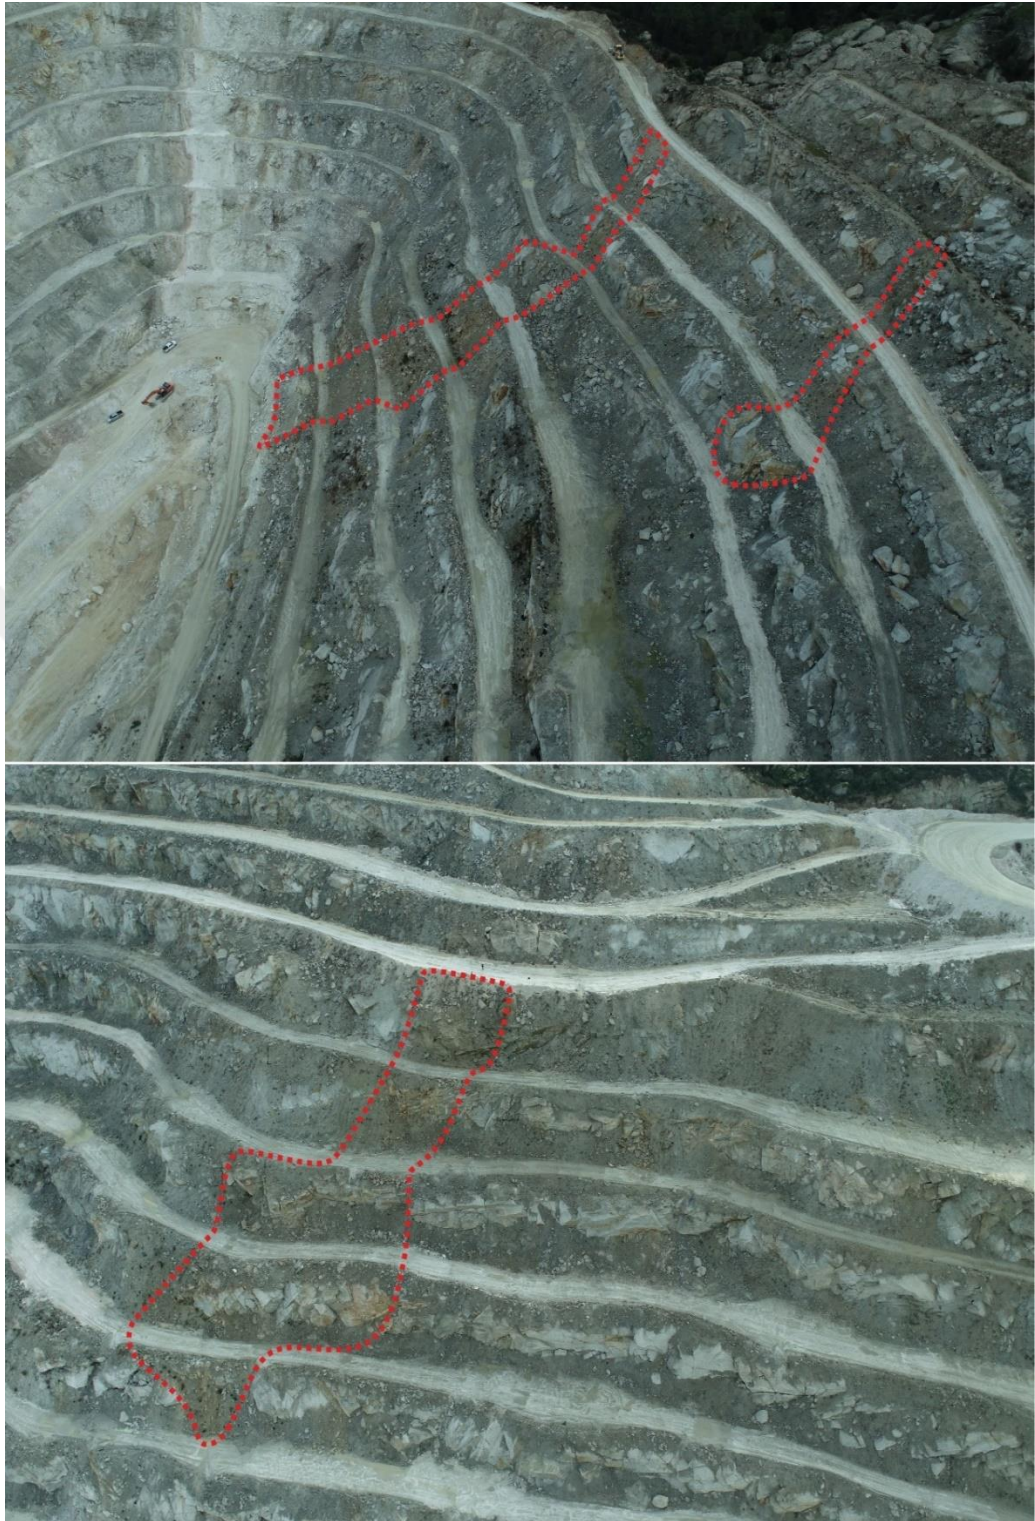
Figure 3.22 Some weathering zones on the eastern slopes (Personal archive, 2020)

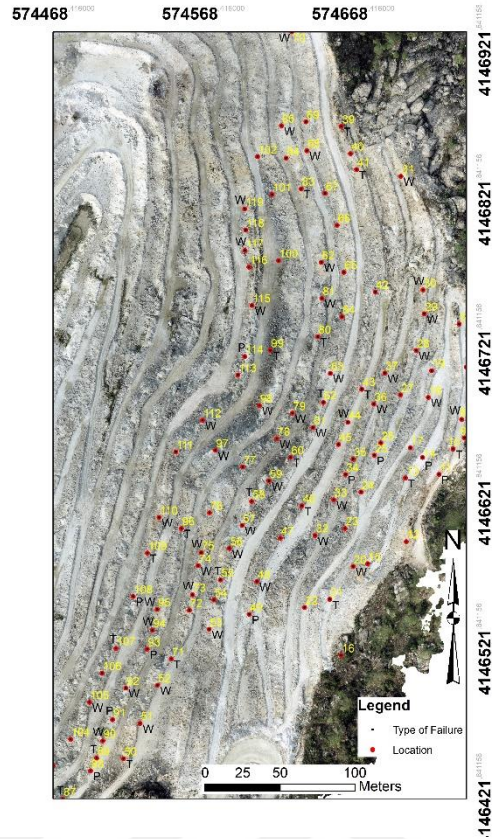
Figure 3.23 Observation points where eastern slopes have kinematic failure potential

1613 discontinuity measurements were taken from these observation points and the data were evaluated according to ISRM (2007) standards. The orientations of the discontinuity planes were transferred to the stereographic projection with Dips 7.016 (RocScience, 2019) software and the type of failures at each observation point were evaluated kinematically and expressed as a percentage in the pie chart (Figure 3.23) (Table 3.13) (Figure 3.24).

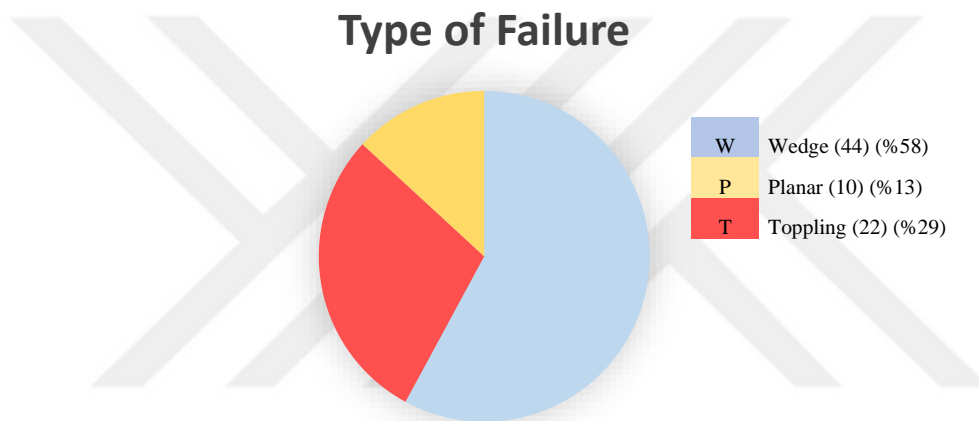
Figure 3.24 Pie chart of kinematic failures at observation points

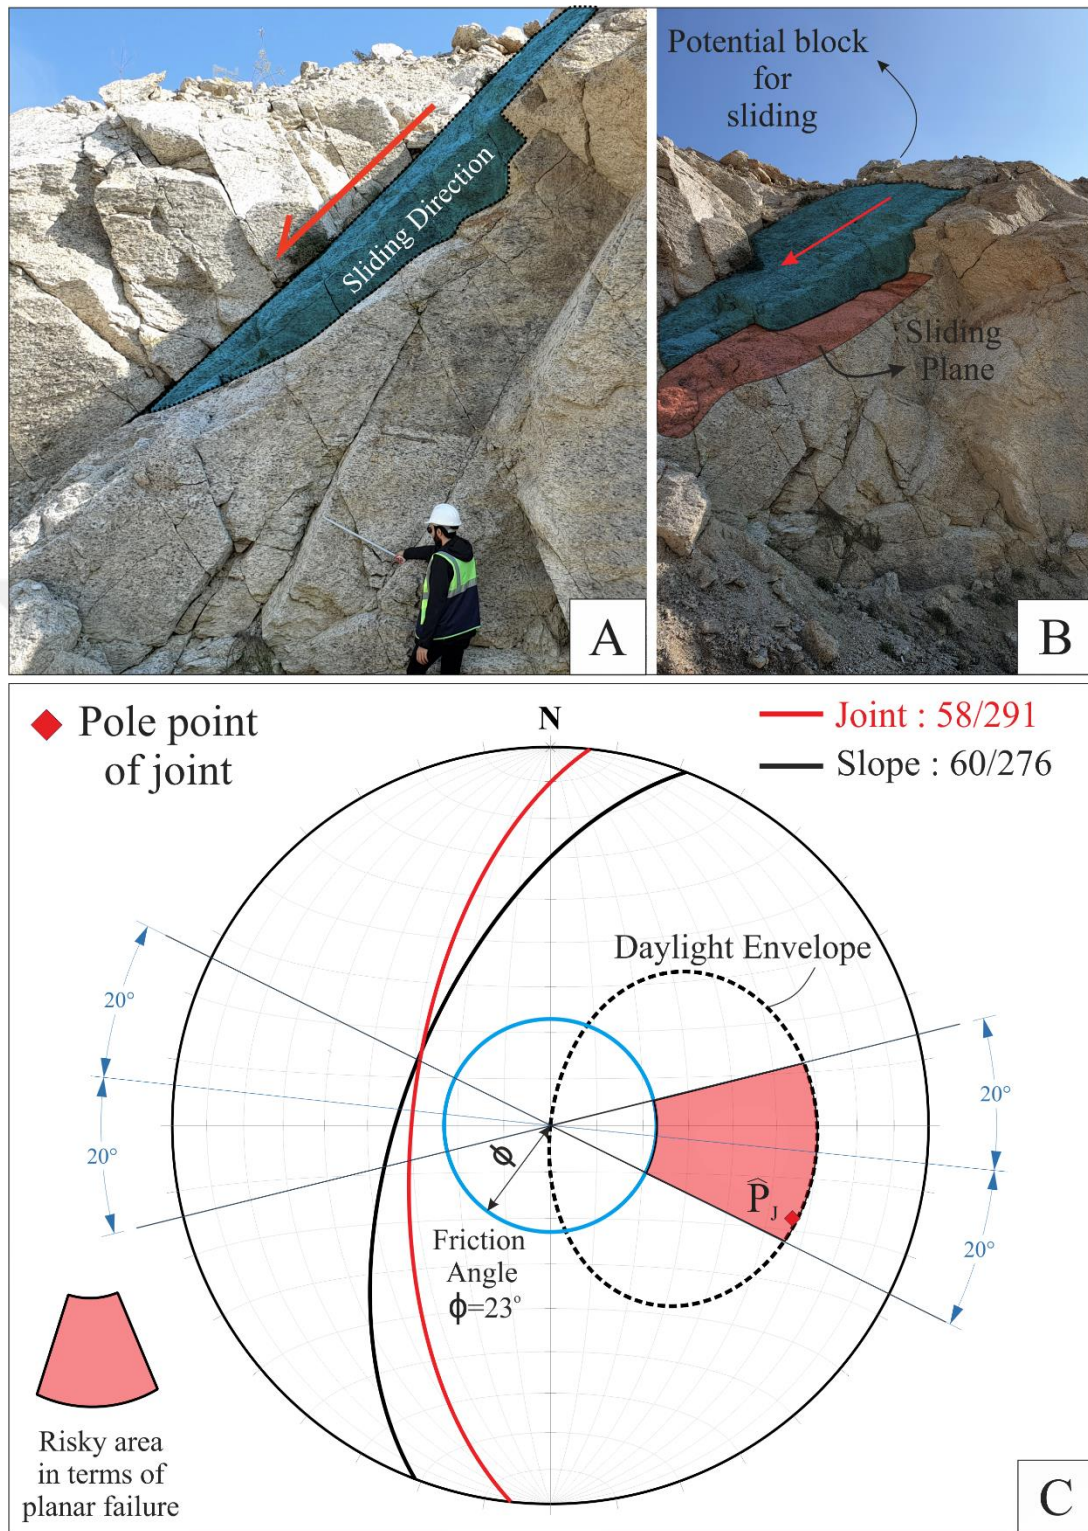
Figure 3.25 Planar sliding failure caused by joints; (a) The view of the sliding in the field and the direction of the sliding, (b) The block and sliding plane that is likely to sliding, (c) Kinematic analysis of the planar failure

In the kinematic analyzes made with the discontinuities taken in the eastern part of the study area, a total of 45 planar failure potentials were determined. The mean orientation of these discontinuity planes, which cause planar failure, was determined as 41/285. The field view of these planar slips caused by the joints and their kinematic analysis using the lower hemisphere projection are given in Figure 3.25.

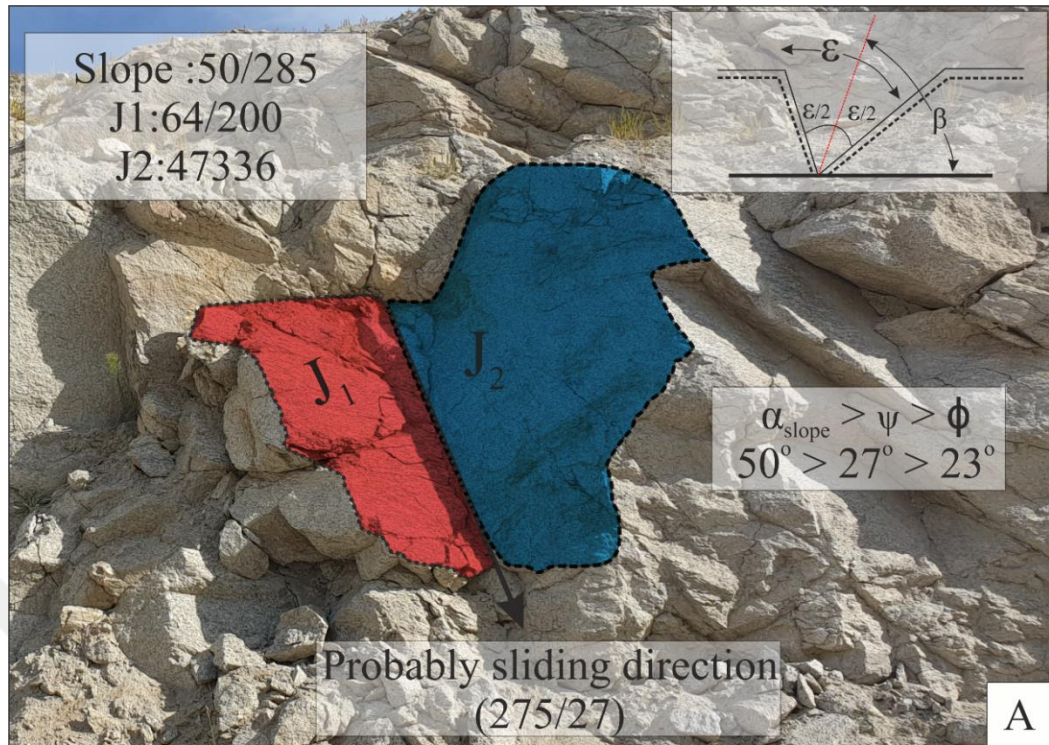
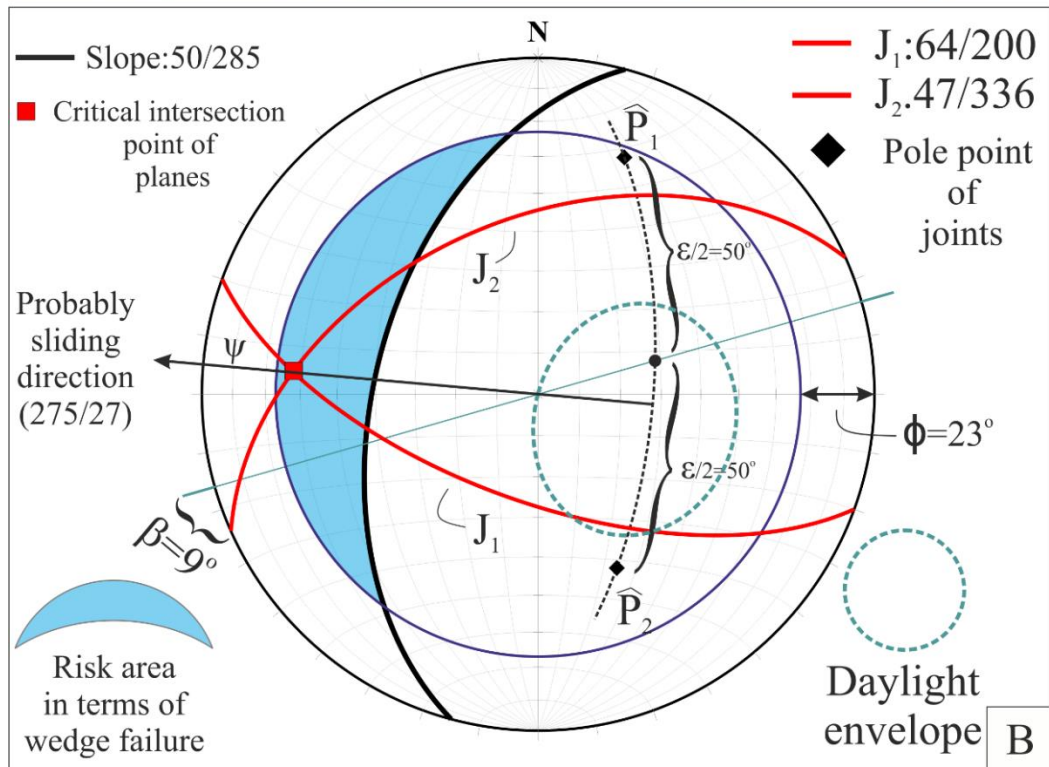
Figure 3.26 Wedge type sliding failure, (a) View of planes forming the wedge in the field, (b) Kinematic analysis of wedge type sliding failure

According to the discontinuity measurements taken from the slopes in the eastern part of the mine, 72 wedge failures were determined. The field view and kinematic analysis of an example of 74 wedge-type failures seen in the study area are given in Figure 3.26.
