**MONITORING AND NUMERICAL ANALYSIS OF
OPEN PIT MINE SLOPES IN GNEISSES**

August, 2021

**A Thesis Submitted to the
Graduate School of Natural and Applied Sciences of Dokuz Eylül University
In Partial Fulfillment of the Requirements for the Degree of Master of
Science in Geological Engineering, Applied Geology Program**

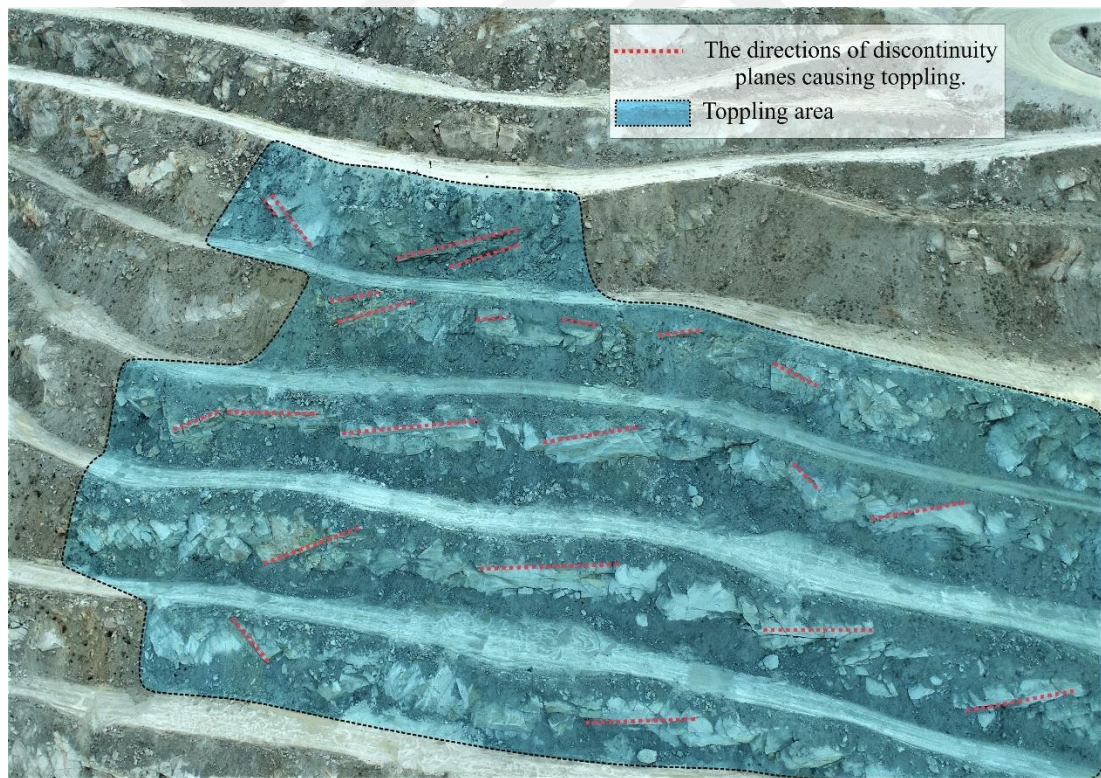
Figure 3.27 Generally the directions of high persistence and high angle discontinuity planes that caused toppling failures

It also proved that the discontinuity angles in the cluster analysis made with the discontinuity measurements taken in the study area are mostly high-angle and the overturn failures with a 45% slice determined by the kinematic analysis technique (a total of 98, 54 flexural and 44 direct toppling) are high. The thematic map showing the types of rollover failures observed in the study area and their distribution in the field is presented in Figure 3.27.

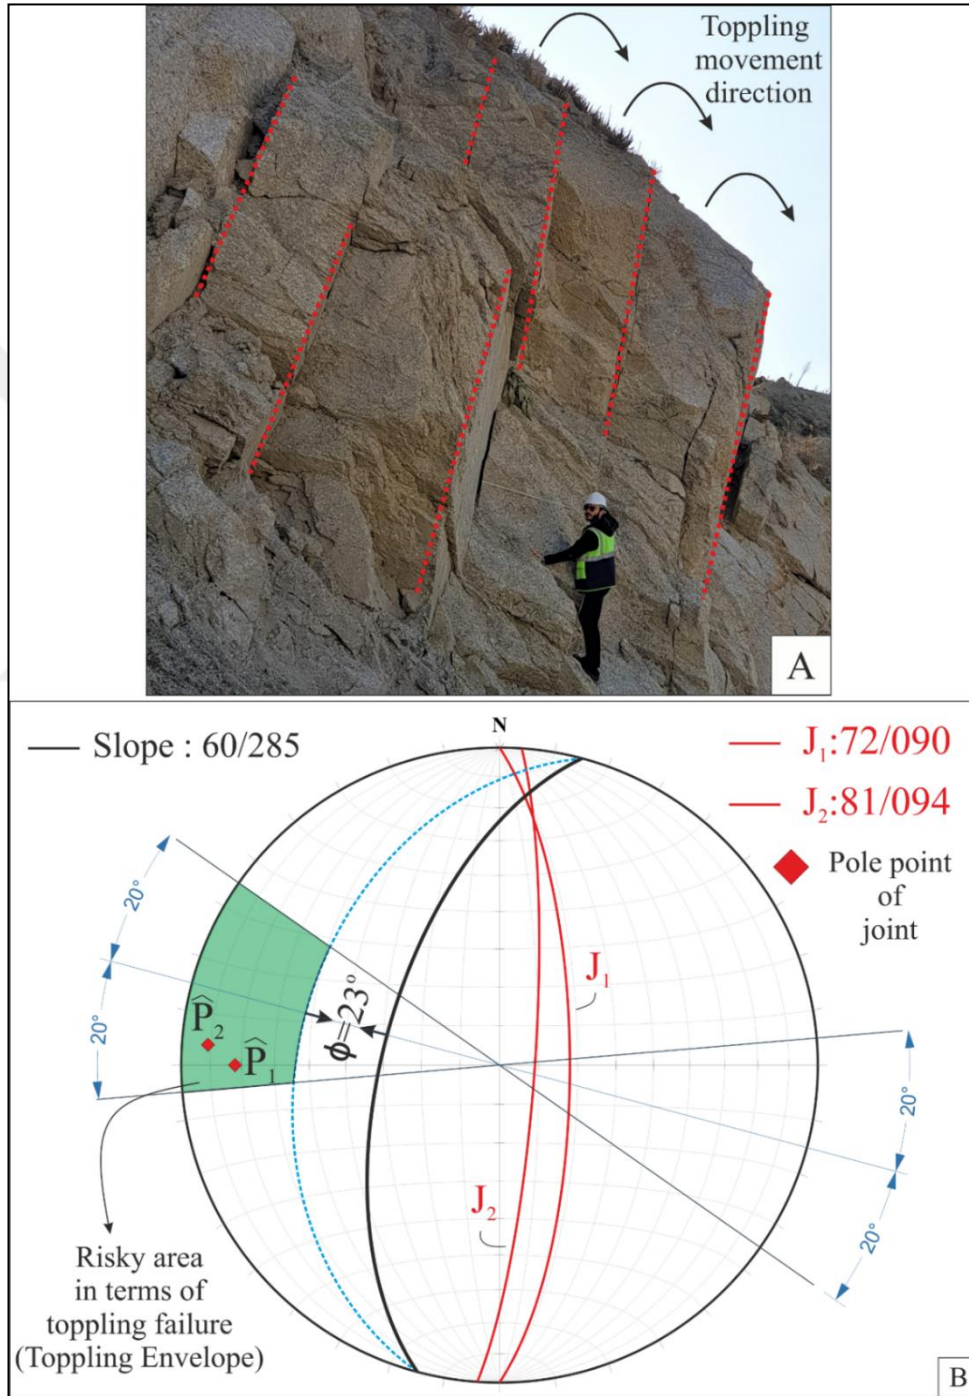
Figure 3.28 Flexural toppling failure; (a) High angle discontinuities and possible toppling blocks in the field view, (b) Kinematic analysis of flexural toppling failure

With the measurements taken from the eastern slopes of the mining operation, the slopes with potential overturn failure were determined. The kinematic analyzes and related figures of these slopes are shown in 3.28, 3.29 and 3.30.

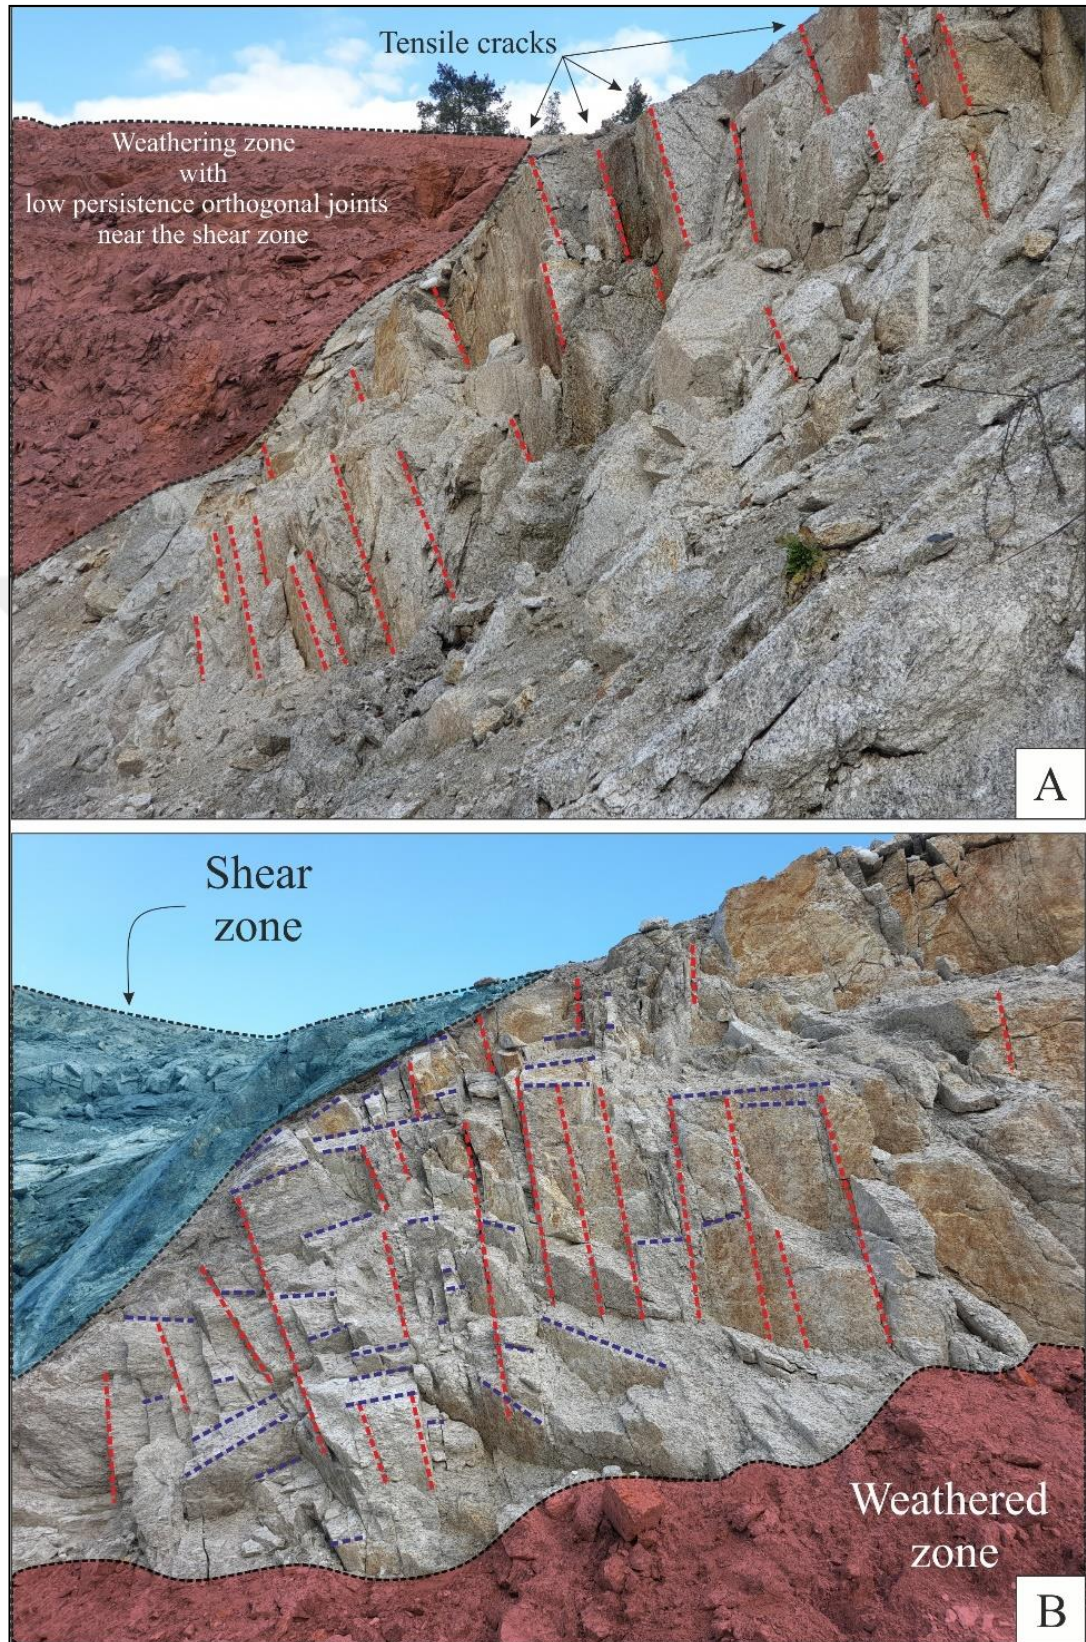
Figure 3.29 Direct toppling field view; (a) High angle discontinuity planes, (b) Sets of discontinuities perpendicular to each other (front view of a)

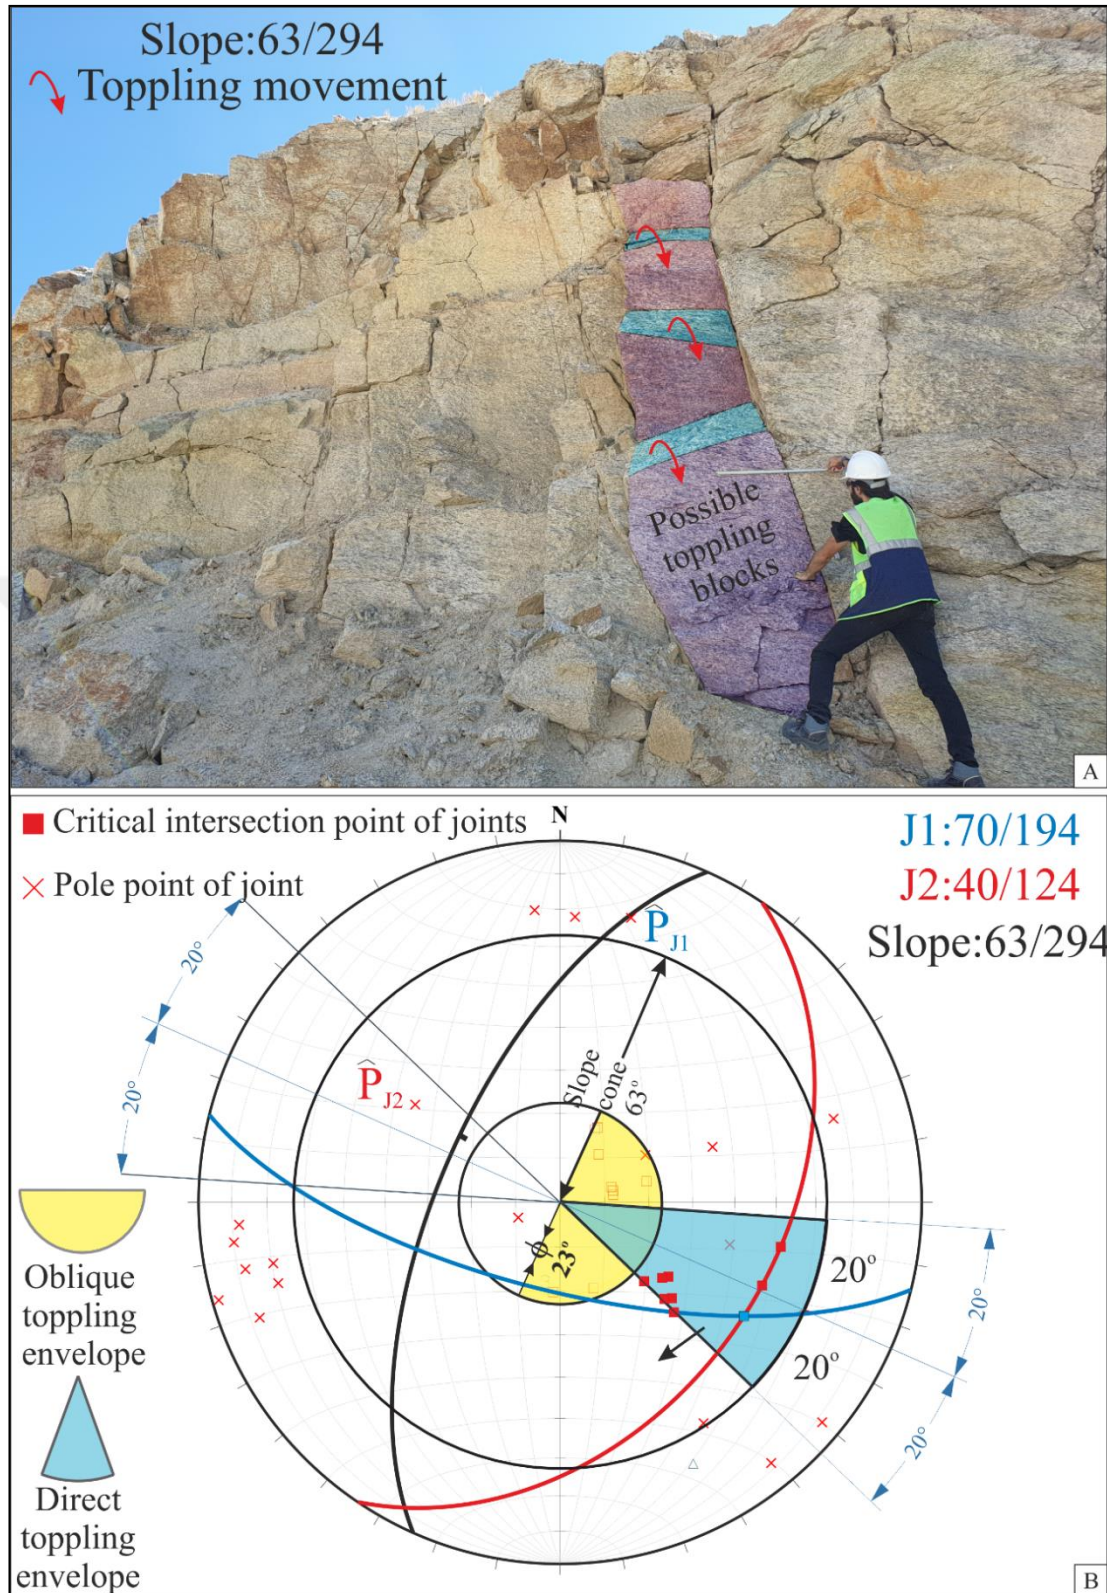
Figure 3.30 Direct toppling type failure; (a) Blocks formed by sets of joints perpendicular to each other, (b) Kinematic analysis of direct (block) toppling type failure

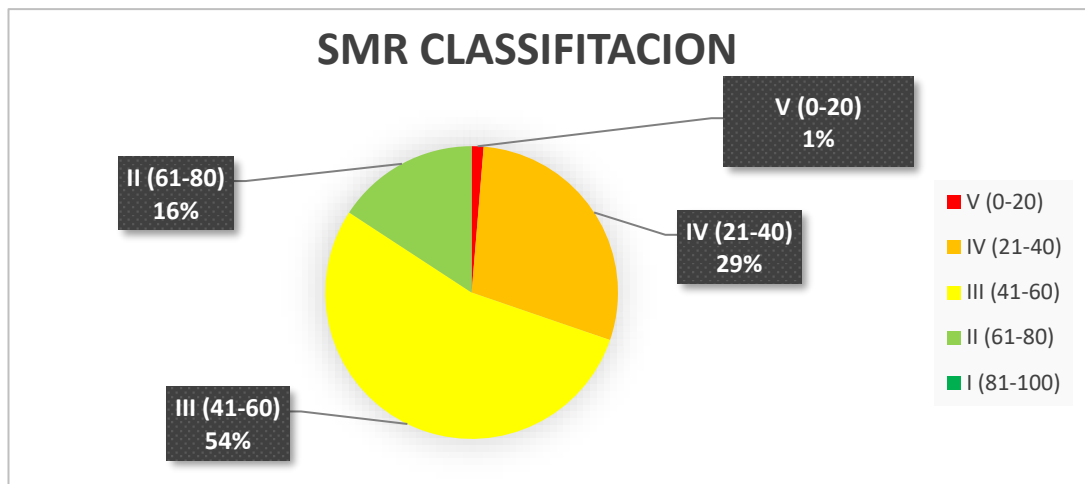
Figure 4.2 Pie chart of SMR classification system on slopes

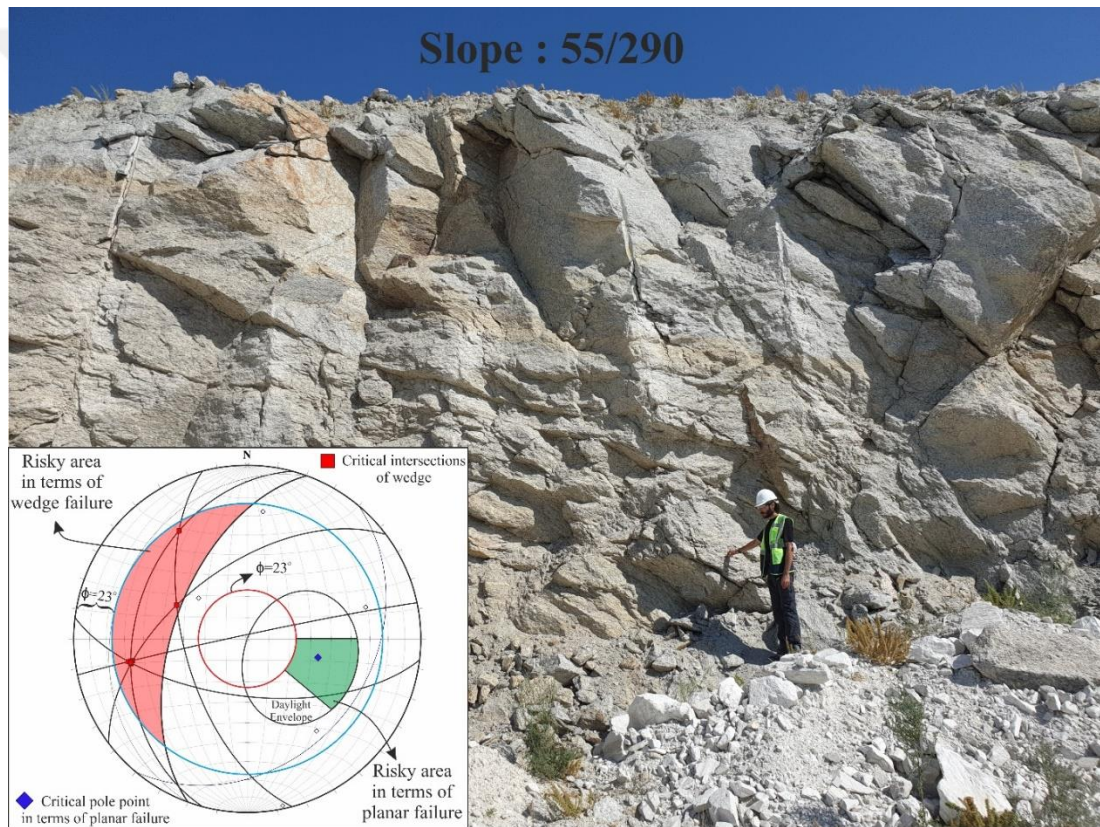
Figure 4.3 View of slope number 32 from the field and its kinematic analysis

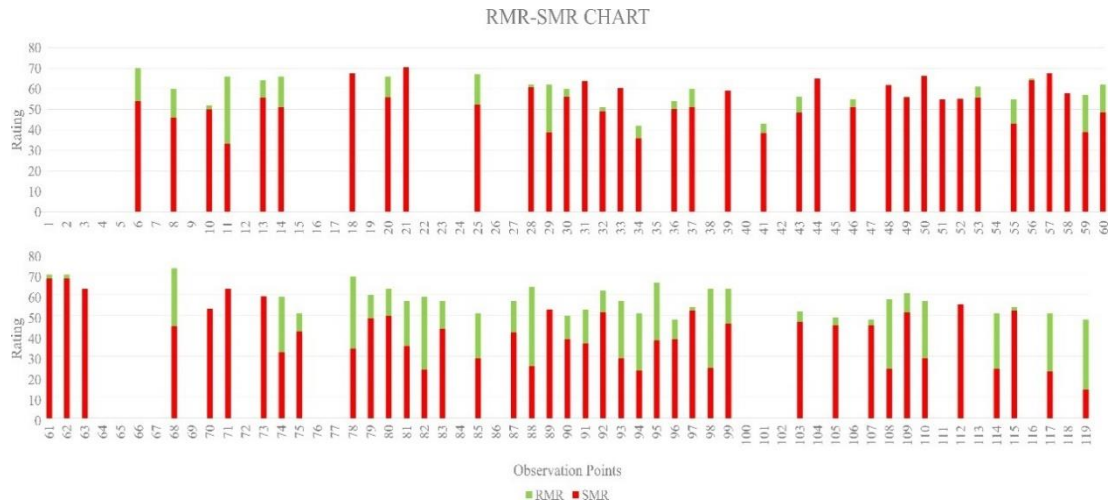
Figure 4.4 SMR-RMR chart

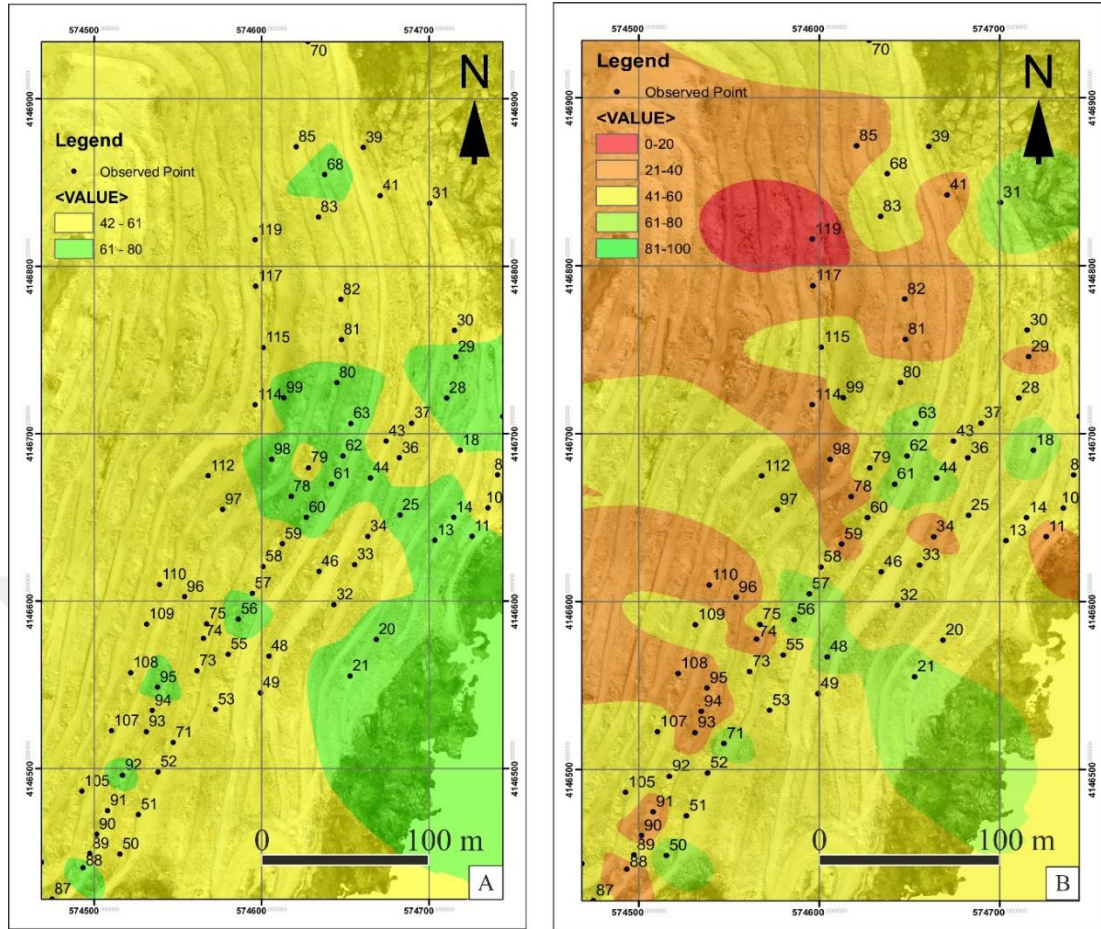
Figure 4.5 Thematic map of the scores in the study area created with the IDW method; (a) RMR map, (b) SMR map

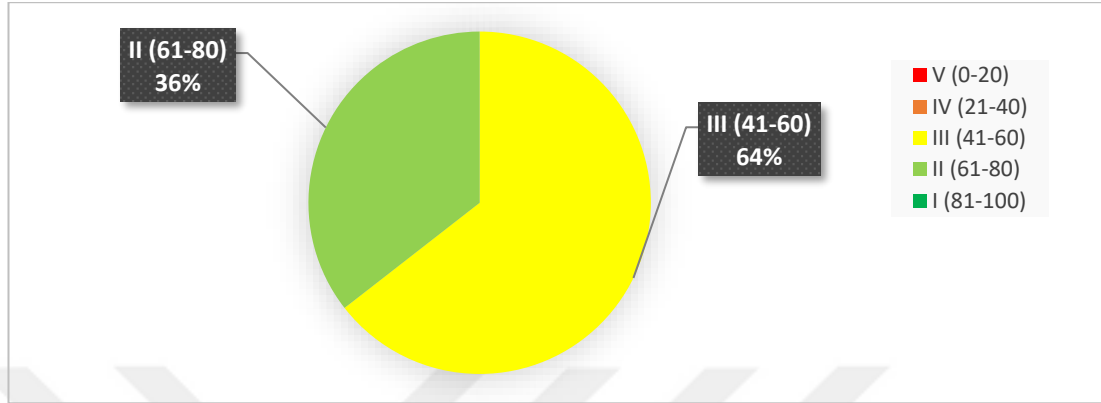
Figure 4.6 Classification of RMR systems as a percentage

of slopes in the "good rock (II)" class in SMR system is 16%, this rate is calculated as more than twice in the RMR system, that is, 36%.

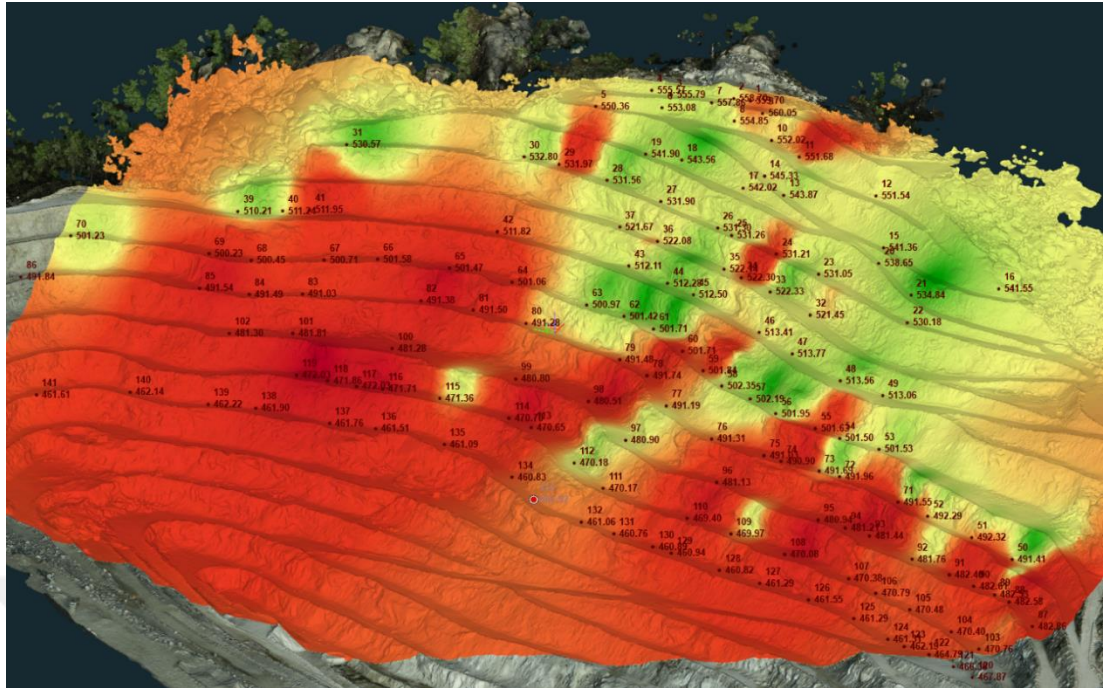
Figure 4.7 3D view of the SMR score on the slopes

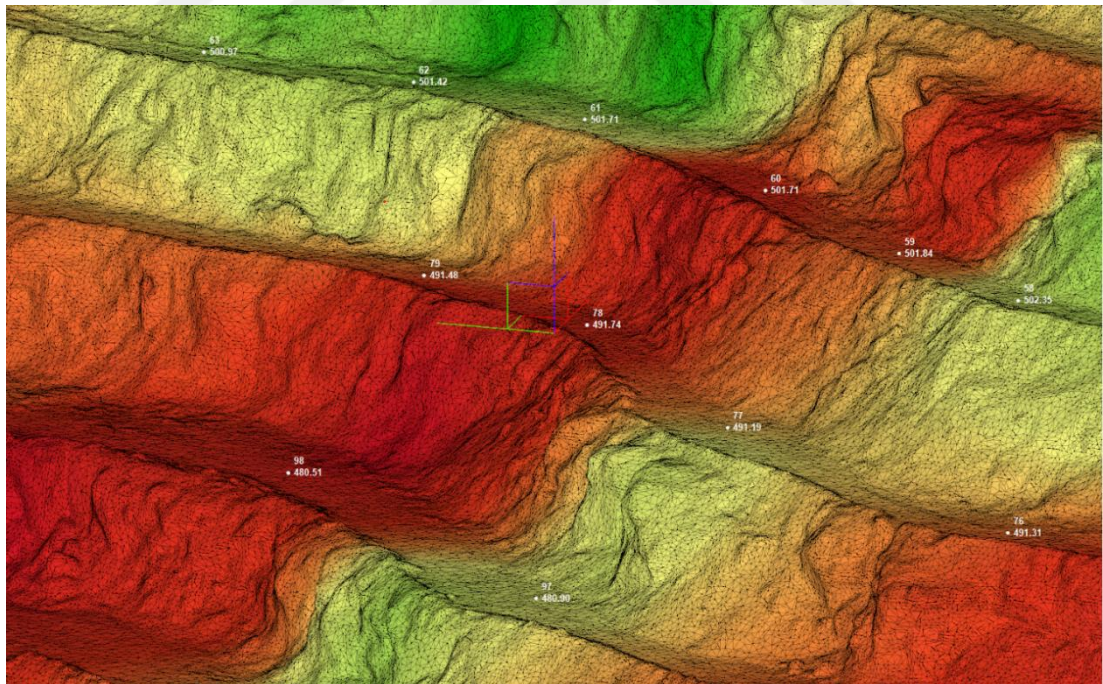
Figure 4.8 3D view of slopes 59 and 61

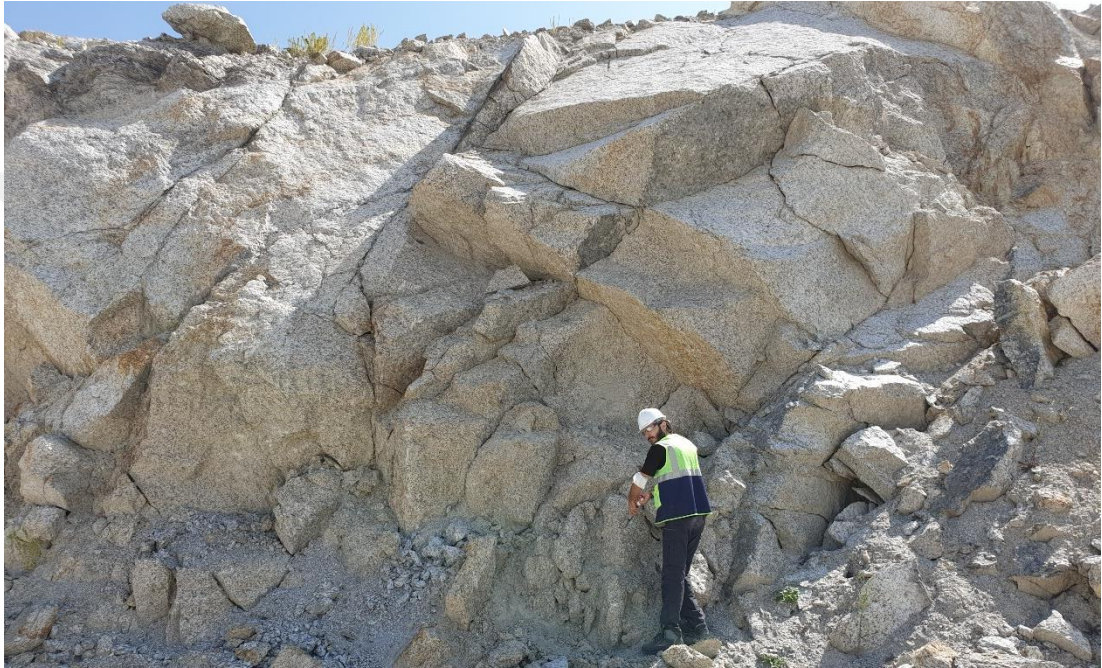
Figure 4.9 Field view of 59. Observation point

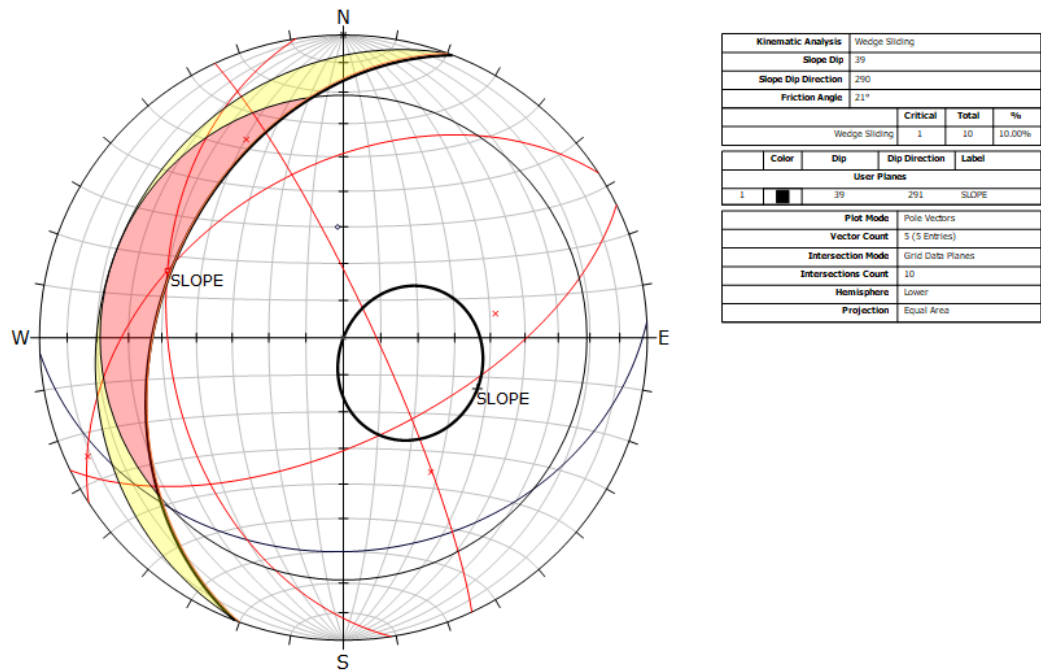
Figure 4.10 Kinematic failure type of 59. observation point

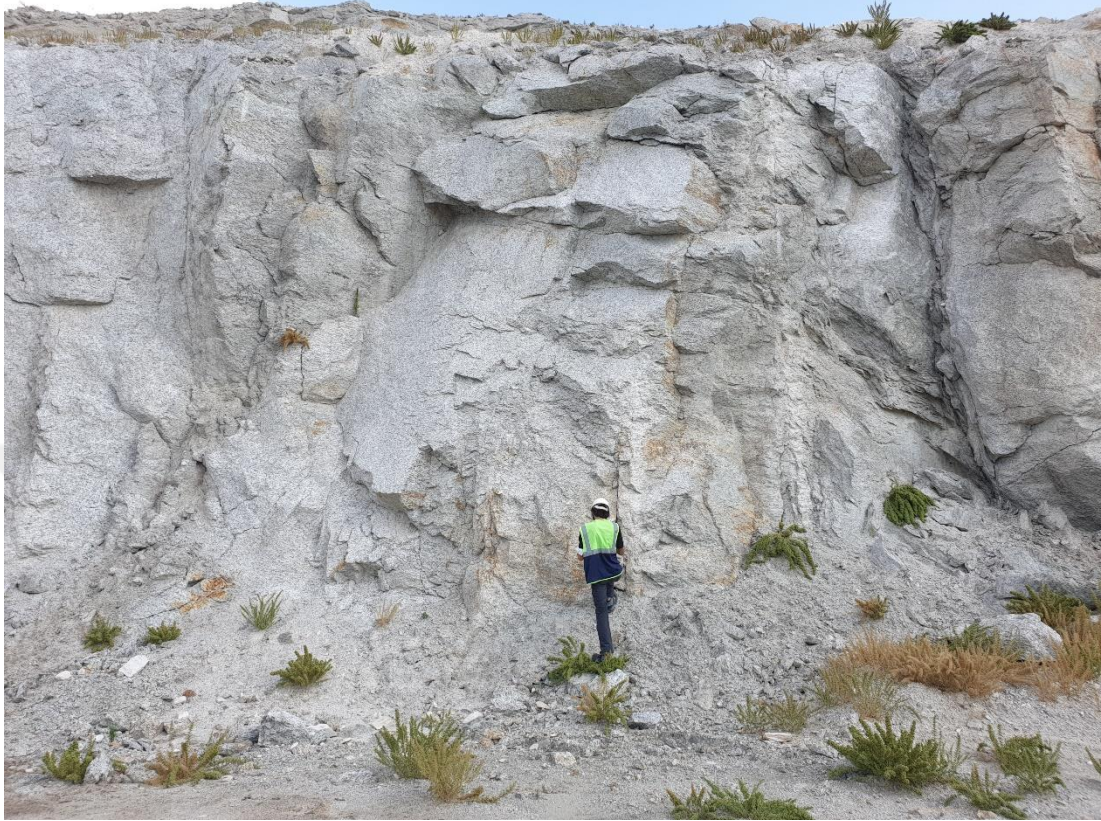
Figure 4.11 Field view of 61. observation point

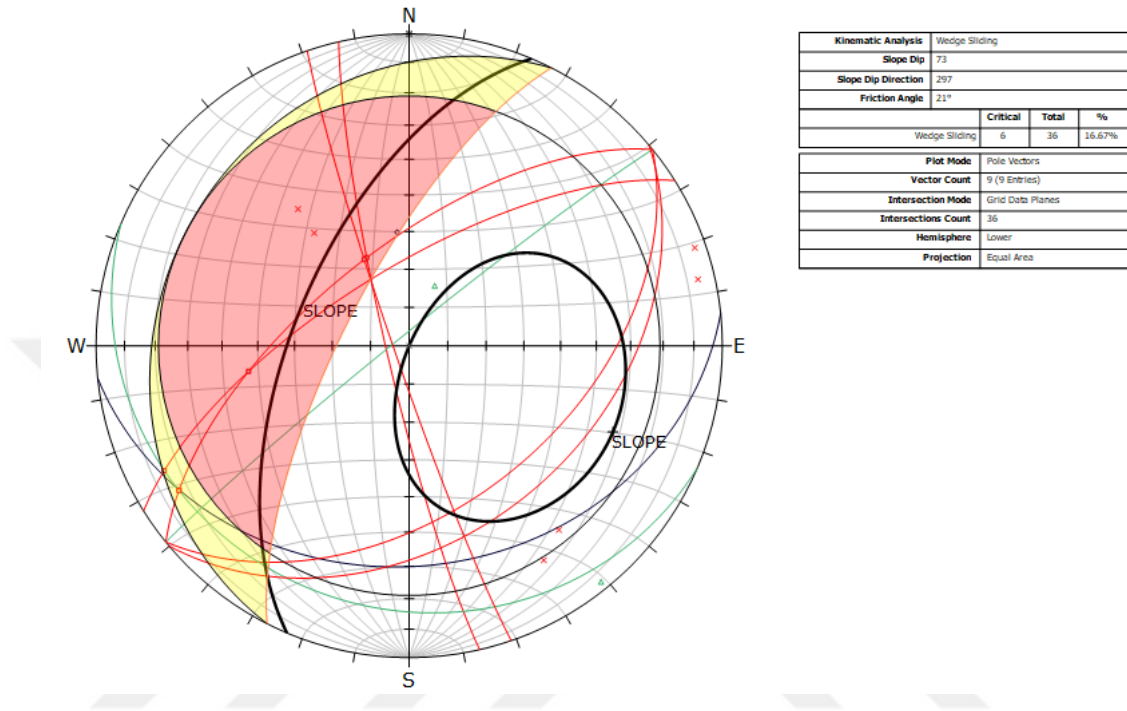
Figure 4.12 Kinematic failure type of 61. observation point

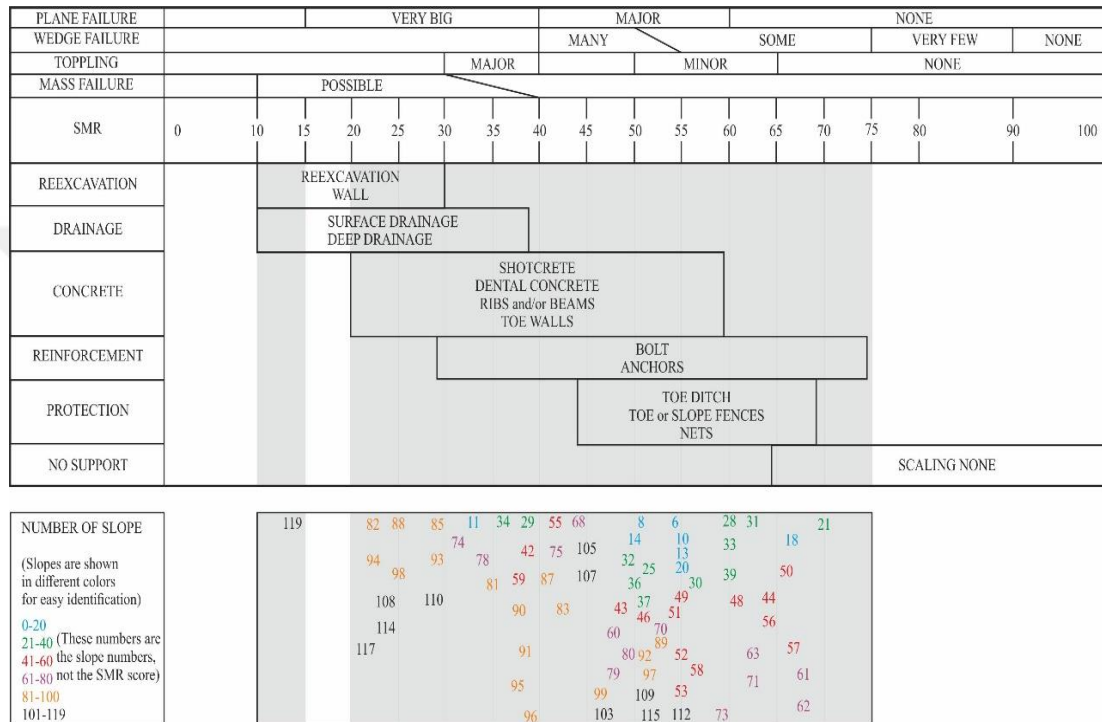
Figure 4.13 Showing the slopes in the study area in the support system

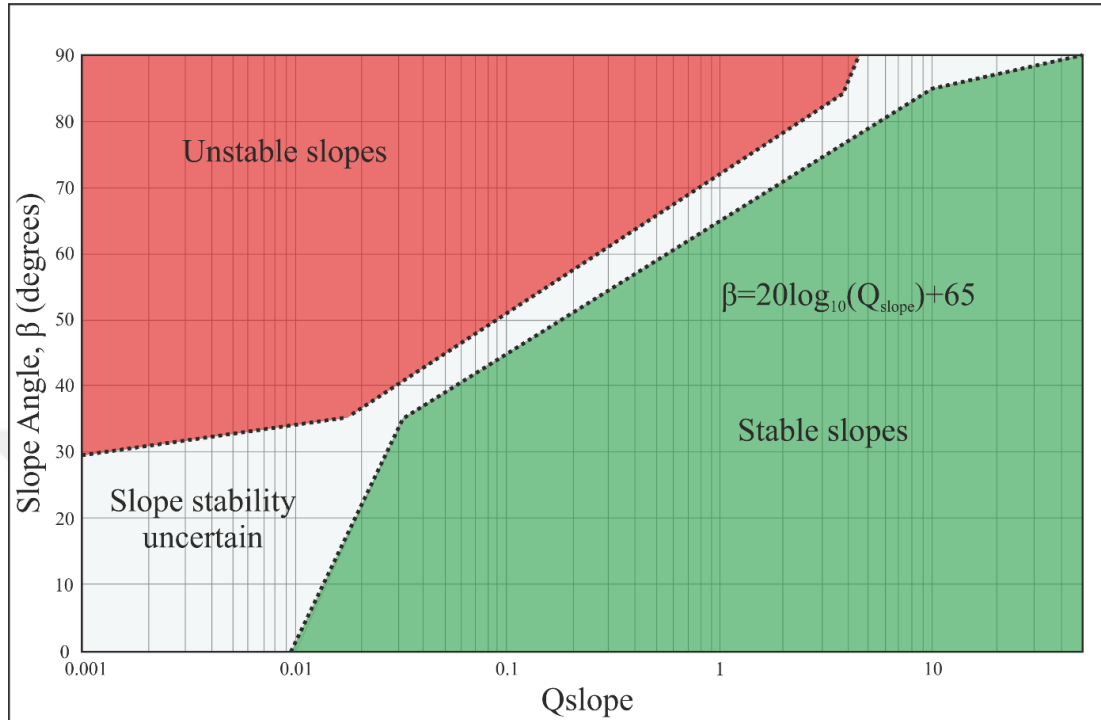
Figure 4.15 Q-slope stability chart

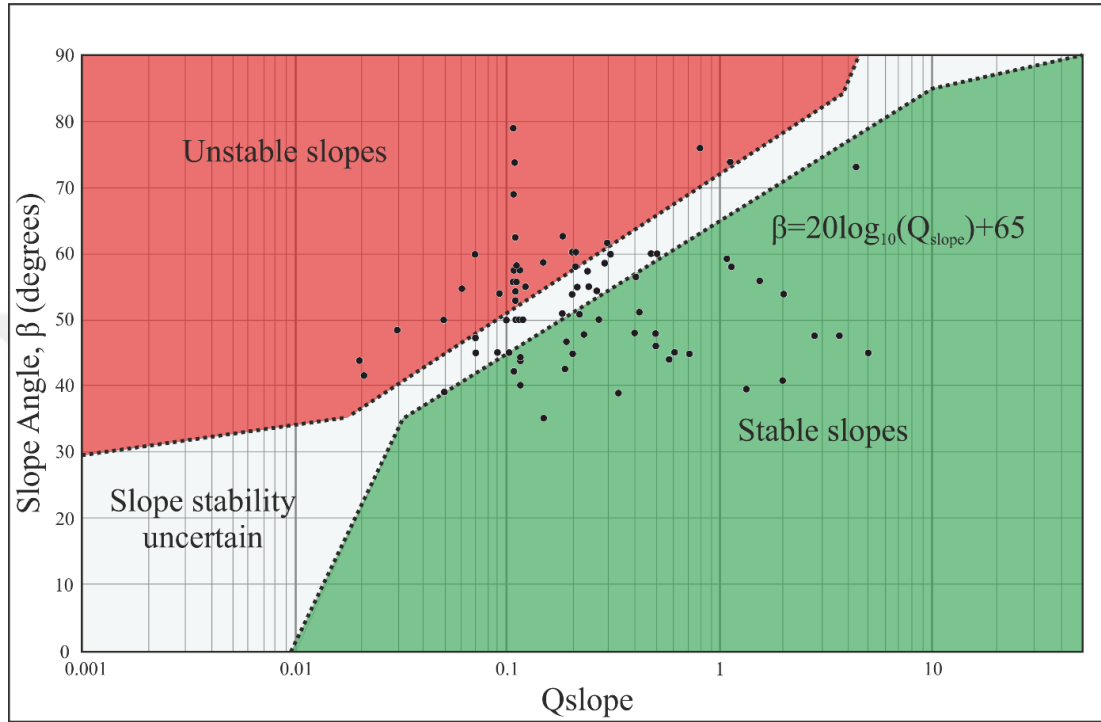
Figure 4.17 Classification of slopes in Qslope

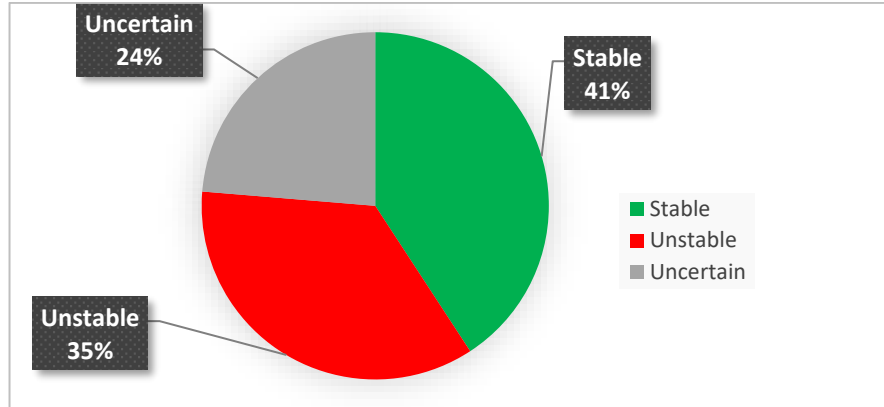
Figure 4.18 Pie chart of Q slope classes

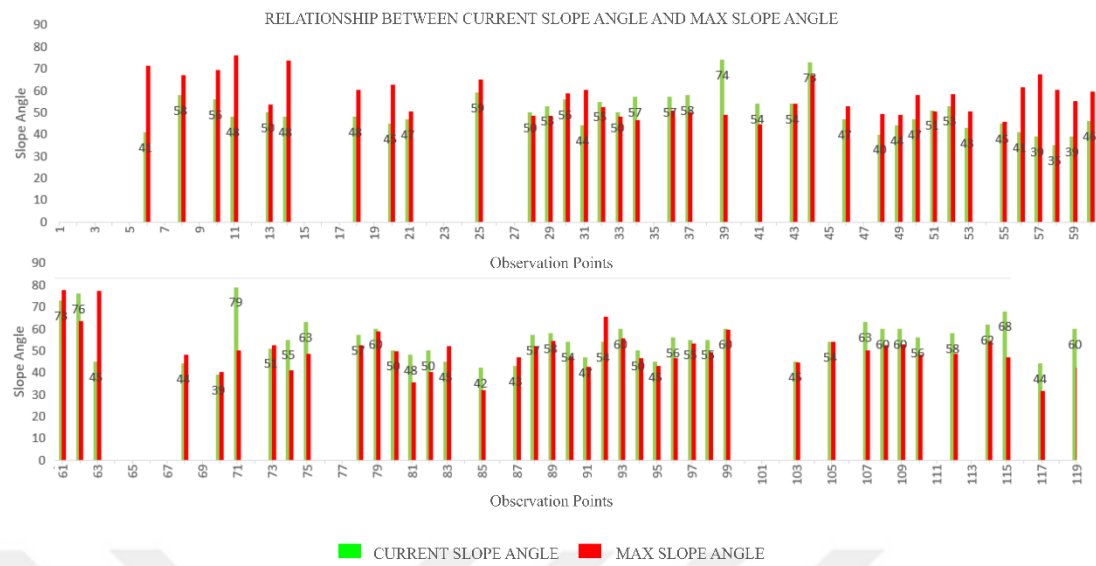
Figure 4.19 The relationship between the current slope angles and maximum slope angles at the observation points

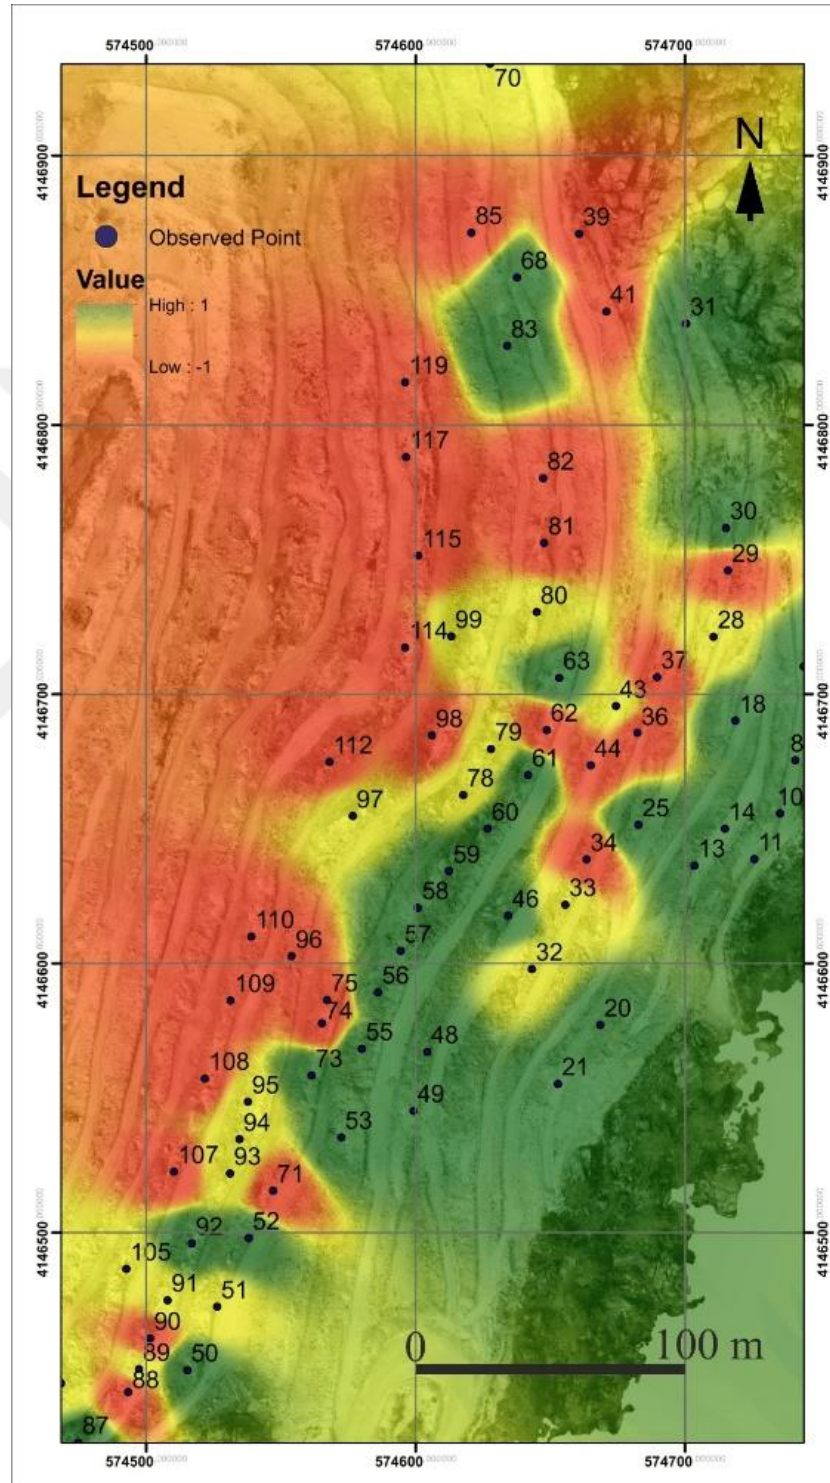
Figure 4.20 Depict of Qslope scores by IDW method

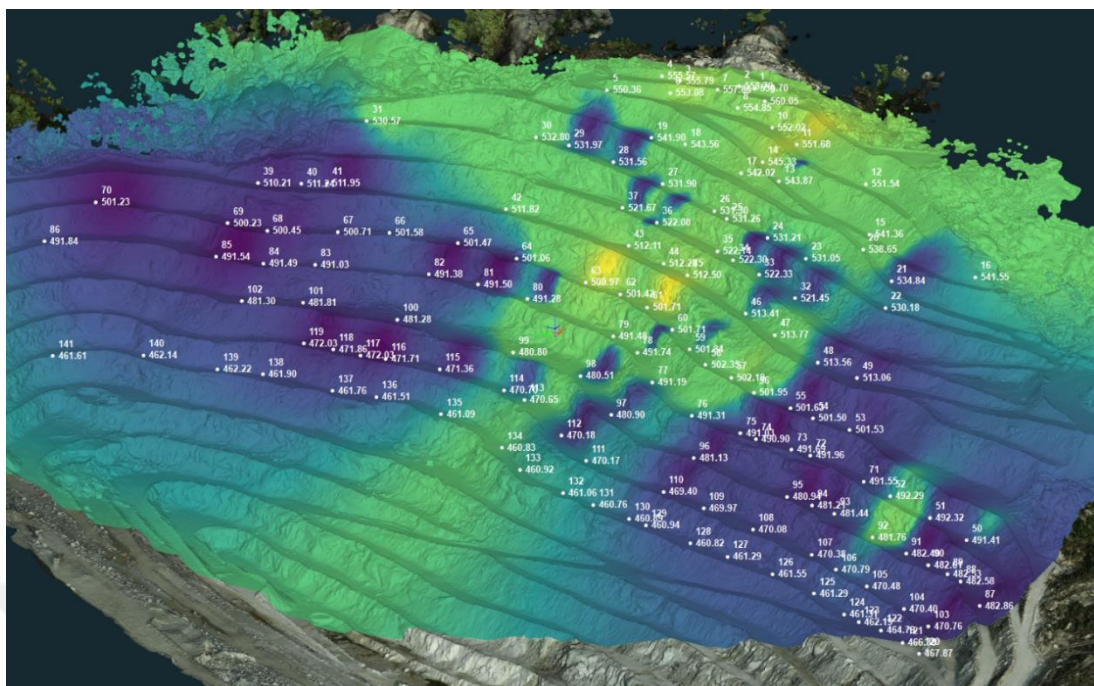
Figure 4.21 Representation of the Qslope classification system on slopes in 3D after visualization with the IDW method

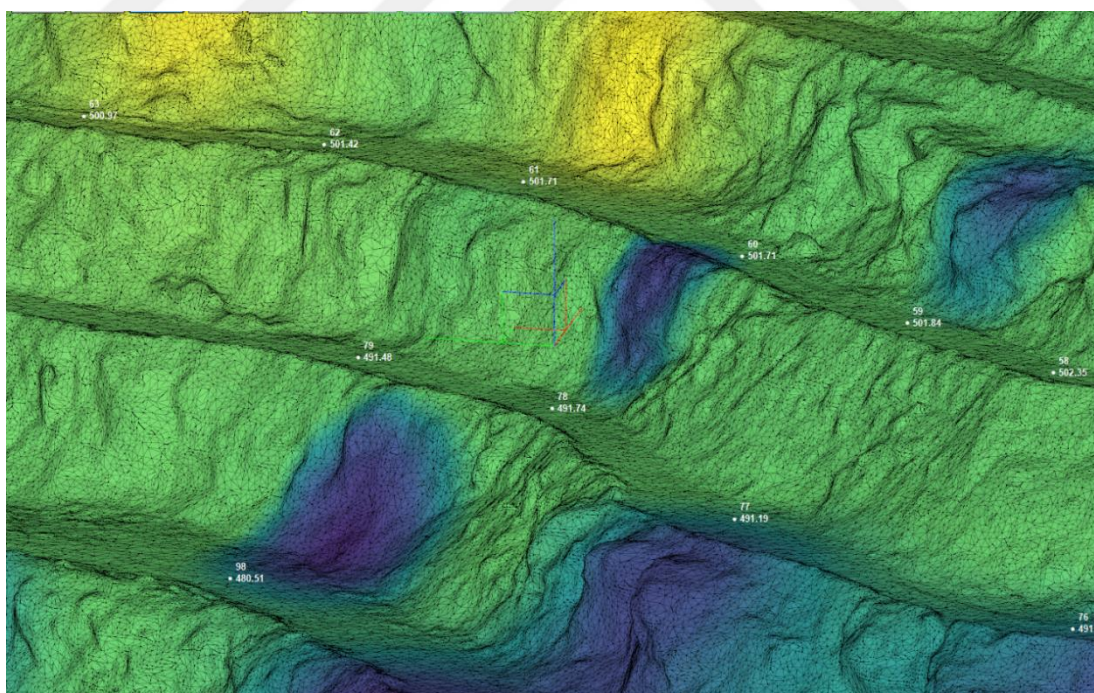
Figure 4.22 Close examination of the Qslope score of slopes 59-61

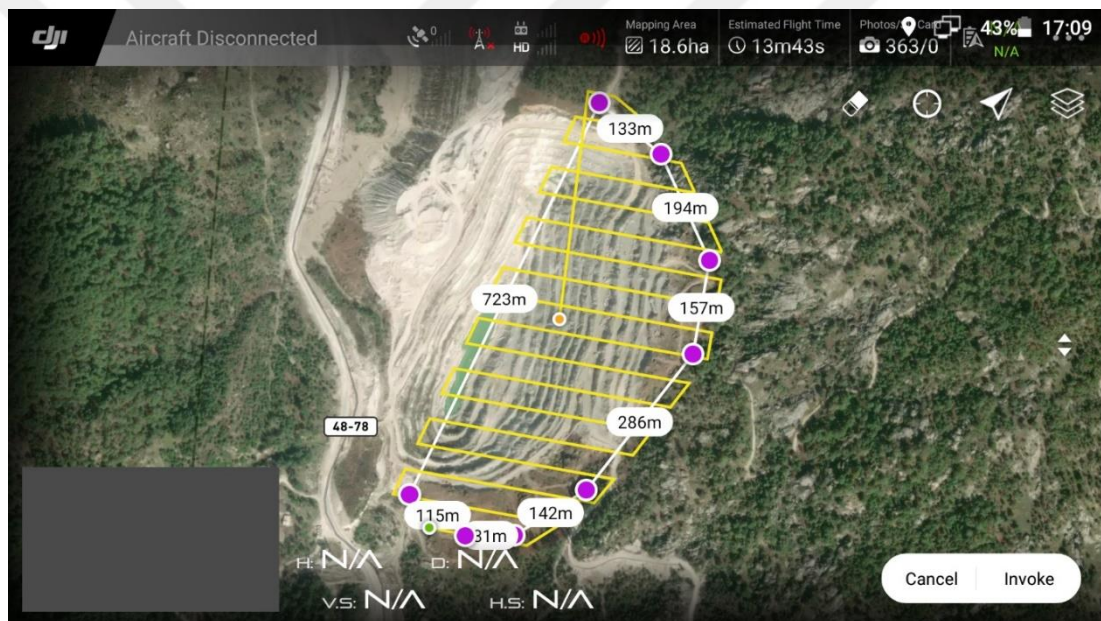
Figure 5.1 Flight plan of the worksite in the GS RTK app on the Phantom 4 RTK's onboard display controller

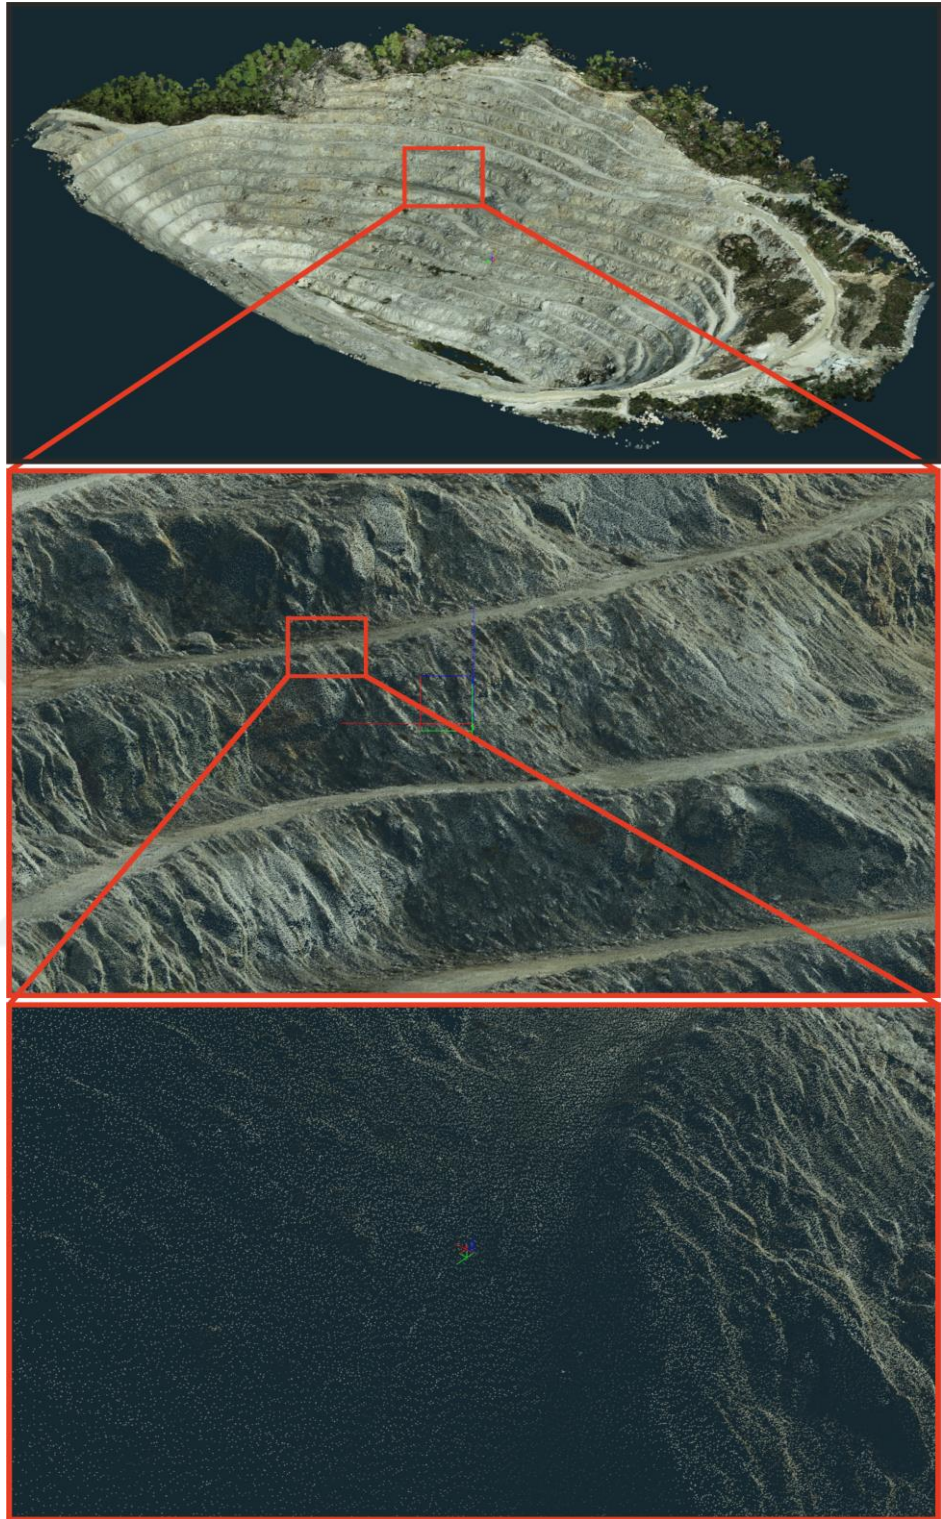
Figure 5.2 The "dense point cloud" data model with 144,786,888 points and its detailing
