**MONITORING AND NUMERICAL ANALYSIS OF
OPEN PIT MINE SLOPES IN GNEISSES**

August, 2021

**A Thesis Submitted to the
Graduate School of Natural and Applied Sciences of Dokuz Eylül University
In Partial Fulfillment of the Requirements for the Degree of Master of
Science in Geological Engineering, Applied Geology Program**

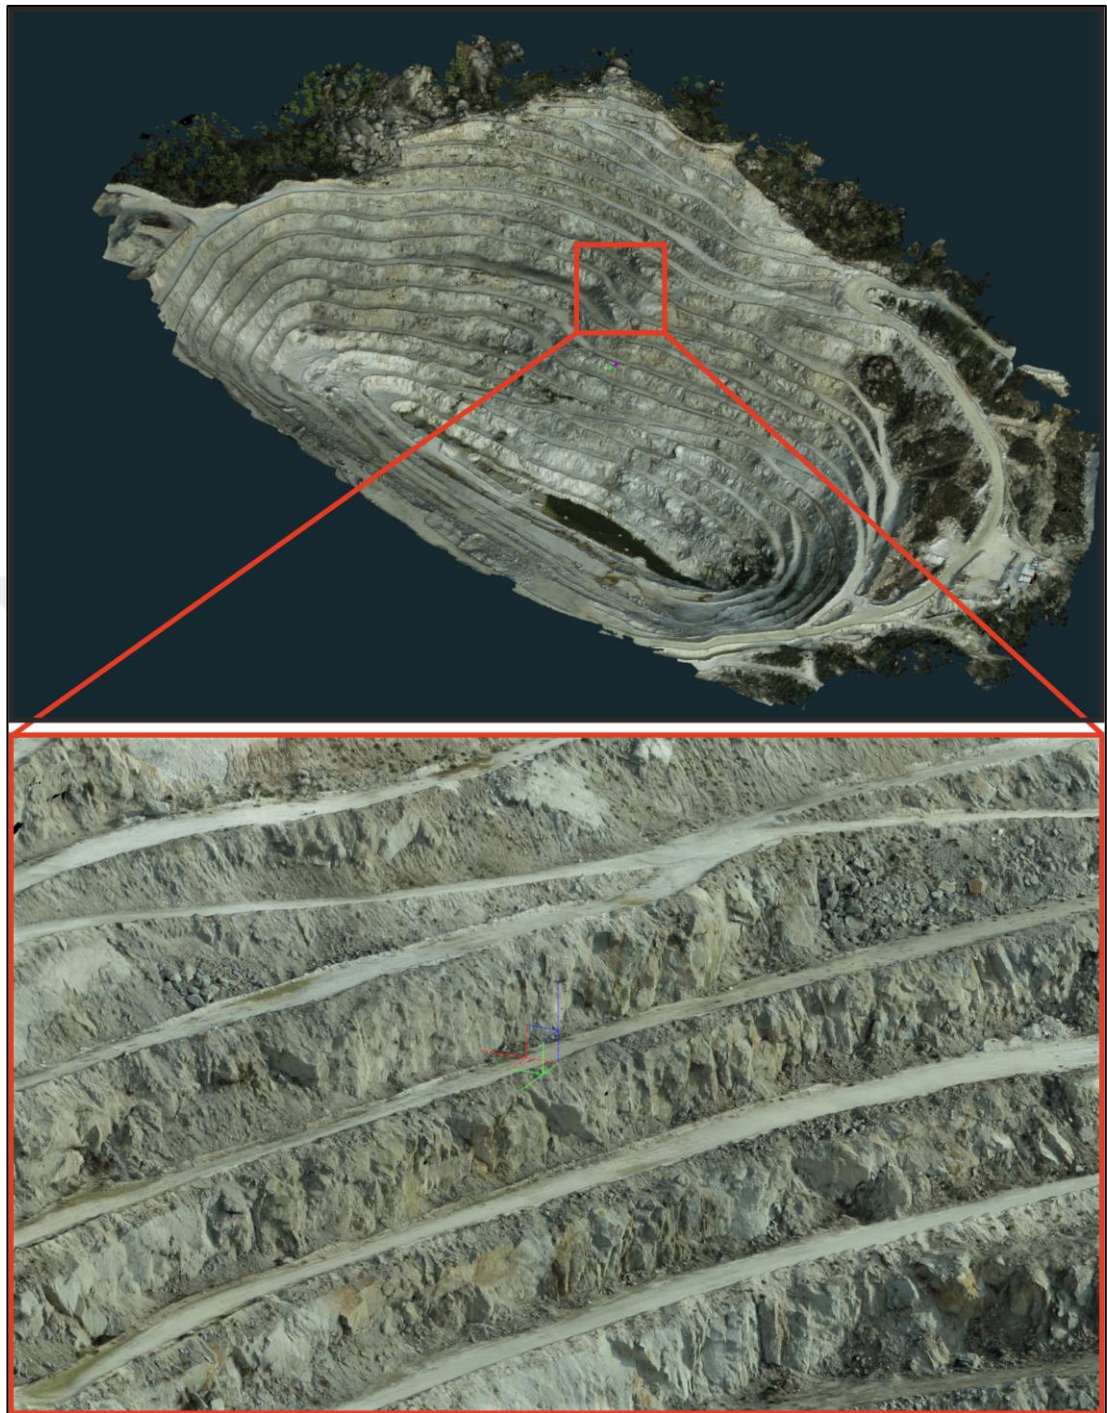
Figure 5.3 Textured mesh model created with 7.000.000 triangles and details from close-up view

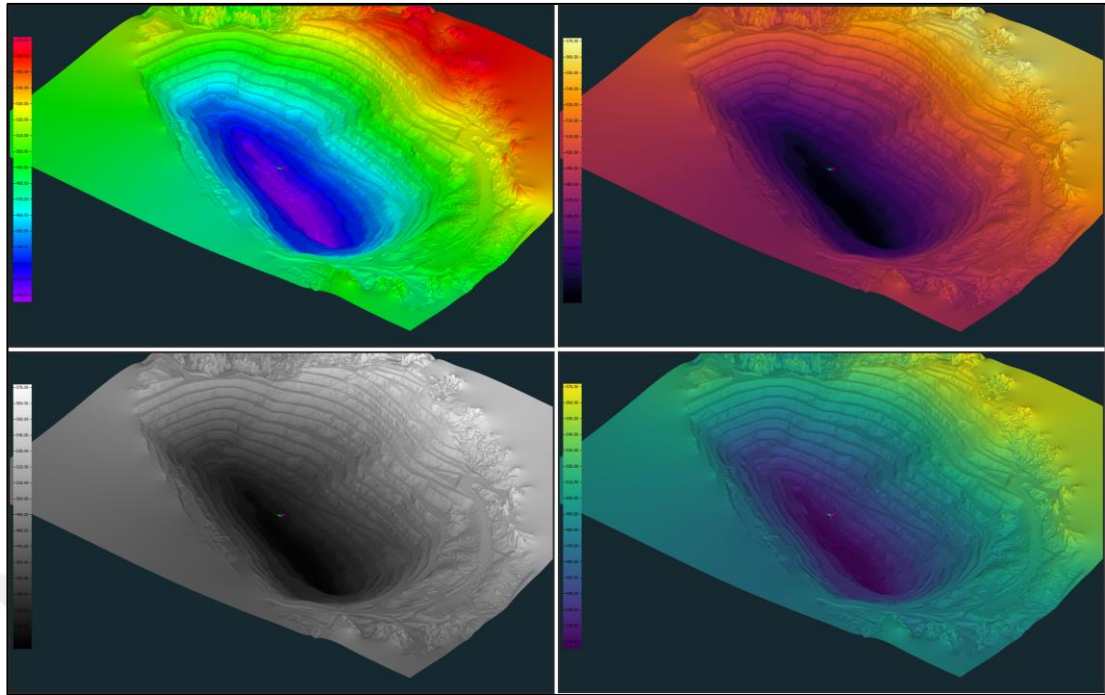
Figure 5.4 Digital elevation models (DEM) presented with different color palettes

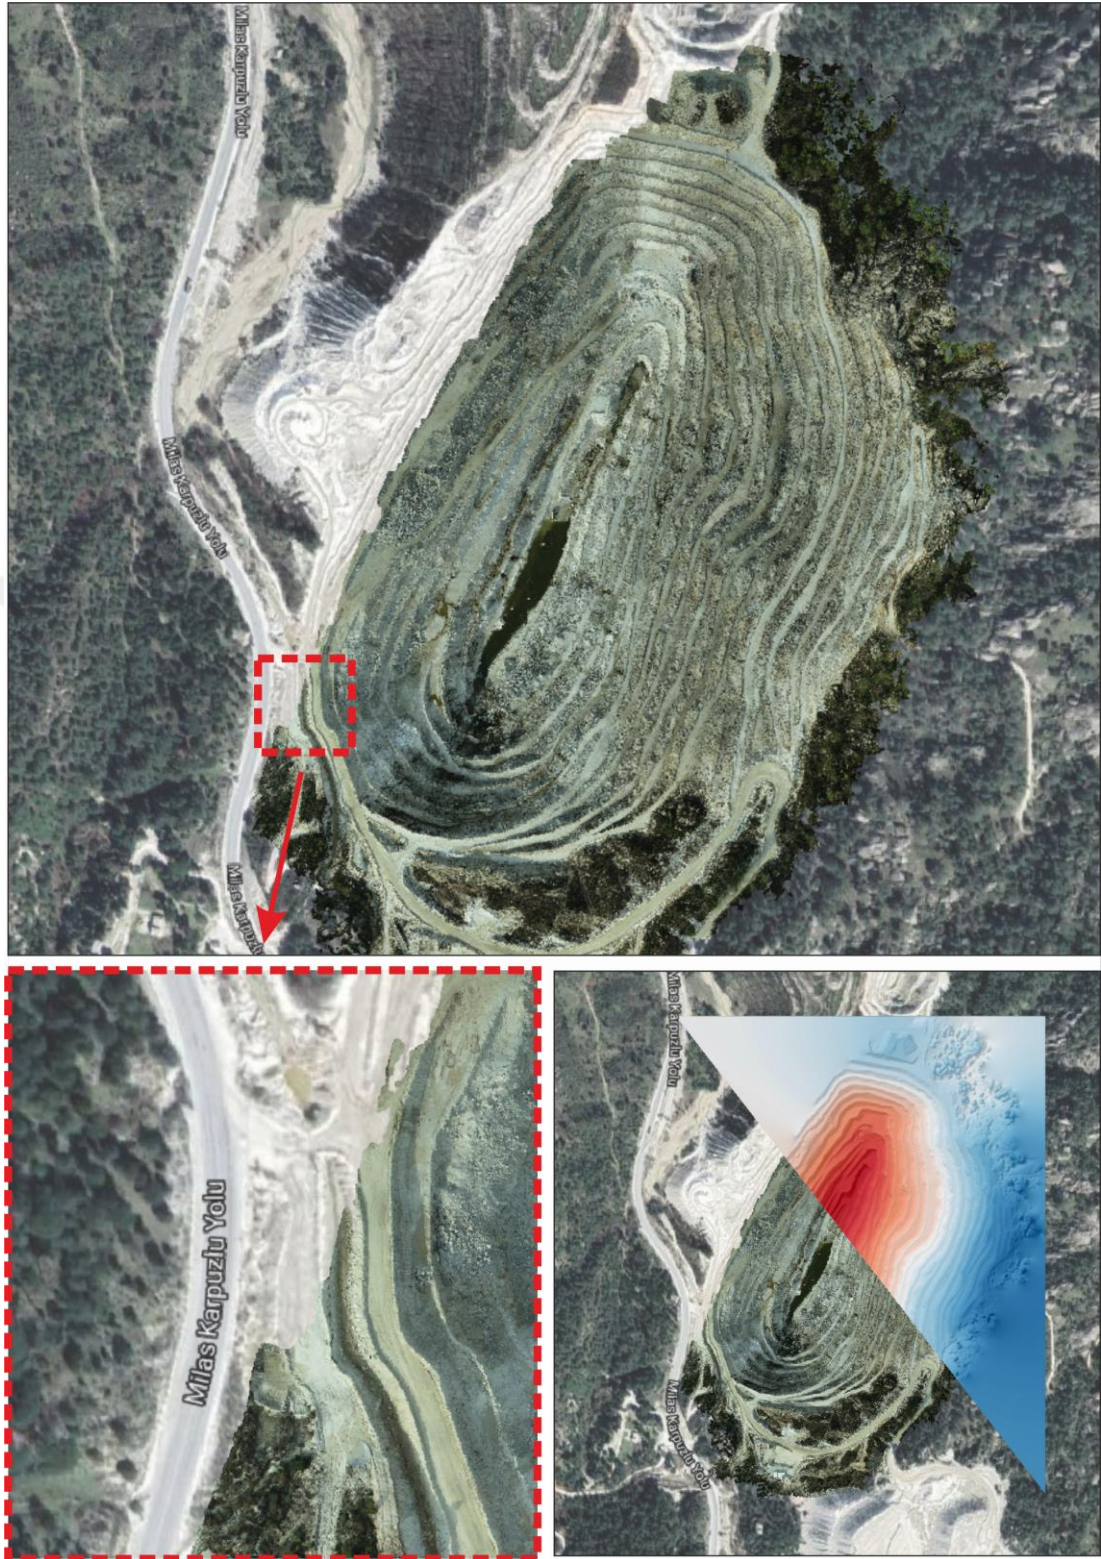
Figure 5.5 Proof of true orthophoto and digital elevation model fit on Google Satellite Hybrid image and positional accuracy

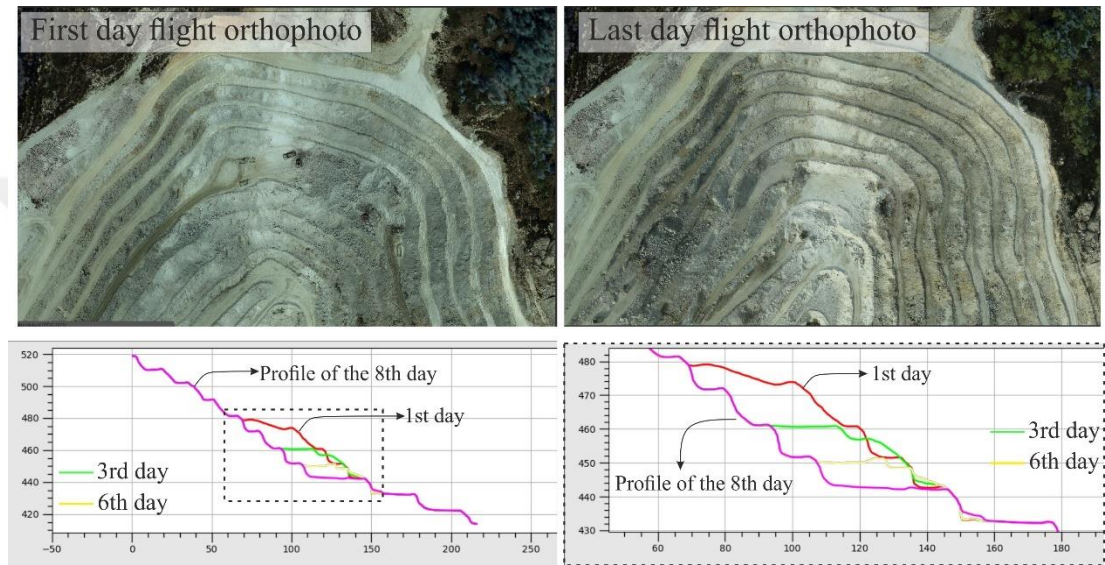
Figure 5.6 Difference analysis from the first and last day flights in the production region

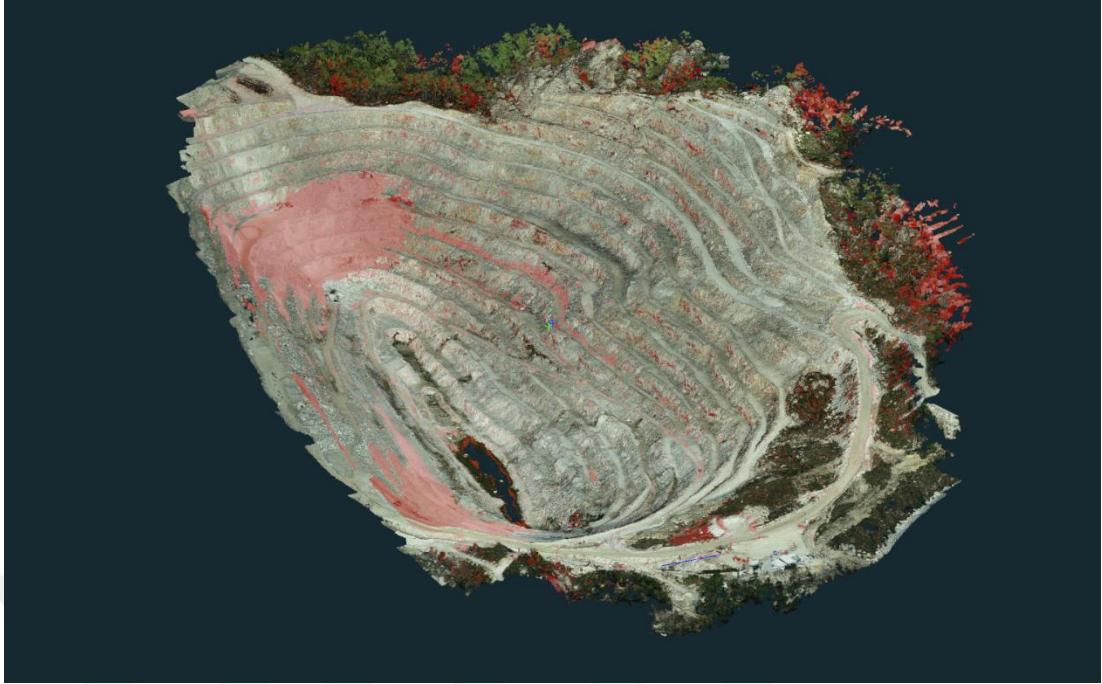
Figure 5.7 Analysis image showing the volume change in the production area

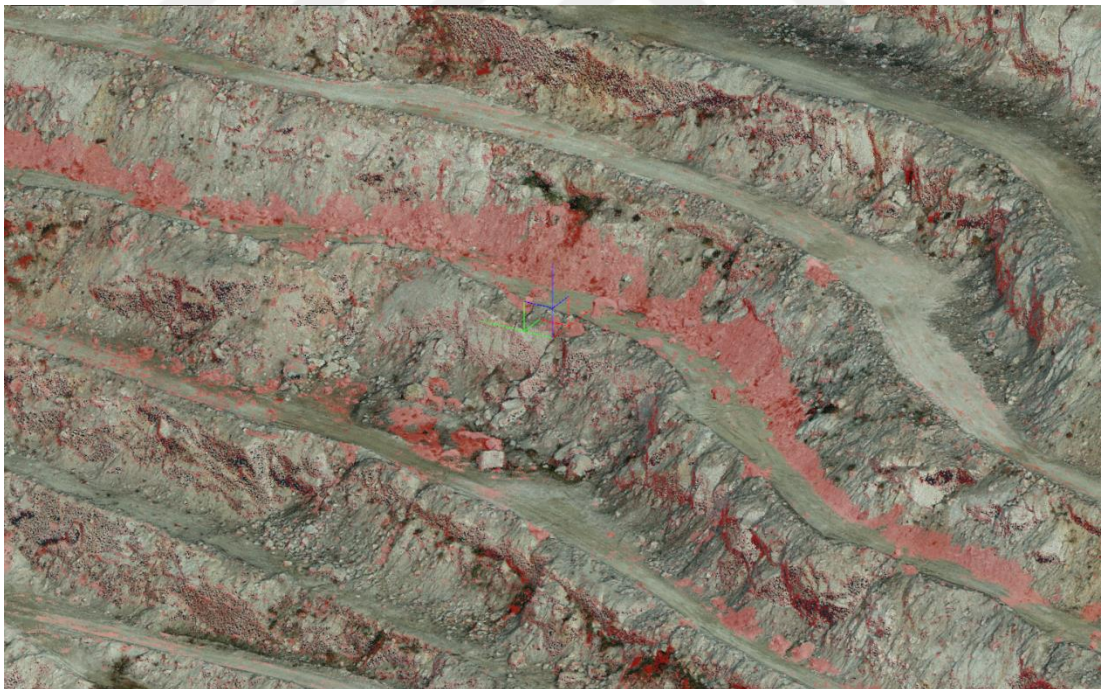
Figure 5.9 Material movement on the surface due to environmental factors

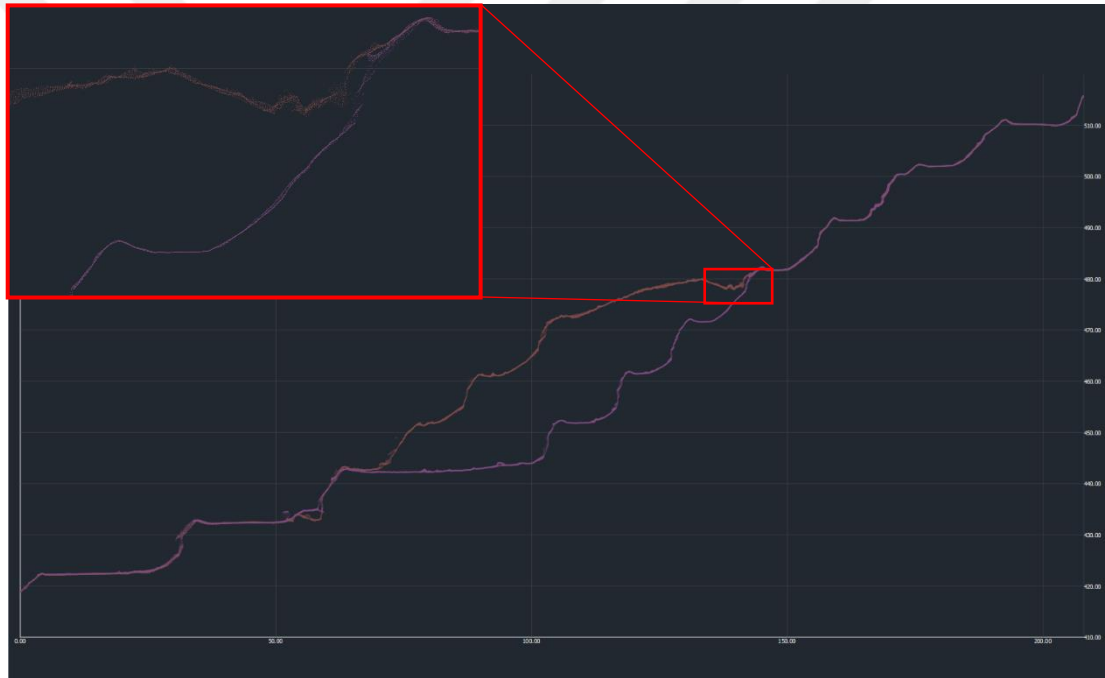
Figure 5.10 Difference analysis in the region of production

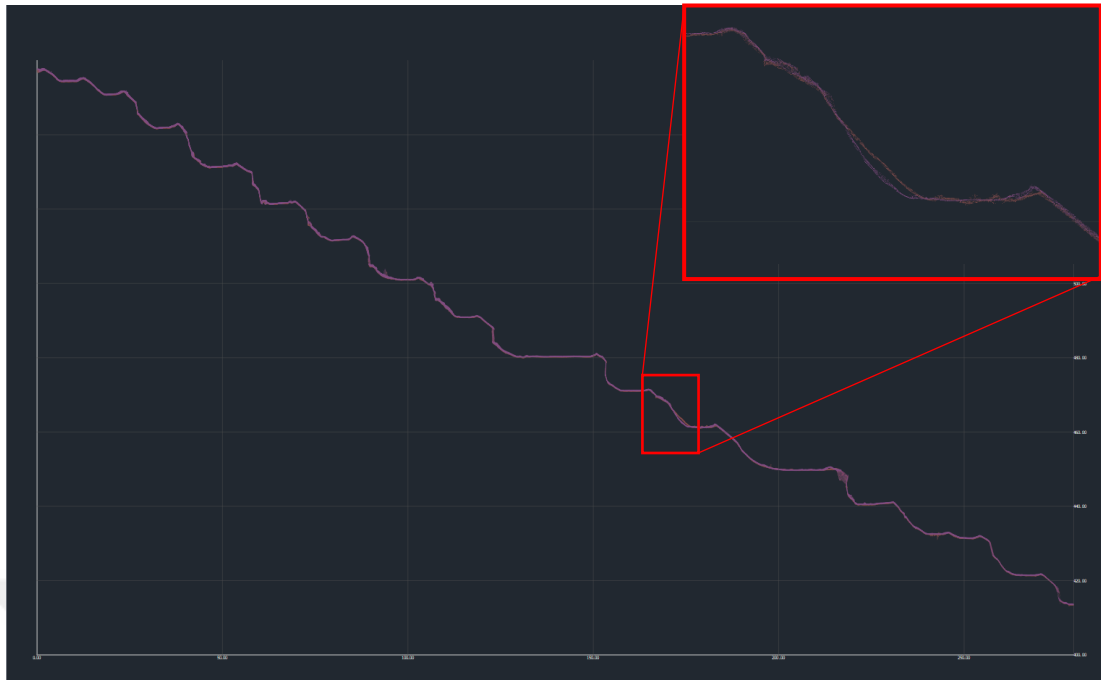
Figure 5.11 Eastern slopes where production is stopped (Only surface movement is observed)

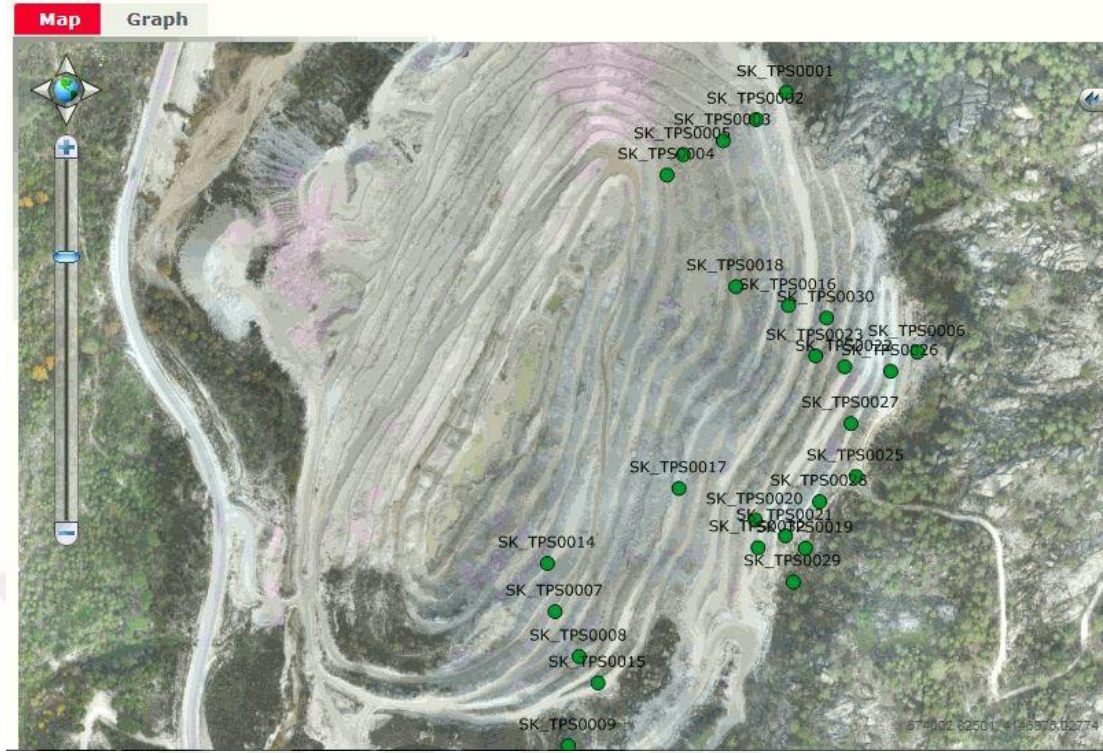
Figure 5.12 Locations of total stations in the mining area

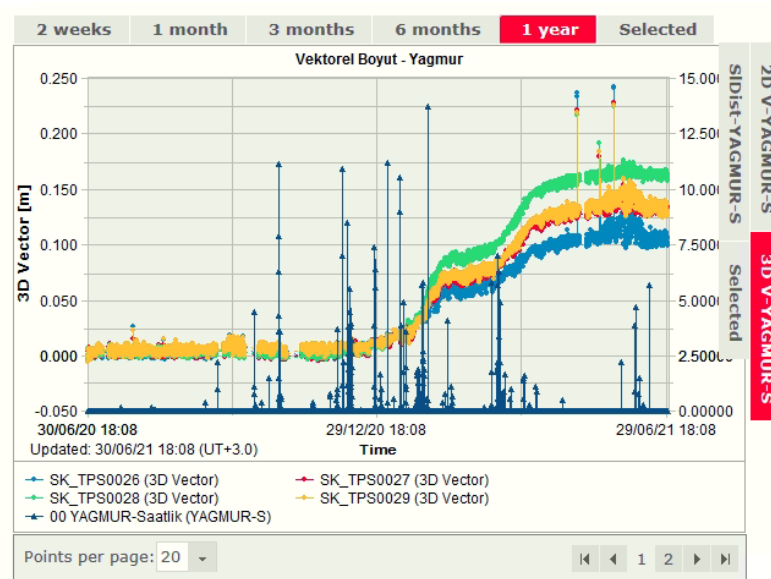
Figure 5.13 Data from total stations

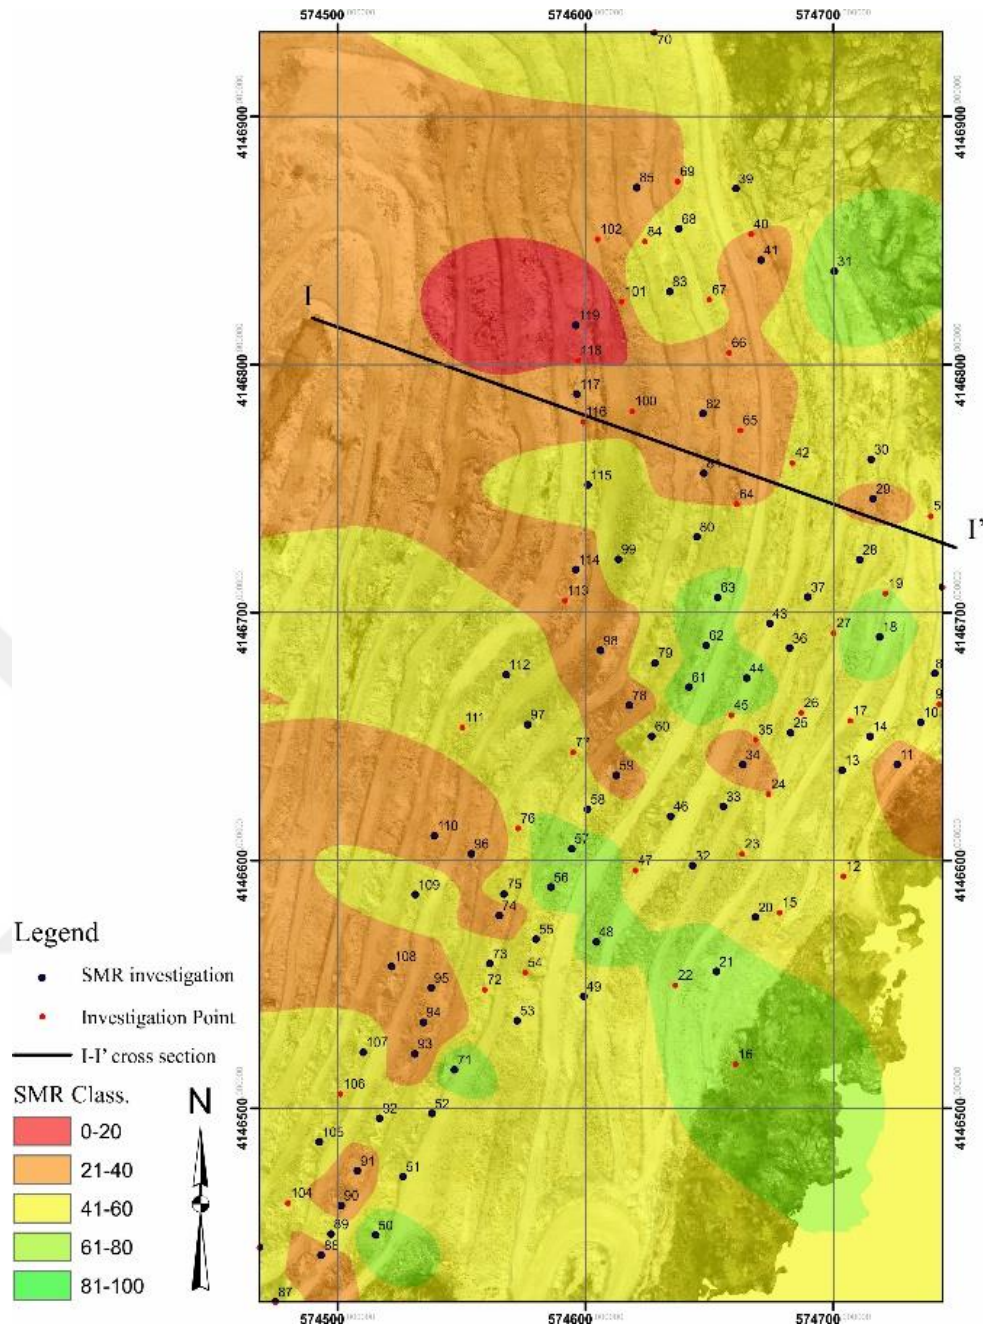
Figure 6.1 Interpolated state and cross section of the SMR system

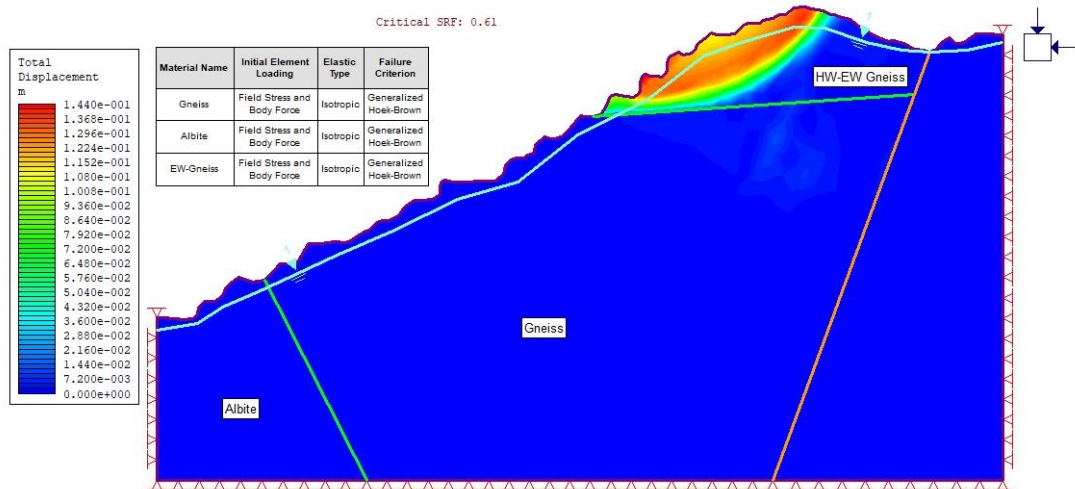
Figure 6.2 As a result of the data entered into the system, the SRF score in the I-I section (light blue line is GWT)

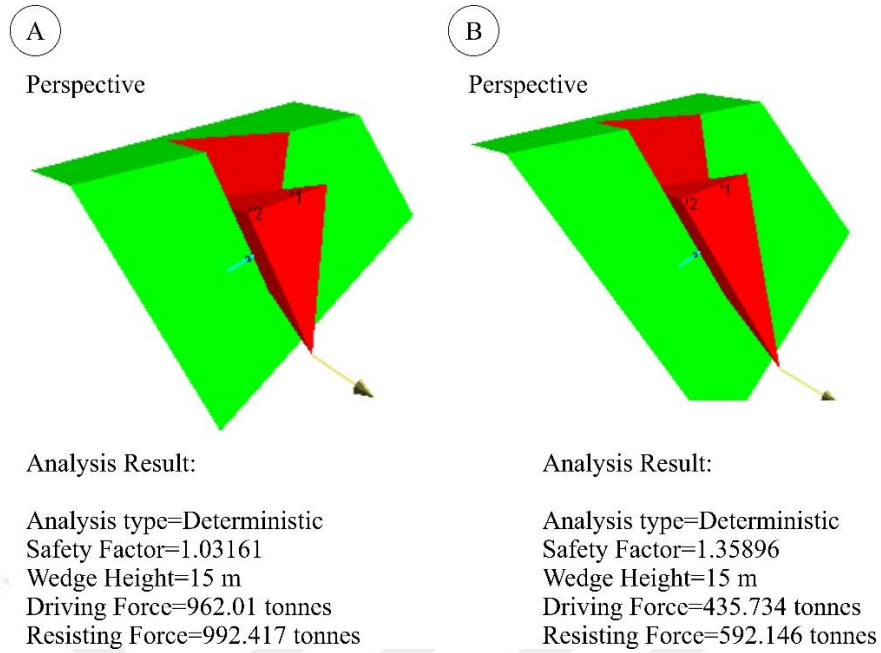
Figure 6.3 a) Simplified version of current slope geometry (slope =53°). b) Safety factor at steepest slope angle according to Qslope system (slope = 48°)
