AN APPROACH OF REUSING ANATOLIAN SELJUK CARAVANSERAIES - A SUGGESTION PROJECT ON A SELECTED CARAVAN ROAD

A Thesis Submitted to the
Graduate School of Natural and Applied Sciences of
Dokuz Eylül University
In Partial Fulfillment of the Requirements for
the Degree of Master of Science in Architecture, Restoration Program

by
Esra EKMEKÇİ

October, 1997

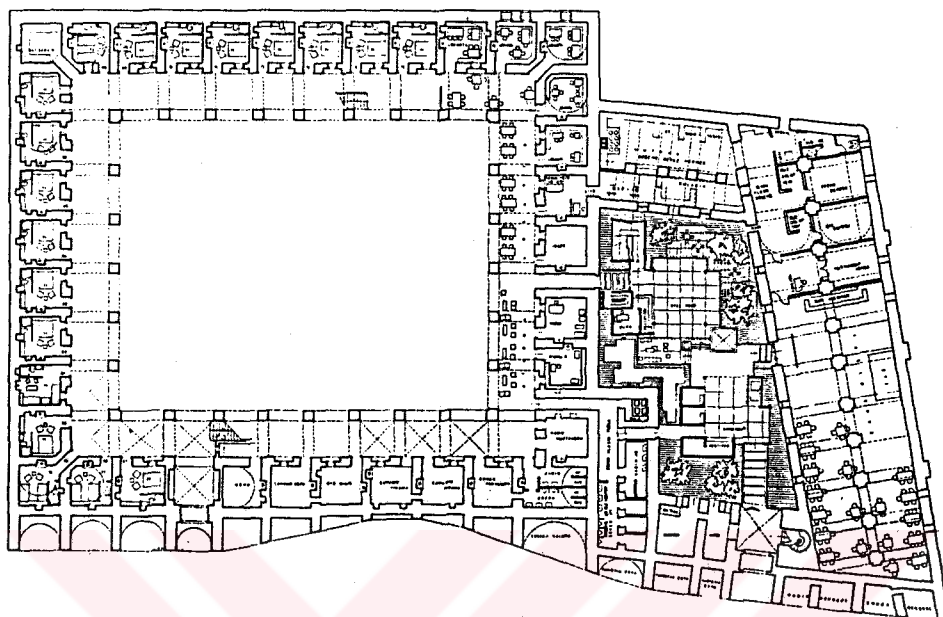
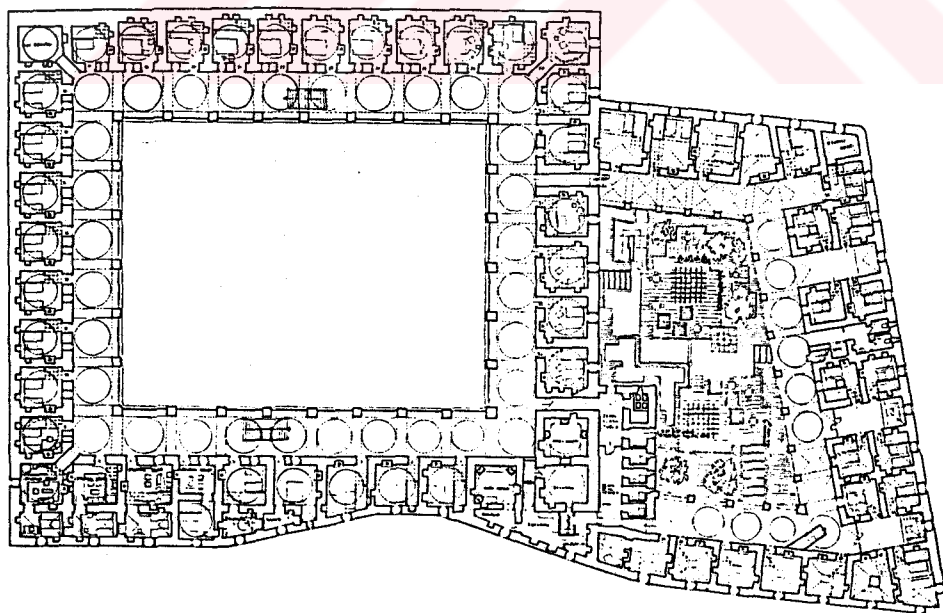
Figure 4.3 Rüstempaşa Caravanserai in Edirne - Plan Drawings

GROUND FLOOR PLAN

FIRST FLOOR PLAN

The restoration procedure began in 1960, and after 1966 the process continued considering the necessary alterations of the new function. The first floor of the section containing the rear façade and 12 rooms, had completely fallen down. This section was reconstructed according to the original plan (figure 4.3), and the ground floor was strengthened by a frame of concrete beams connected to the main body. The superstructure consisting of pillars, arches and domes was in a ruined condition and was supported by using concrete material and building technique. The köşk mescid which stood in the center of the courtyard, could not be reconstructed because of the insufficient traces. The plan layout provided available common spaces for a hotel. The required service spaces and

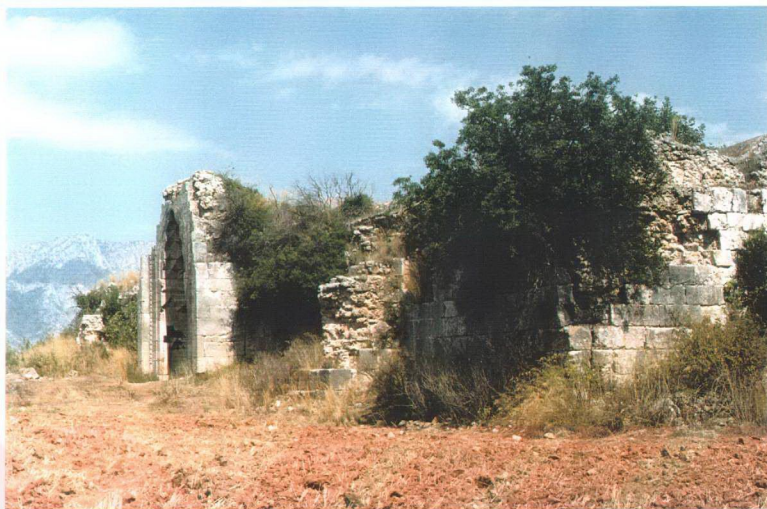
Figure 5.6 Front Façade at the South Covered with Plants (8/1997)

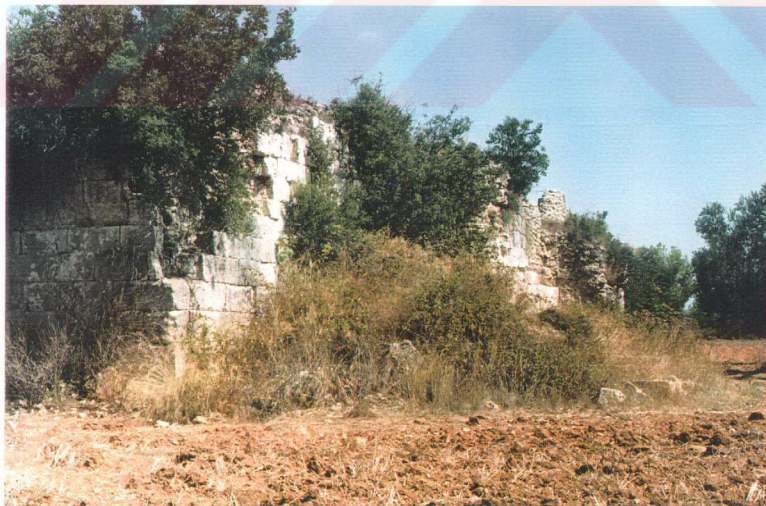
Figure 5.7 Ruined East Façade with Trees Grown on It (8/1997)

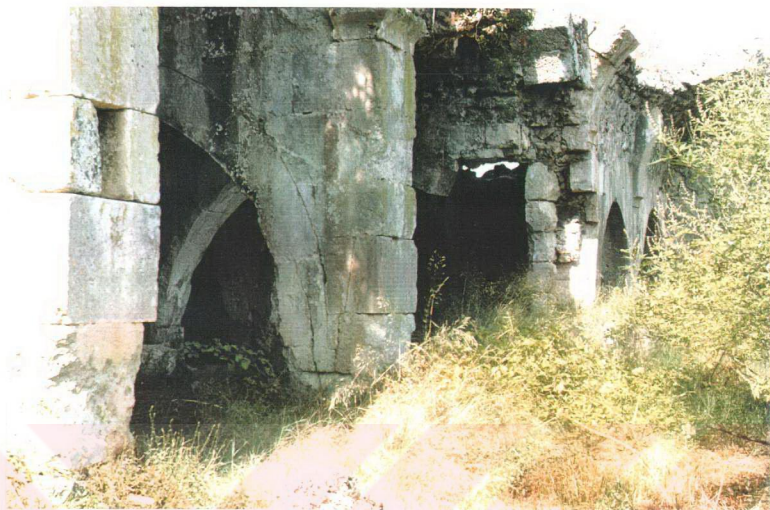
Figure 5.15 Arches Near the Entrance Gate (8/1997)

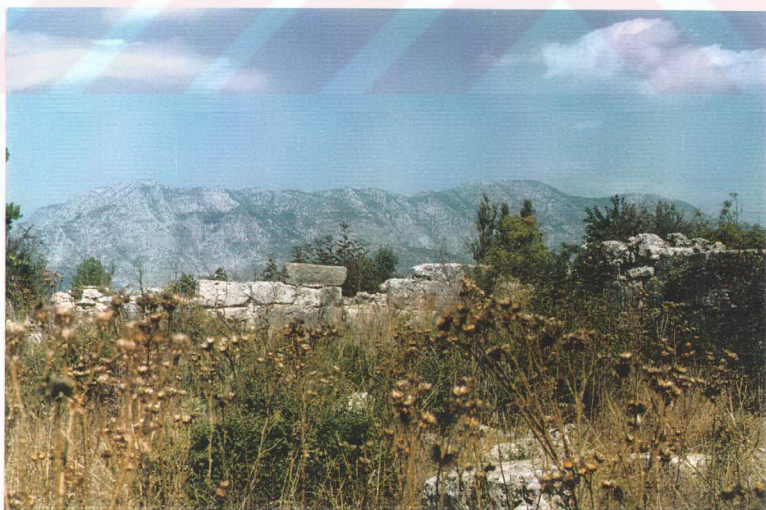
Figure 5.16 Traces of the Walls of the Courtyard (8/1997)

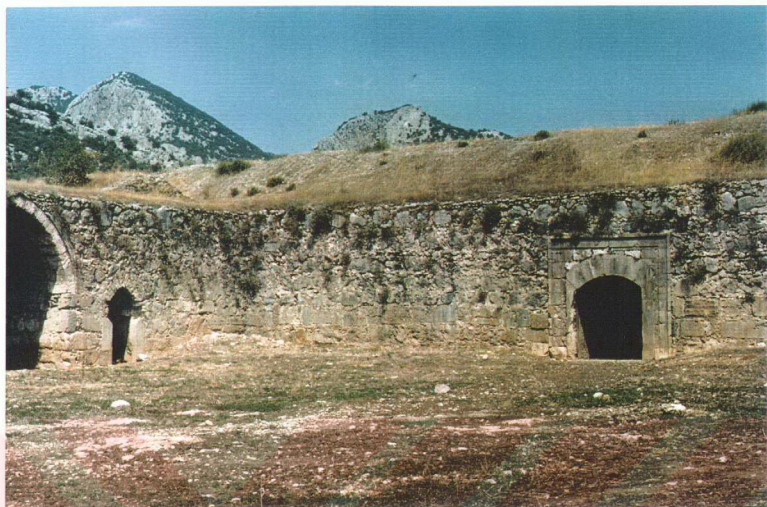
Figure 5.26 Entrance of Closed Section with Its Roofing Covered with Soil (8/1997)

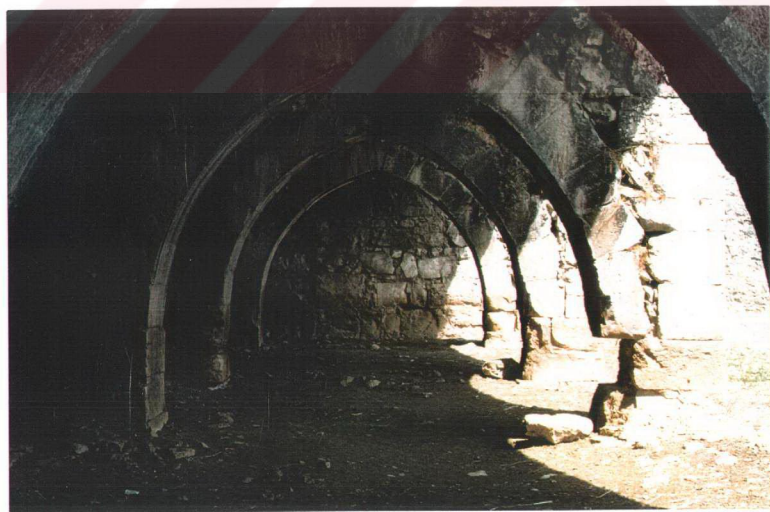
Figure 5.27 Arches and Piers that Constitute the Arcades (8/1997)

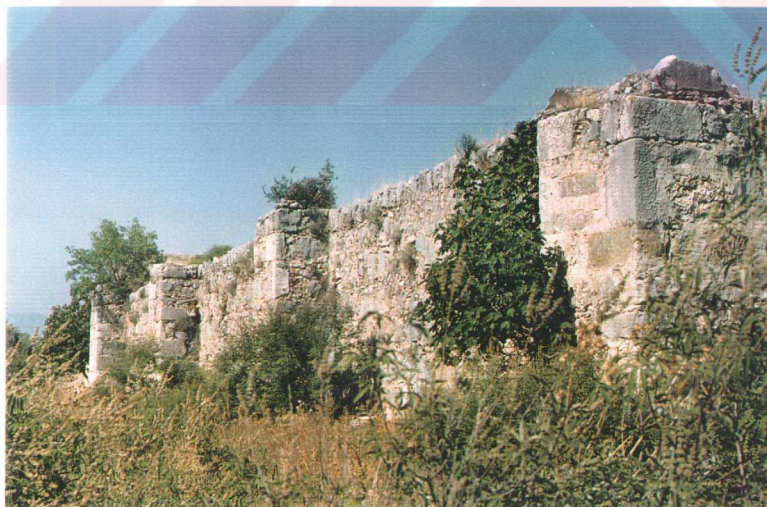
Figure 5.29 Western Wall Covered with Plants (8/1997)

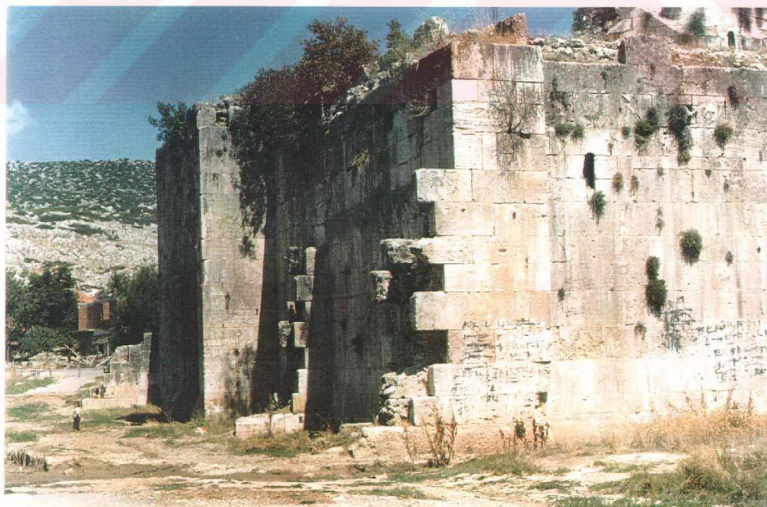
Figure 5.36 Western Façade with Perpendicularly Attached Wall Pieces (8/1997)

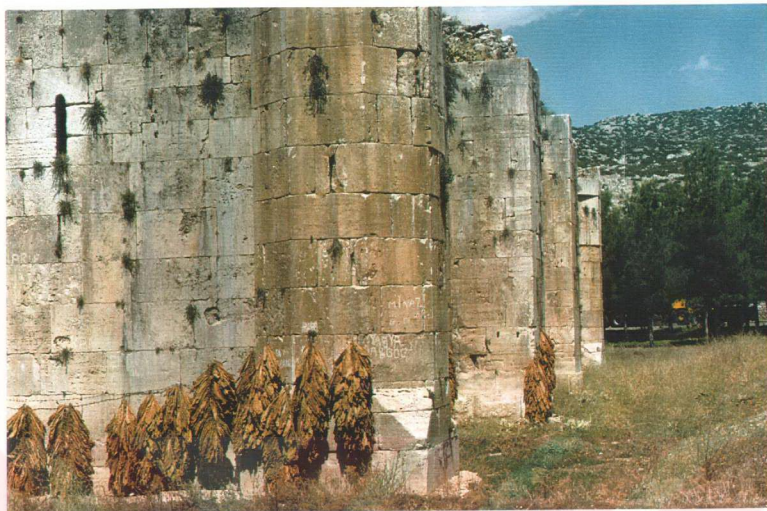
Figure 5.39 The Rectangular Buttresses at the Middle of the Rear Façade (8/1997)

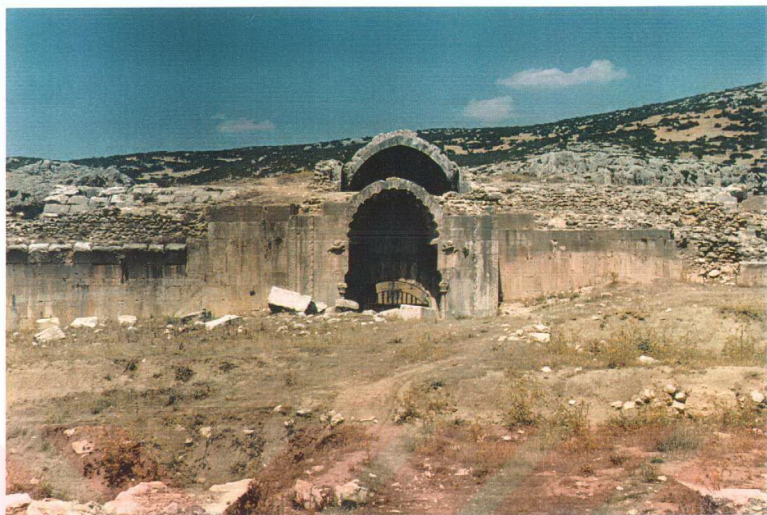
Figure 5.57 Front Façade and Partially Collapsed Central Portal (8/1997)

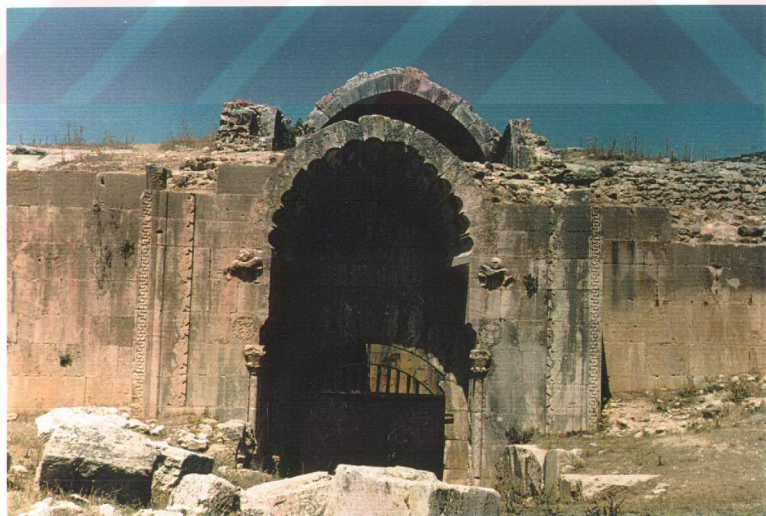
Figure 5.58 Portal Niche with Lion Figures, Rozettes and Colonnets (8/1997)

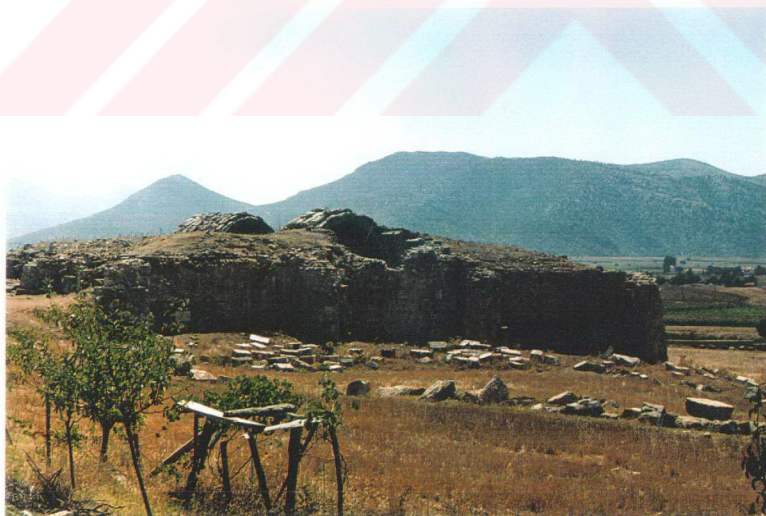
Figure 5.60 Northern Façade and the Fallen Down Stone Blocks Around (8/1997)

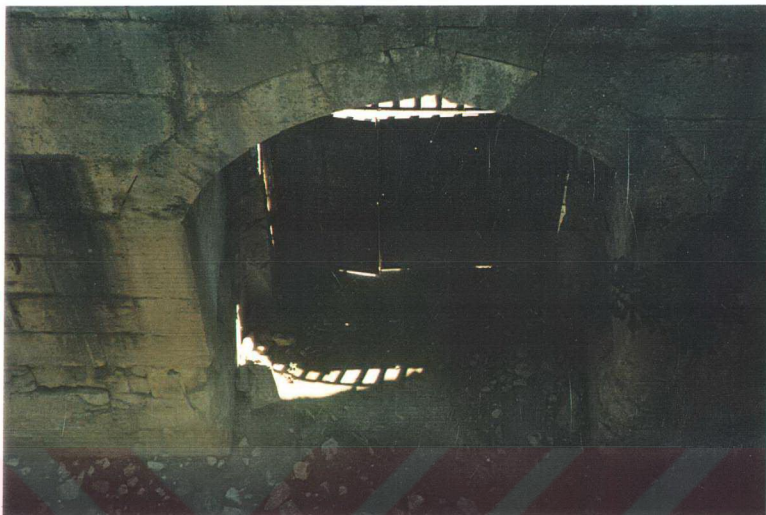
Figure 5.69 Entrance Eyvan with Iron Door Made to Prevent Destruction (8/1997)

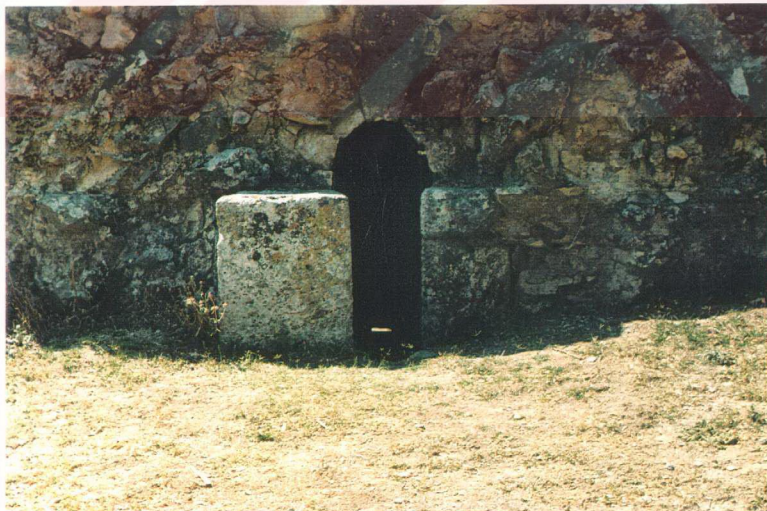
Figure 5.70 Window at the Ground Level on East Façade Filled with Soil (8/1997)
