**COMPARISON OF KINEMATIC ANALYSIS
RESULTS OBTAINED FROM UNMANNED
AERIAL VEHICLE DATA AND SCAN-LINE
DISCONTINUITY MEASUREMENTS IN THE
GNEISS ROCK SLOPES**

by
Melikhan KARAKAŞ

August, 2021
İZMİR

**A Thesis Submitted to the
Graduate School of Natural and Applied Sciences of Dokuz Eylül University
In Partial Fulfillment of the Requirements for the Degree of Master of Science
in Geological Engineering, Applied Geology Program**

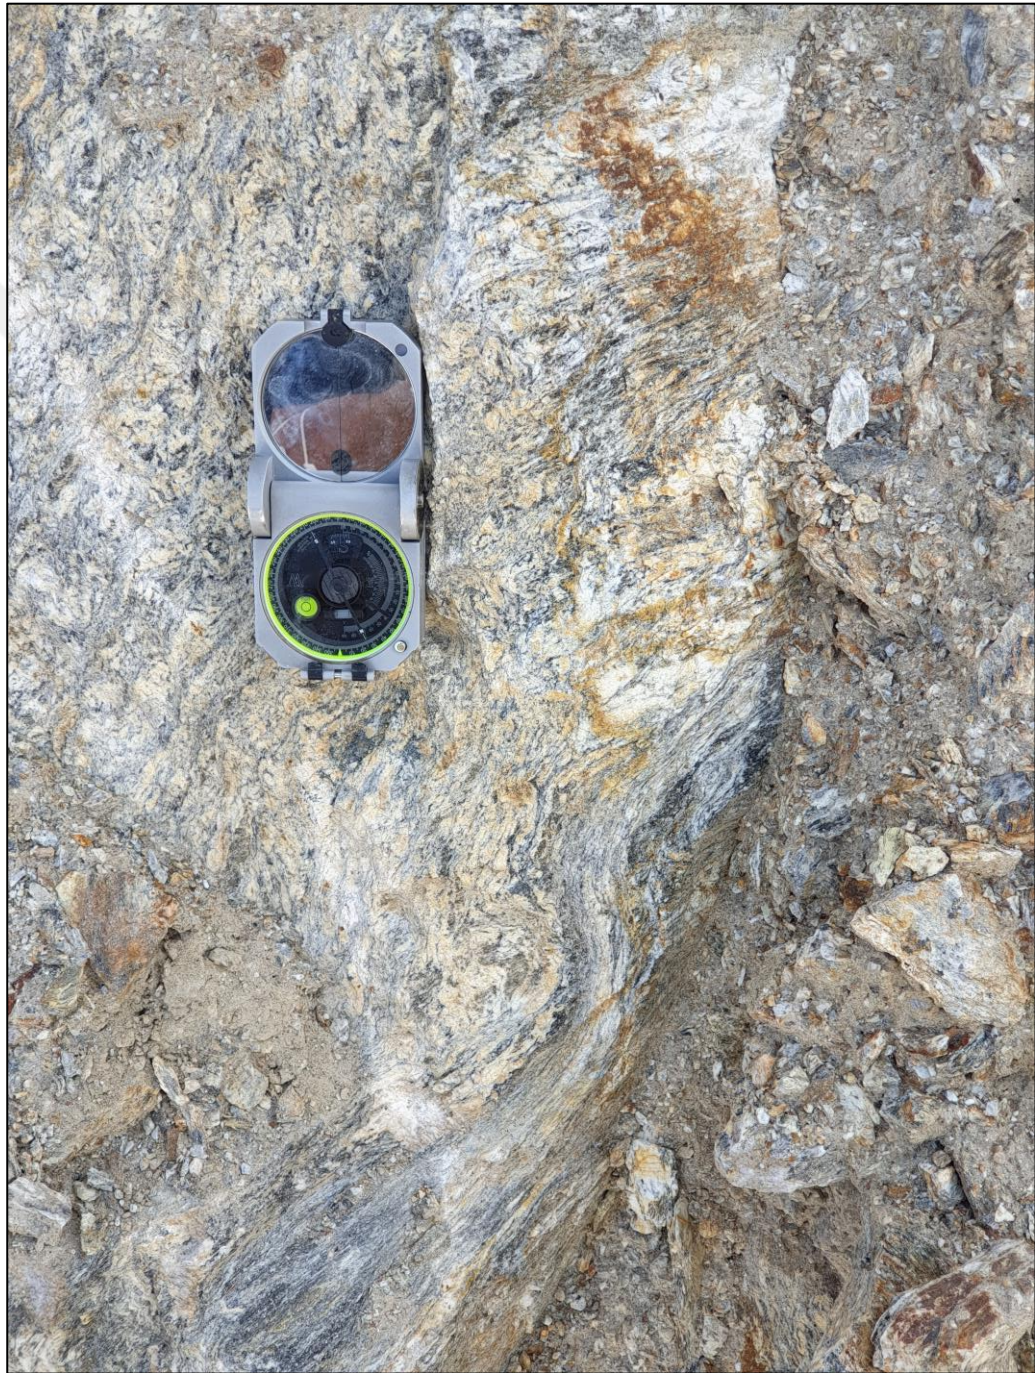
Figure 3.4 The field view of foliation planes that change (folds) due to deformation (Personal archive, 2021)

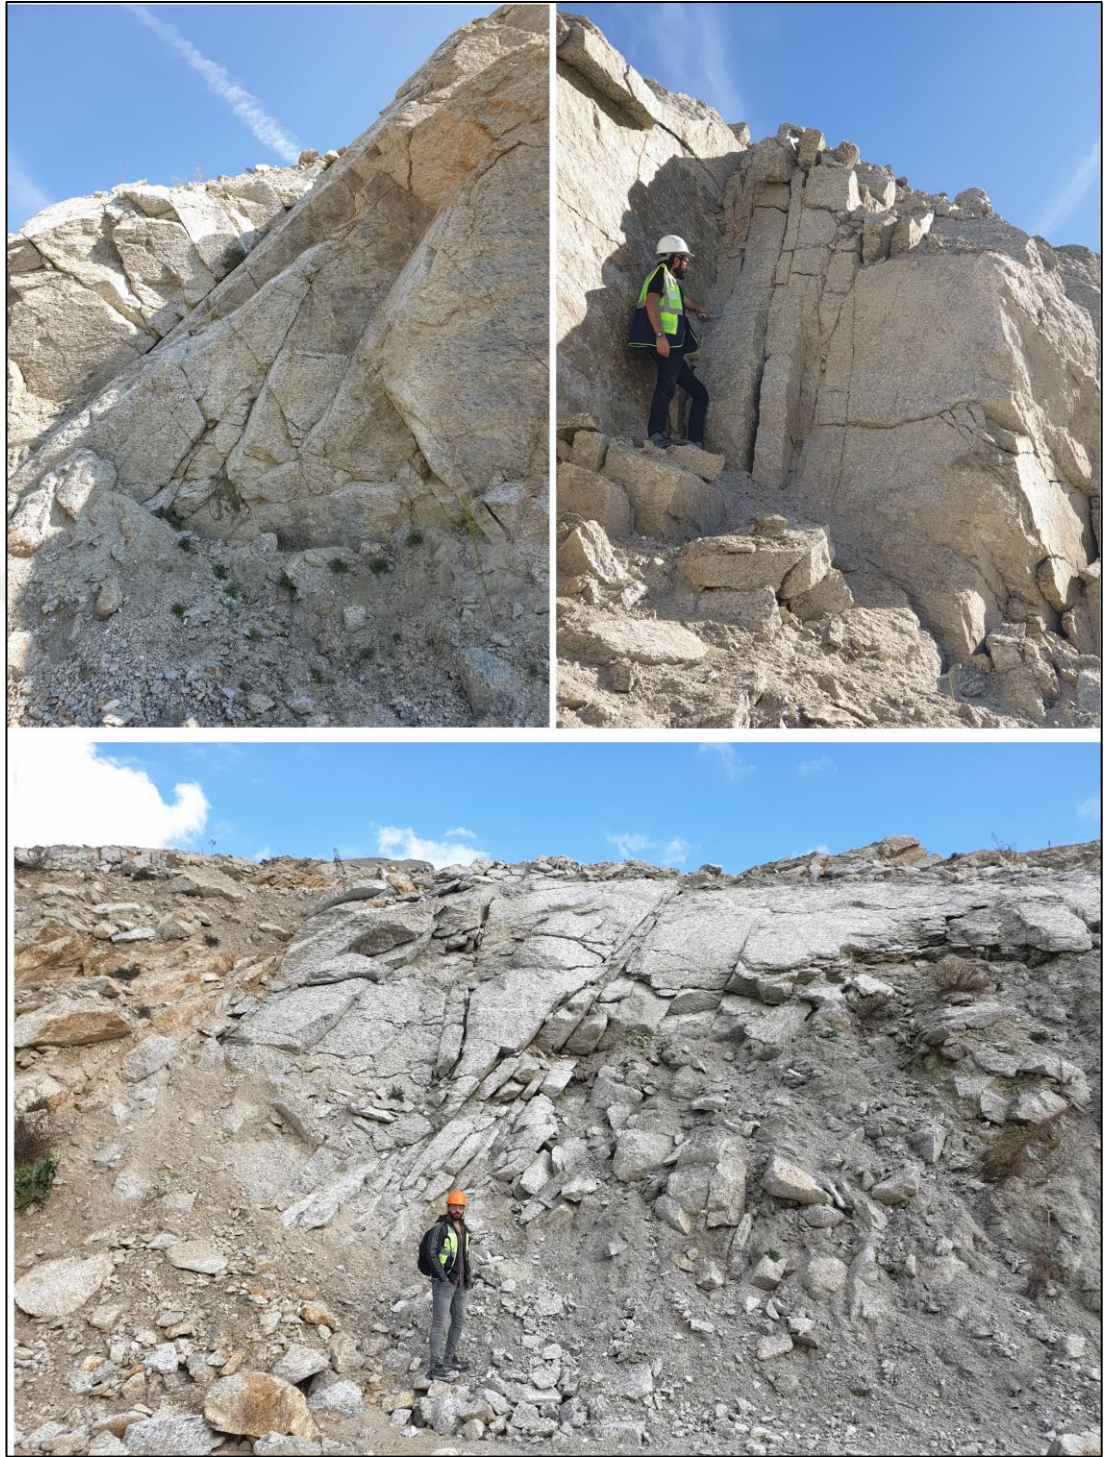
Figure 4.5 Discontinuity planes with different apertures observed in slopes at different investigation locations (Personal archive, 2021)

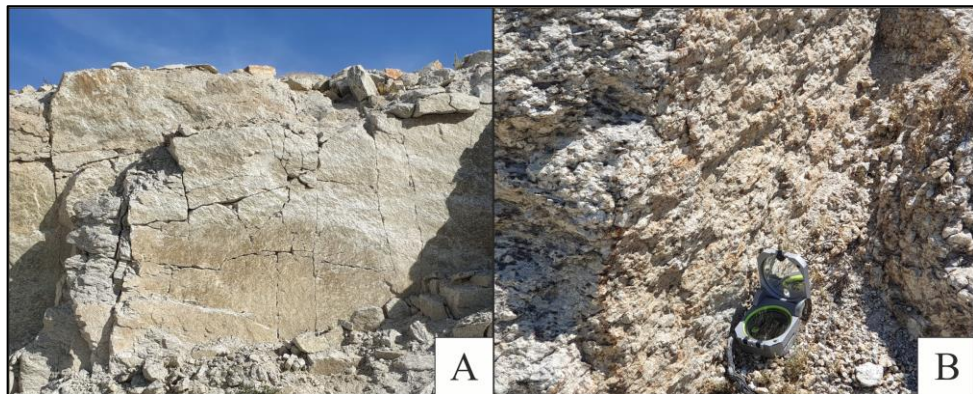
In the observations in the study area, the surface roughness of the rock slopes varies from region to region, but it has been seen that it has a medium and very rough structure in general (Figure 4.7). Roughness measurements were made in almost all of the discontinuity planes in the investigated slopes. Since the slopes in the weathering zones lost their rock feature, roughness measurement could not be made at the x point.

Figure 4.7 Roughness in slopes; (A) Slightly rough surface, (B) Very rough surface (Personal archive, 2021)

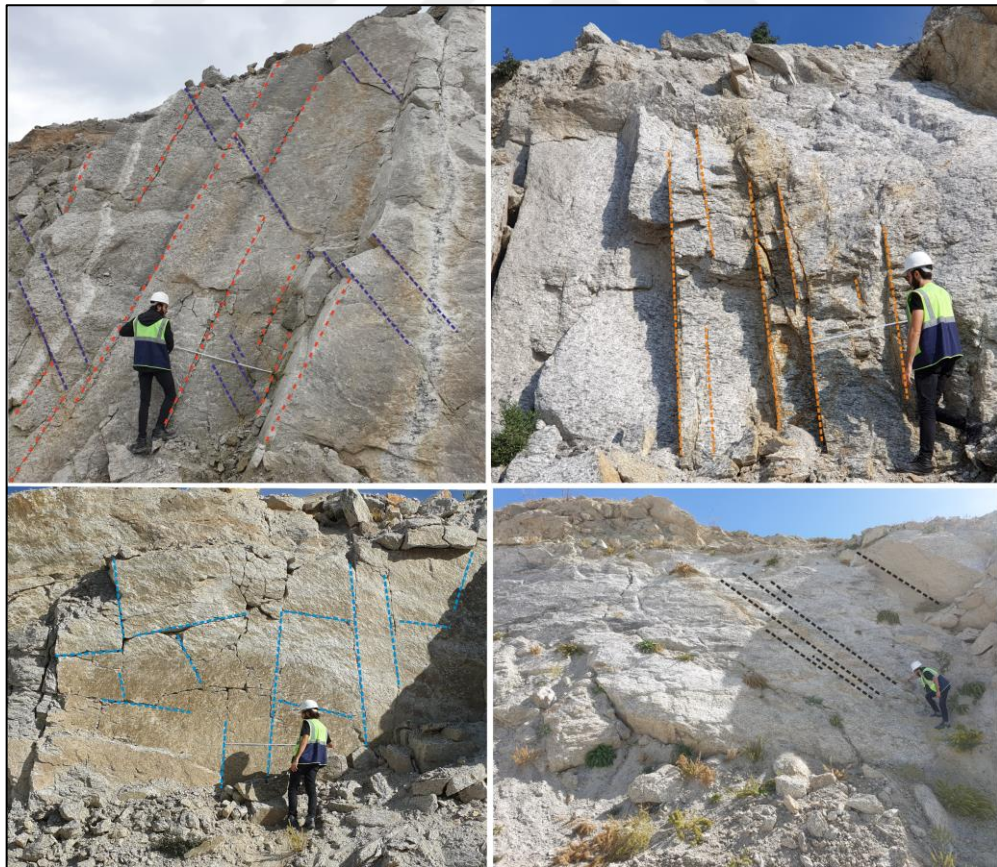
The frequency of discontinuities affects the strength of the rock mass as well as a factor that causes instability problems. In this thesis study, the distance between the discontinuities and the number of repeating discontinuities were recorded by measuring the tape measure taken perpendicular to the discontinuities in the slopes at the observation points (Figure 4.9). Since there are discontinuities with many different orientations in the eastern part of this quarry, the frequency of these discontinuities also varies (Figure 4.9). The distance between the discontinuities, which varies from region to region, varies between 1 cm and 1 meter. The distances between these discontinuity walls, which vary widely, formed a parameter that directly affects the instability mechanism in this quarry where discontinuity-controlled failures occur. Since these distances between the discontinuity walls are also effective in the formation of blocks, it has been determined that as the distance between the discontinuities decreases, the probability of failure increases and creates a danger.

Figure 4.9 Varying distances between discontinuity walls on slopes at different observation points (Personal archive, 2021)

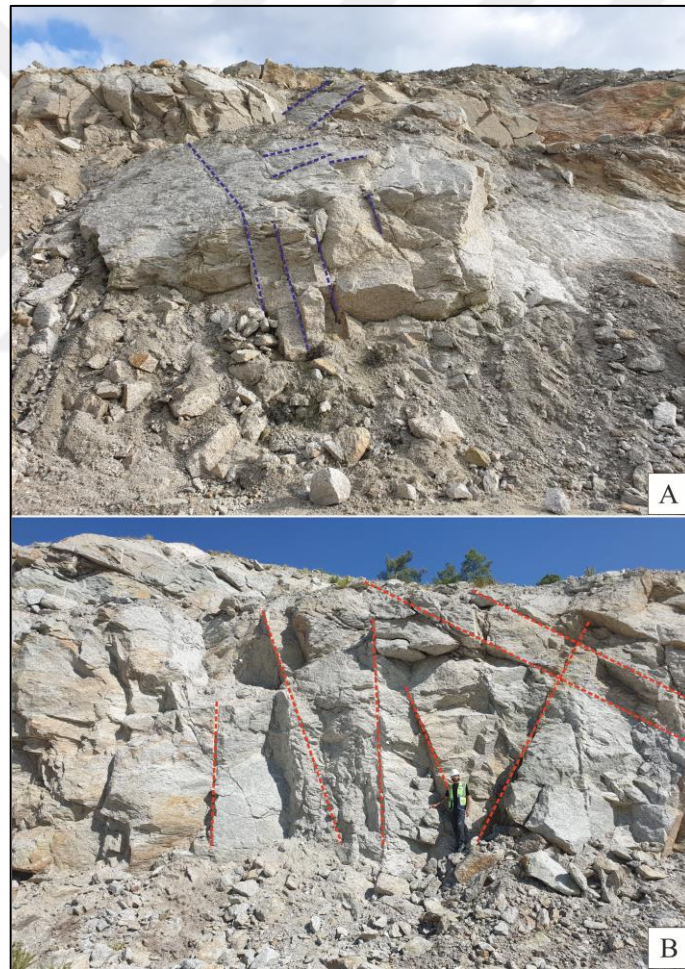
The continuity of the discontinuities on the slopes at the observation points were also recorded in the Scan-Line measurements made in this open field. These discontinuity planes, which offer continuity in a wide range as in the frequency of discontinuity, are an element that should not be ignored in stability problems. It was determined that the continuity of the discontinuities in the examined slopes exceeded the bench length by 1 meter and reached 25-30 meters. The field view of these discontinuity planes that offer continuity at many different distances is given in Figure 4.10. For this reason, considering the classification suggested by ISRM (2007), the continuity of these discontinuities was determined as "very high continuous".

Figure 4.10 Persistence of discontinuities on different slopes; (A) Discontinuities with approximately 1-3 meters of persistence, (B) Discontinuities with approximately 5-10 meters of persistence. (*Slope height: ~10m*) (Personal archive, 2021)

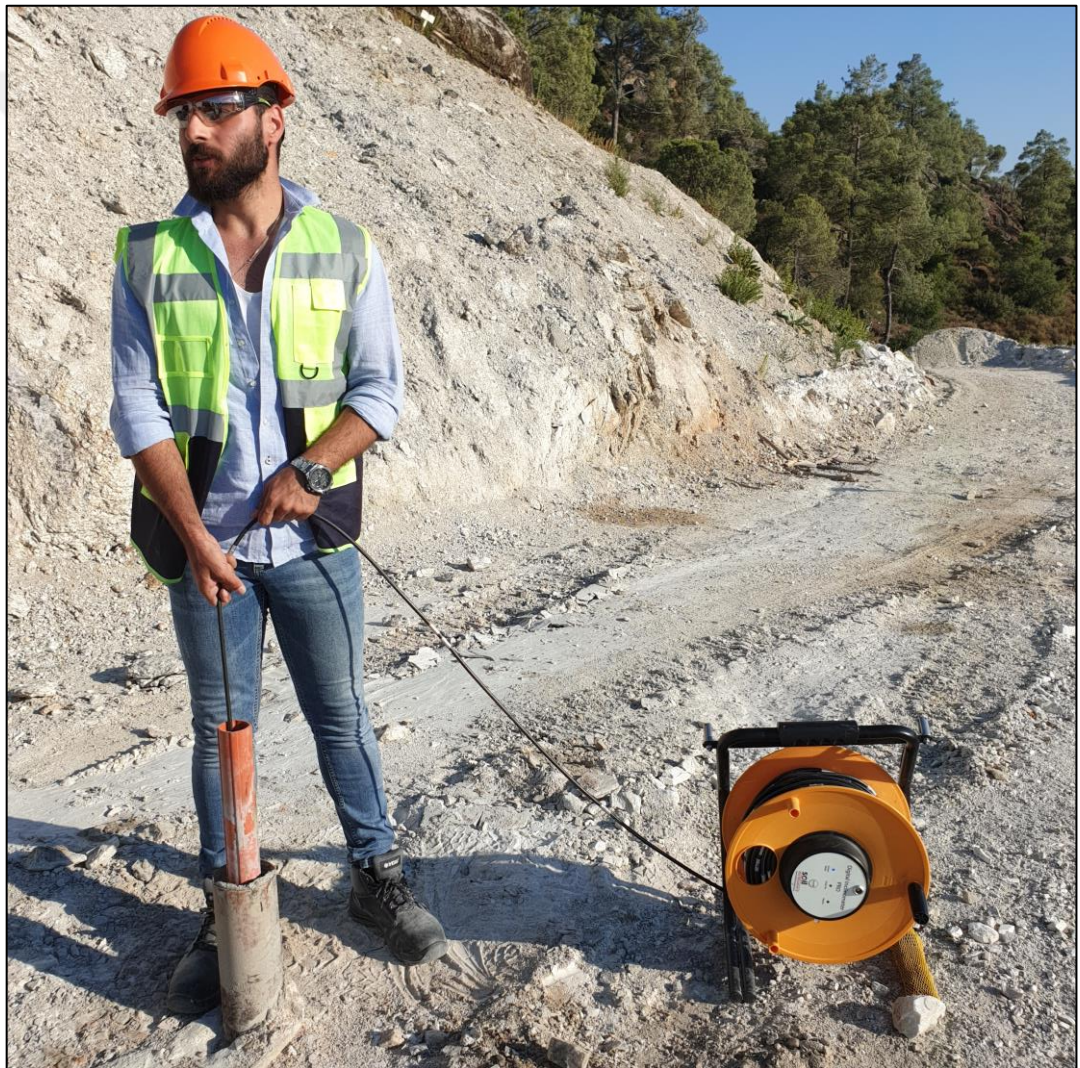
There is an inclinometer well located in the eastern part of the open pit and a 52 meters deep sounding drilled from the same point. The data of this inclinometer set up for motion monitoring are survey regularly (Figure 4.15).

Figure 4.15 The inclinometer hole located at 540 elevation in an open pit and its survey (Personal archive, 2021)

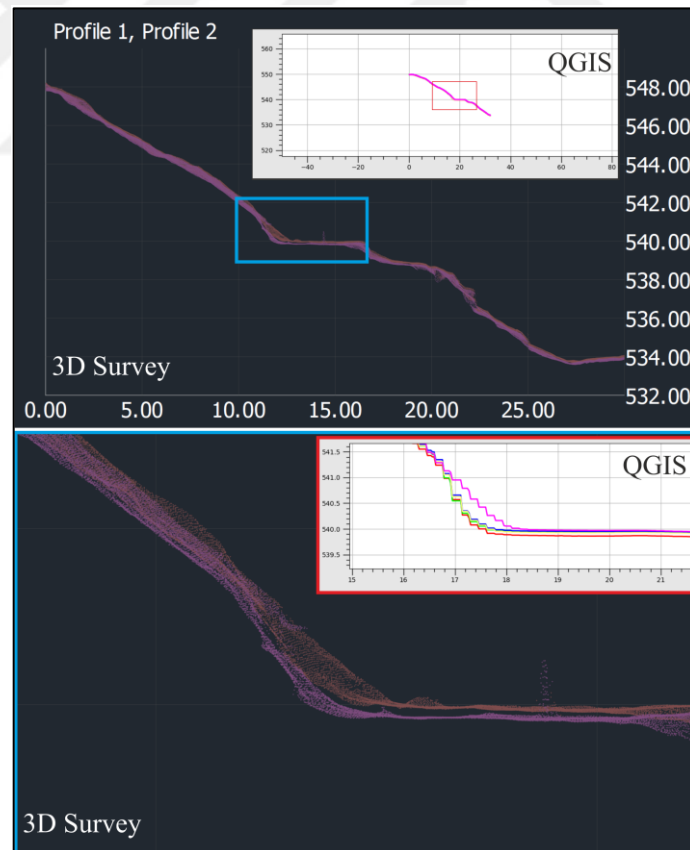
Afterwards, this 10mm displacement observed in the inclinometer data and surface failure in the slope located on the upper part of the stress crack in the drilling location were determined. Geometry distortion (topographic change) due to this failure deformation was detected both by superimposing all the Digital Elevation Models obtained from the UAV flights during the study period and in the topographic cross section taken from the point cloud of the first and last day (4.20). If we examine the geological unit in this slope where failure has taken place, it can be defined as a weathered gneiss mass that has lost its rock feature, is accepted as a continuous material and has undergone ground structure. Therefore, the cohesion (c) value of this material decreased and disappeared with the effect of environmental factors and geomechanical properties. Depending on the decreasing cohesion value, failure occurred by undergoing a displacement of about 40 cm in the horizontal distance. This event has been accepted as one of the parameters that prepare the environment for slope failures (slidings) in this open pit (generally in the eastern part).

Figure 4.20 The probable sliding circle drawn between the stress cracks observed between the 540th and 512th elevation, based on the drilling and inclinometer data

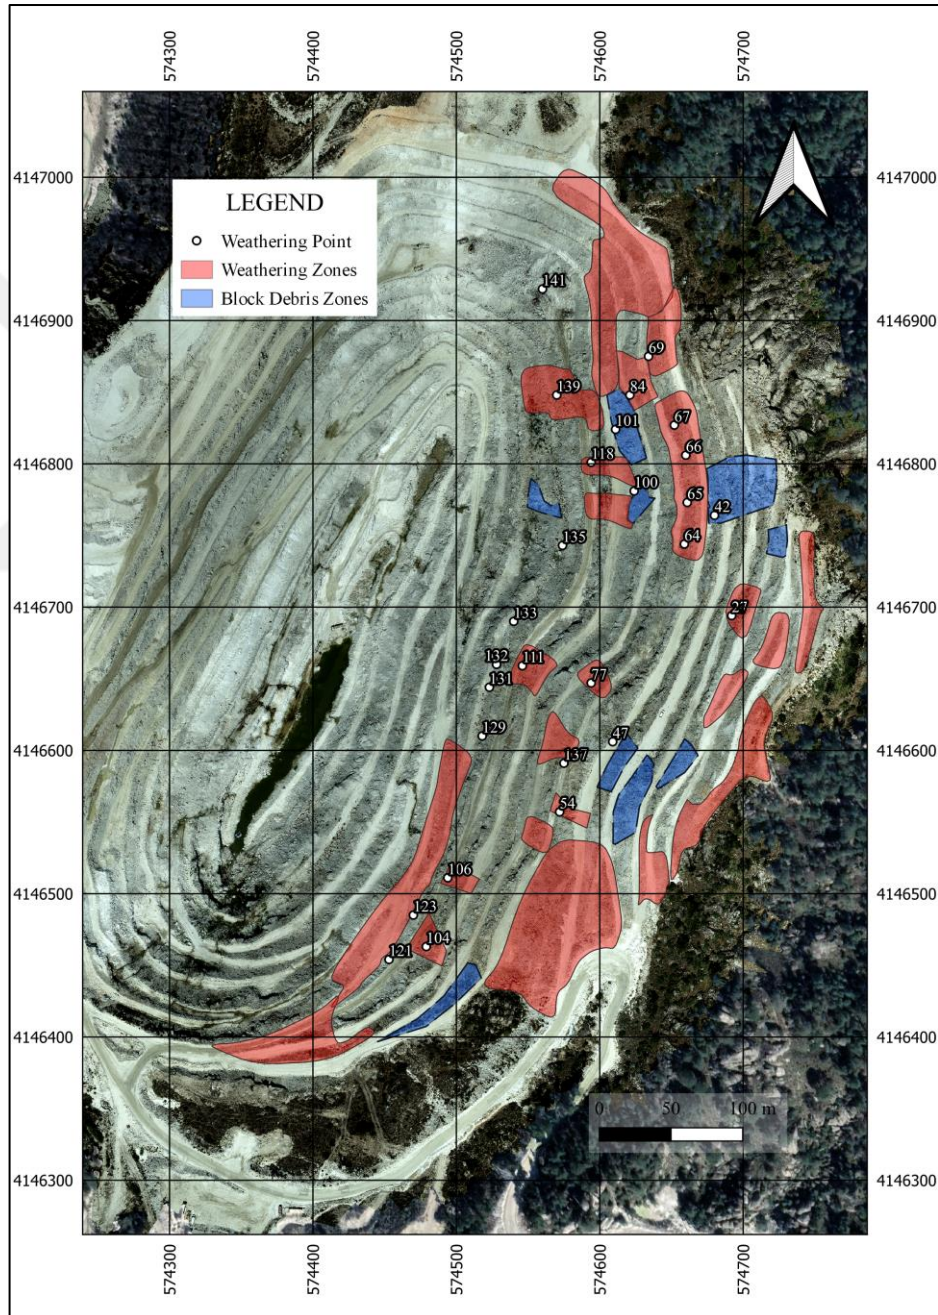
In this section, the weathering and alteration of the slopes at the observation points will be discussed. In the observations made at 141 points, these observations were recorded as weathering points due to the weathering of the slopes at 27 points and some of them losing their rock characteristics. (Fig. 5.1).

Figure 5.1 Map of the study area showing the weathering zones and block debris

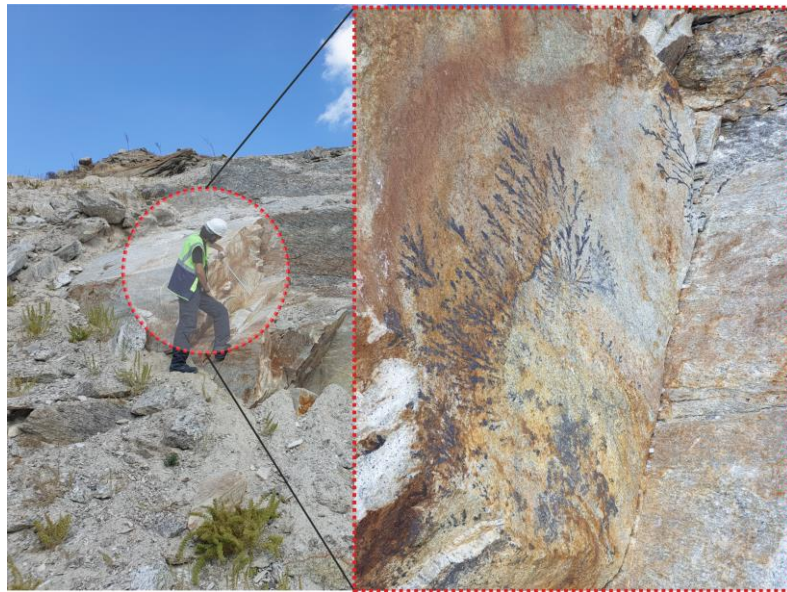
As a result of the meeting of hydrothermal fluids with the rock mass, which developed due to faulting, oxidation occurred on the rock surface and it was observed that the strength of the rock increased at these points. The fact that the UCS values obtained from the Schmidt hammer experiments in these regions were also high, formed a supporting element for this phenomenon. In addition, the presence of a structural element such as the Yarenalan Fault in the study area also supports the faulting event. The presence of hydrothermal fluids released due to faulting is supported by the dendritic structure formed in the rock wall in the image in Figure 5.4.

Figure 5.4 Dendritic traces formed by the hydrothermal fluid located in the alteration zone and exposed due to faulting (Personal archive, 2021)

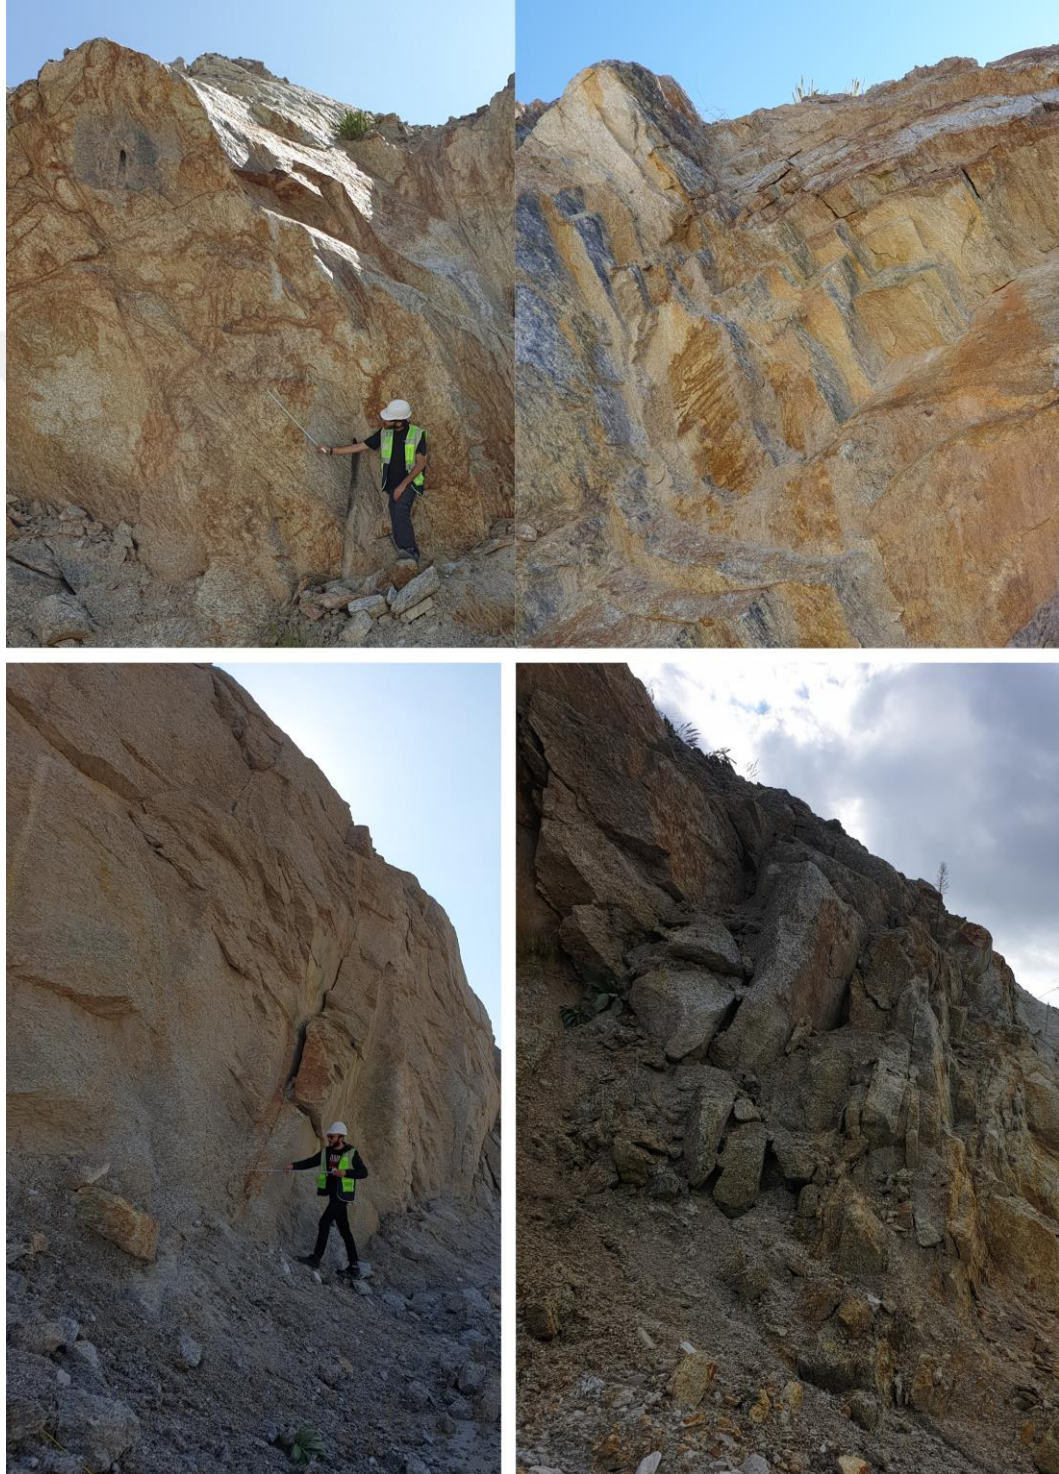
Some of the rock slopes that have oxidized surface and rusted orange tones in the slopes observed in the study area are shown in Figure 5.5. These alteration zones caused by hydrothermal fluids and the appearance of the rocks with this orange surface, which were determined during the observations, are given in Figure 5.6.

Figure 5.5 Rock slopes with oxidized surfaces (Personal archive, 2021)

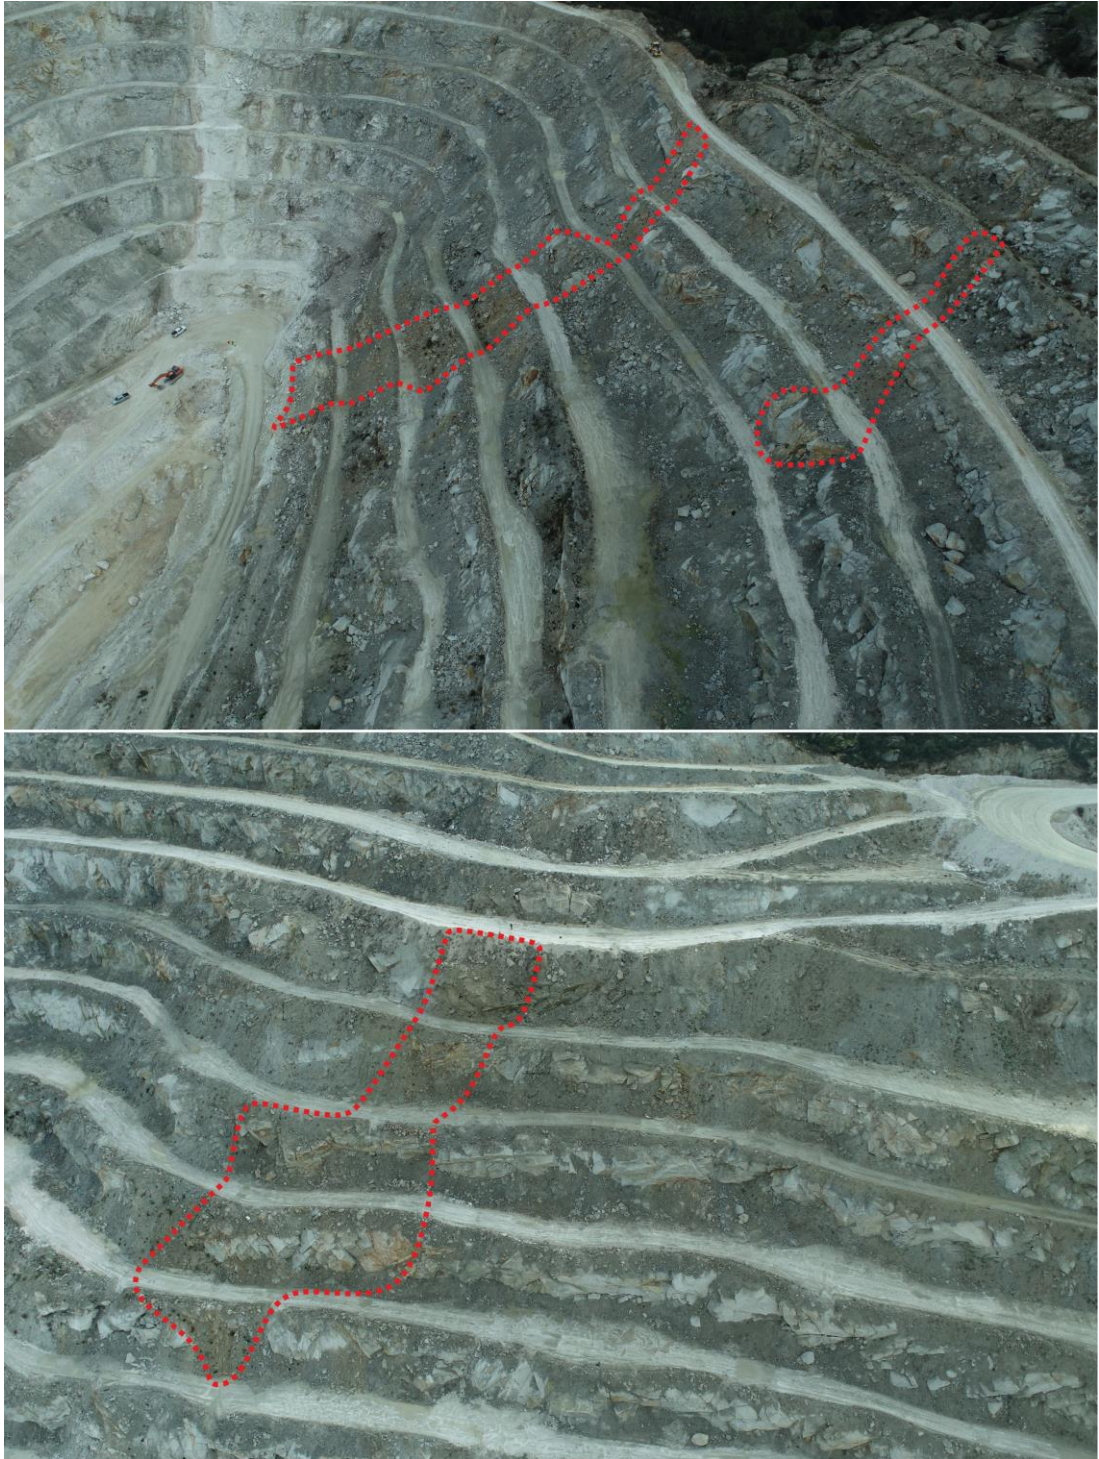
Figure 5.6 Oxide zones seen from angled aerial photographs (Personal archive, 2021)

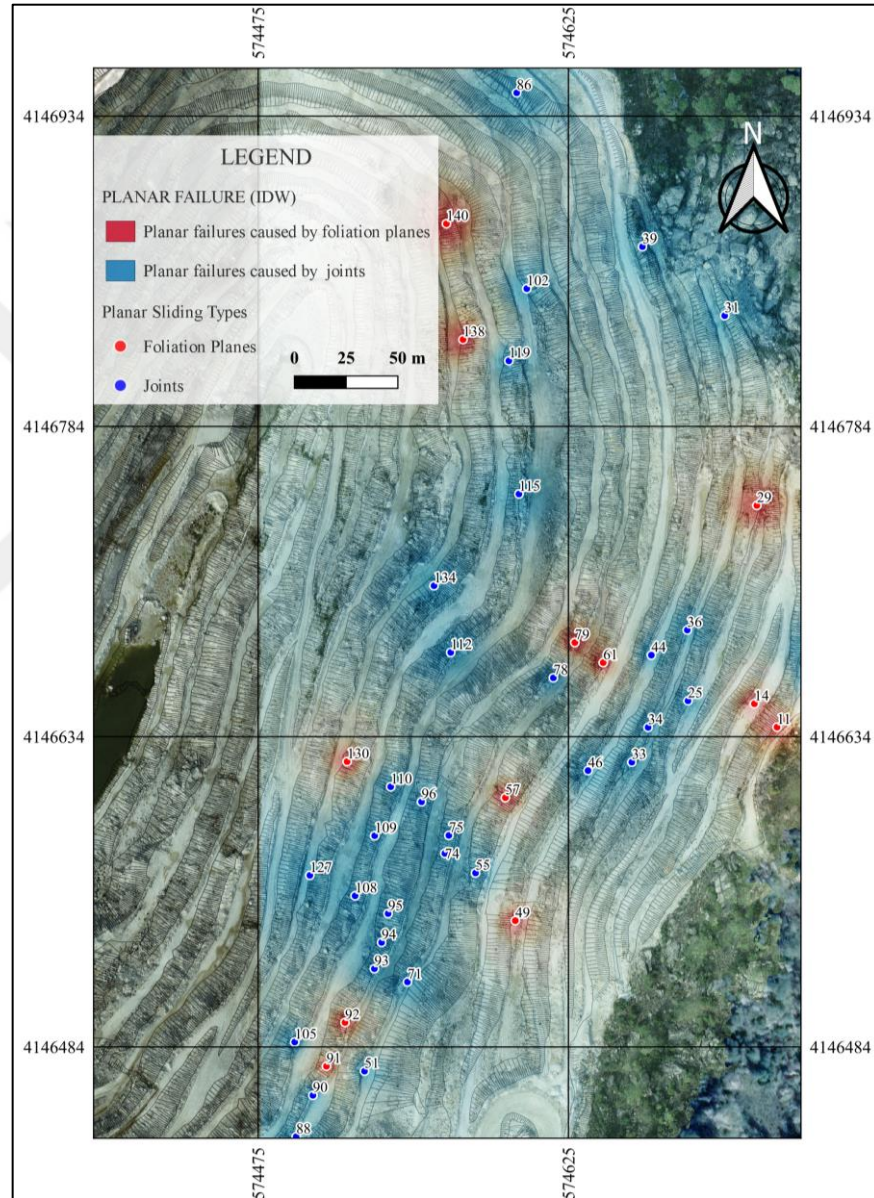
Planar sliding failures in the study area are examined under two sub-titles. These; They are planar slidings caused by foliation planes inclined out of slope and planar slidings caused by structural discontinuity planes formed due to tectonic movements. Foliation planes caused 12 of the 45 planar sliding failures in the 21% slice and the remaining 33 were caused by other joint sets. The distribution of these factors that cause planar sliding in the study area is given in the thematic map created on the orthophoto in Figure 6.2.

Figure 6.2 Thematic map of planar sliding failures determined by the kinematic analysis technique in the study area and the factors caused by these failures

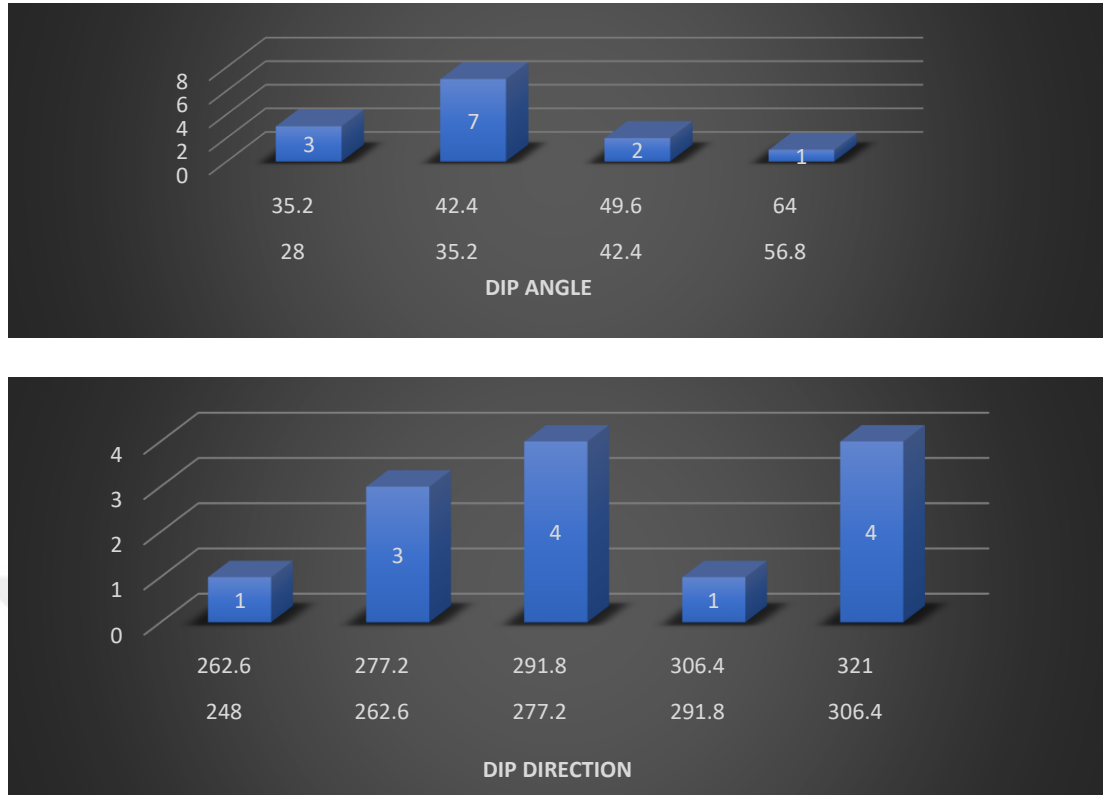
Not all of these foliation planes, which have an average 45/320 orientation, cause shear failures. The mean orientation of the foliation planes causing the sliding was determined as 39/290. At the same time, the orientation of 12 slopes, which have slidings caused by foliation planes, was determined as 51/292 on average. The angular distribution graph of these foliation planes, which cause planar slidings, depending on the inclination angle/inclination direction is presented in the graph in Figure 6.4.

Figure 6.4 Graph showing the angular distribution of the orientation of foliation planes causing planar sliding

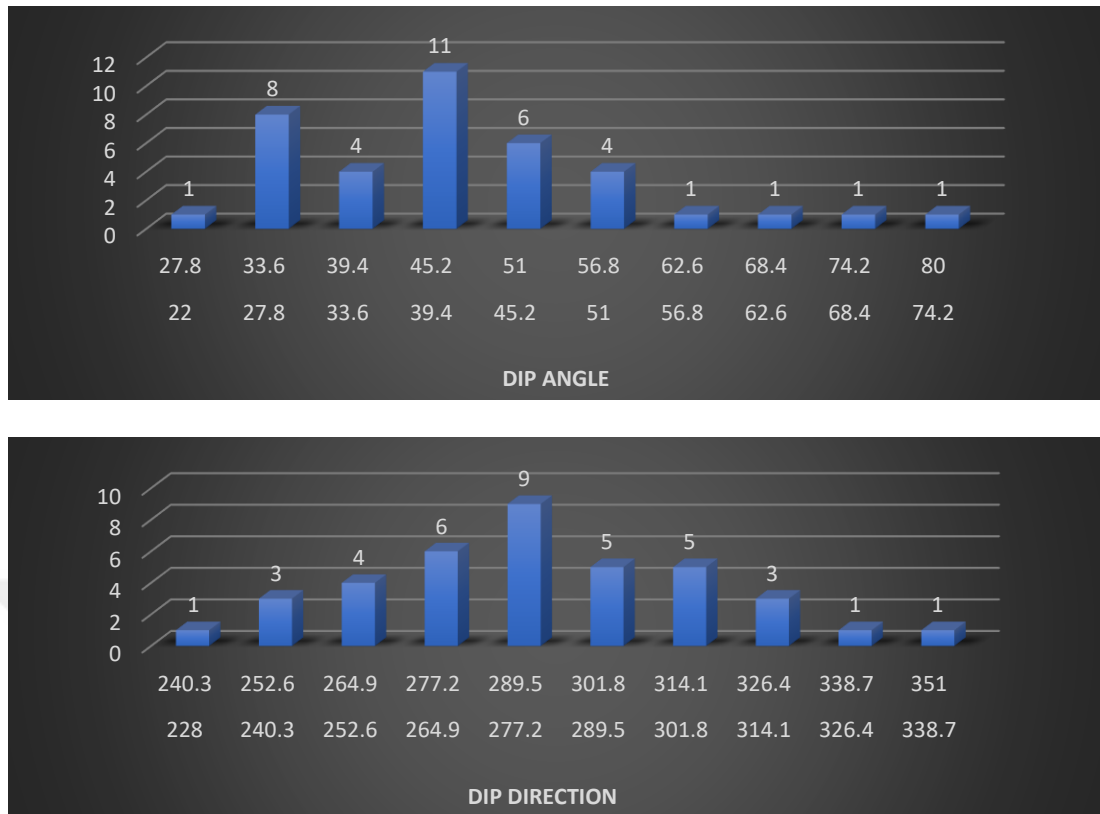
Figure 6.6 Graph showing the angular distribution of the orientation of discontinuity planes (joints) causing planar sliding

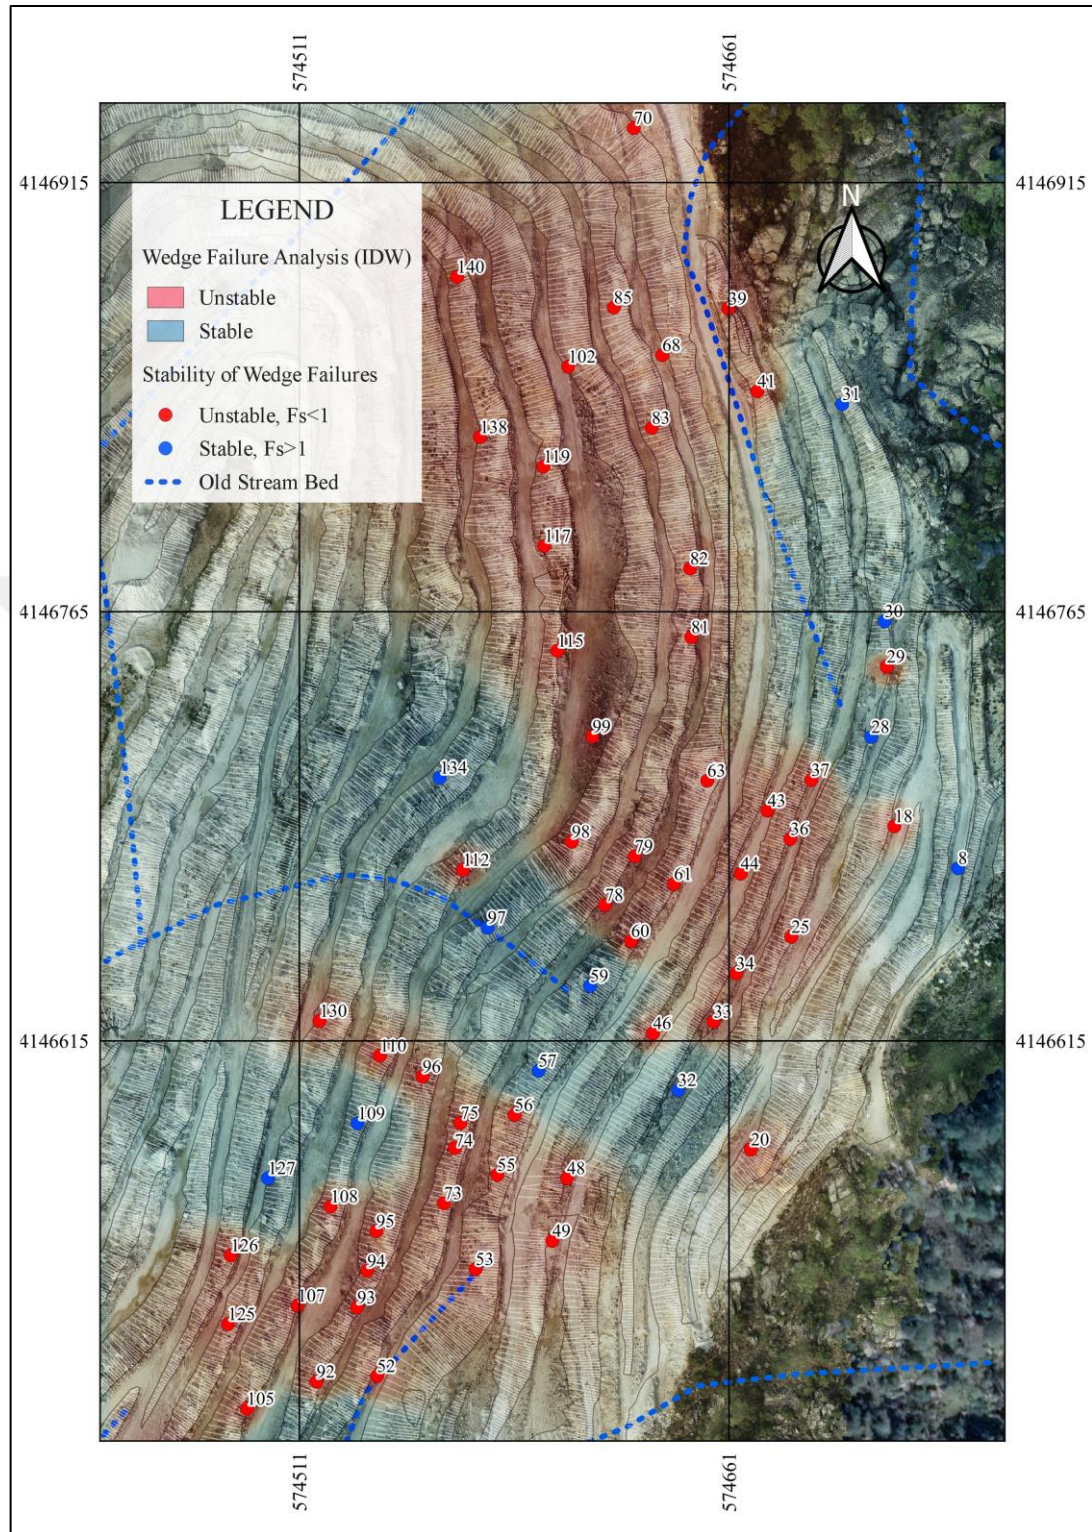
determined. These wedge-type mass movements determined by the kinematic analysis technique, as well as the analytical technique, were calculated with the help of the formula given in Equation 1 (Wyllie & Mah., 2004). According to the result of this factor of safety (FS) calculated by analytical method, 14 of 72 wedge-type sliding were determined as stable ($FS > 1$) and 58 as unstable ($FS < 1$). The thematic presentation of these identified areas is shown on the map in Figure 6.7. As seen in this map, old stream beds limited the stability of wedge failures. In other words, wedge-type failures on the lines of old stream beds are generally stable.

Figure 6.7 The safety factor calculated using the analytical method of wedge-type failures, their stability and their relationship with old stream beds

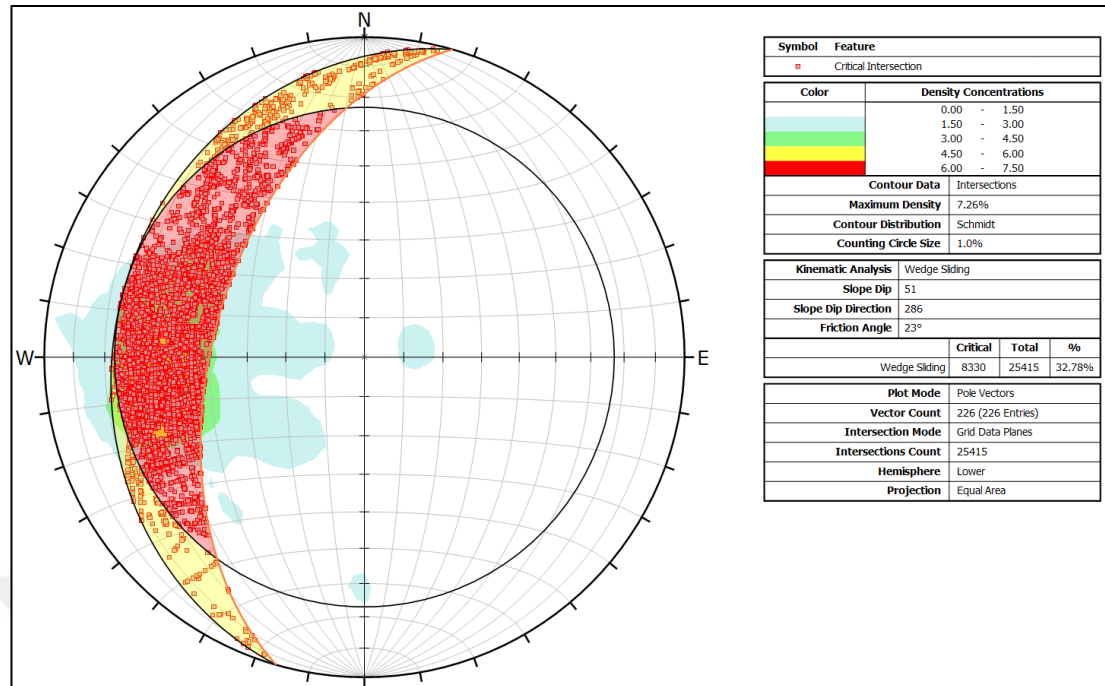
Wedge type sliding failures determined by kinematic analysis technique in the benched slopes in the eastern part of the open pit were examined within the framework of angular relations as in other sliding types. The divergence and direction of the intersection point of these planes forming 72 wedges were determined as 268/51. Likewise, the average orientation of the slopes where wedge failures occur was determined as 51/286. The result of the kinematic analysis using all these planes forming the wedges and the average slope angle is given in Figure 6.9.

Figure 6.9 Kinematic analysis of wedge type sliding using all planes forming the wedge and mean slope orientation

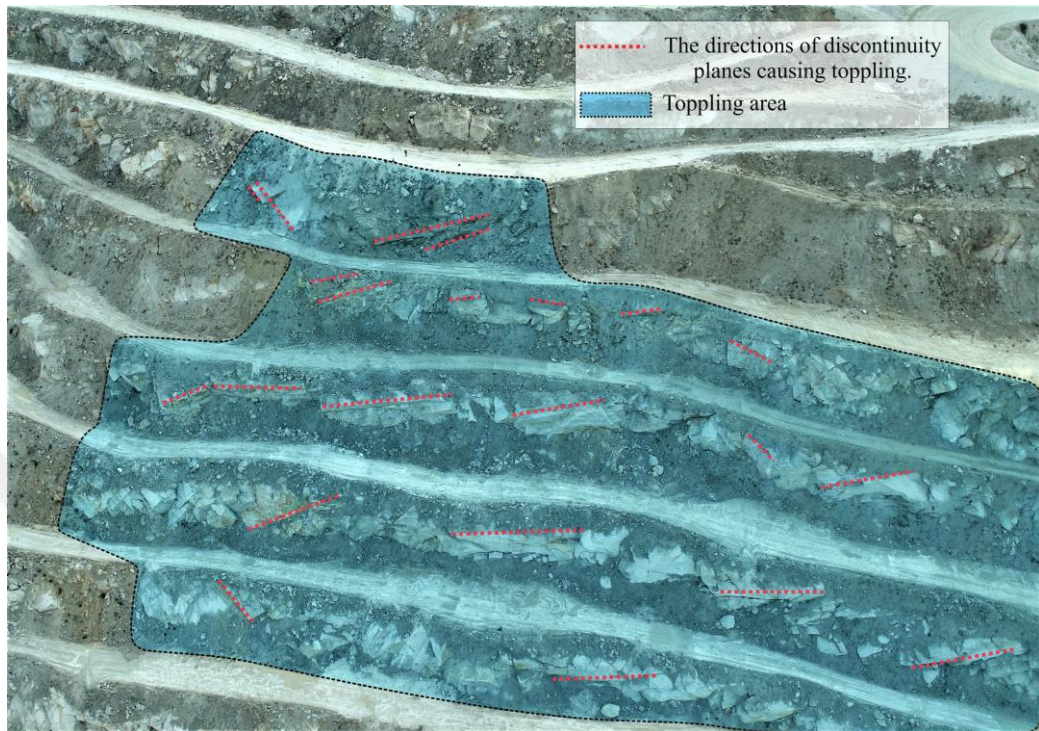
Figure 6.10 Generally the directions of high persistence and high angle discontinuity planes that caused toppling failures (Personal archive, 2021)

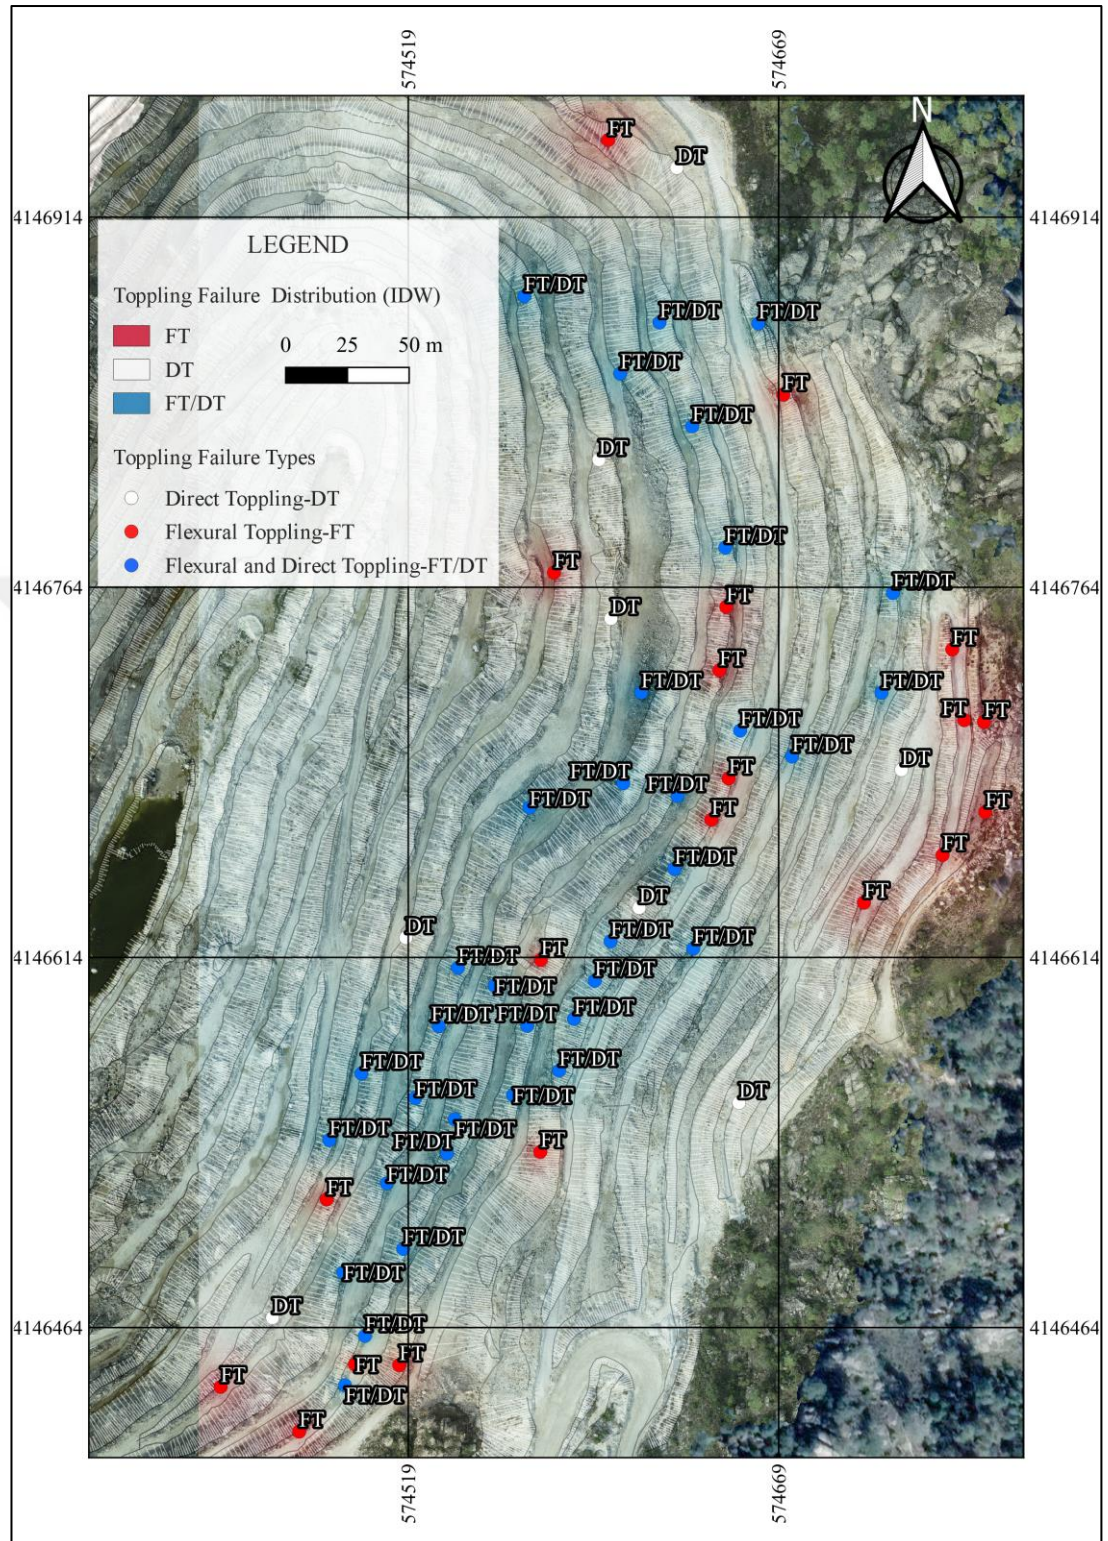
Figure 6.11 Distribution of types of toppling failure in the working area

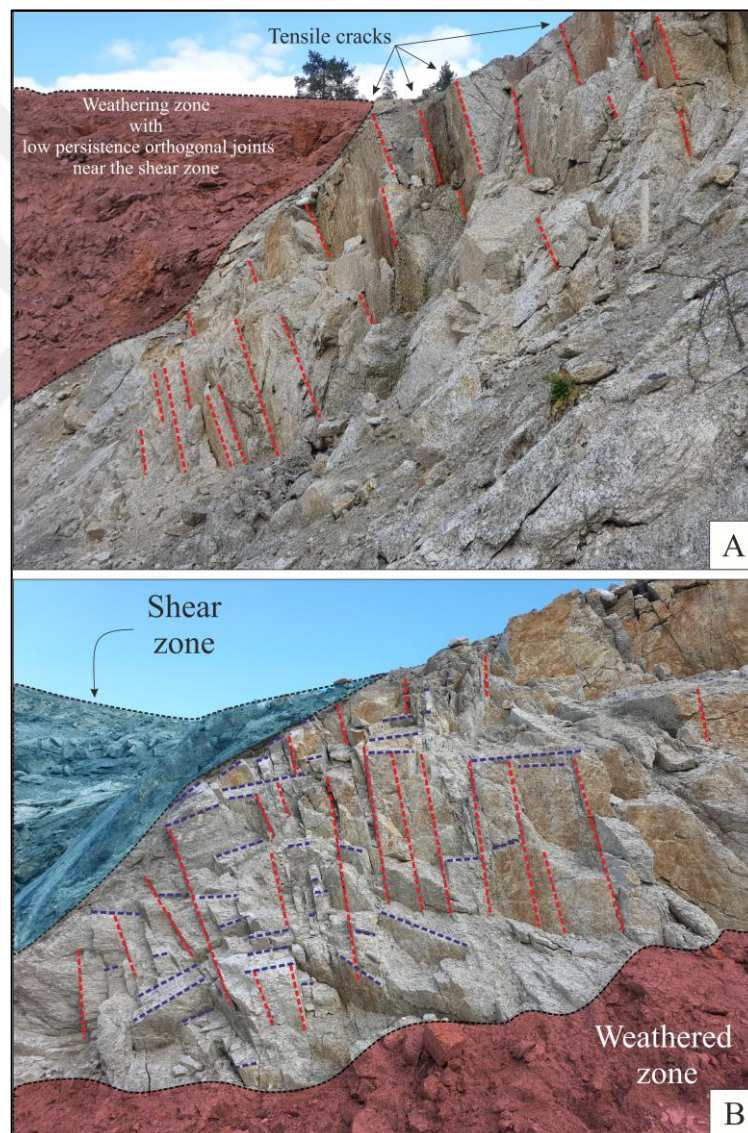
Figure 6.13 Direct toppling field view; (A) High angle discontinuity planes, (B) Sets of discontinuities perpendicular to each other (front view of A)
