**COMPARISON OF KINEMATIC ANALYSIS
RESULTS OBTAINED FROM UNMANNED
AERIAL VEHICLE DATA AND SCAN-LINE
DISCONTINUITY MEASUREMENTS IN THE
GNEISS ROCK SLOPES**

by
Melikhan KARAKAŞ

August, 2021
İZMİR

**A Thesis Submitted to the
Graduate School of Natural and Applied Sciences of Dokuz Eylül University
In Partial Fulfillment of the Requirements for the Degree of Master of Science
in Geological Engineering, Applied Geology Program**

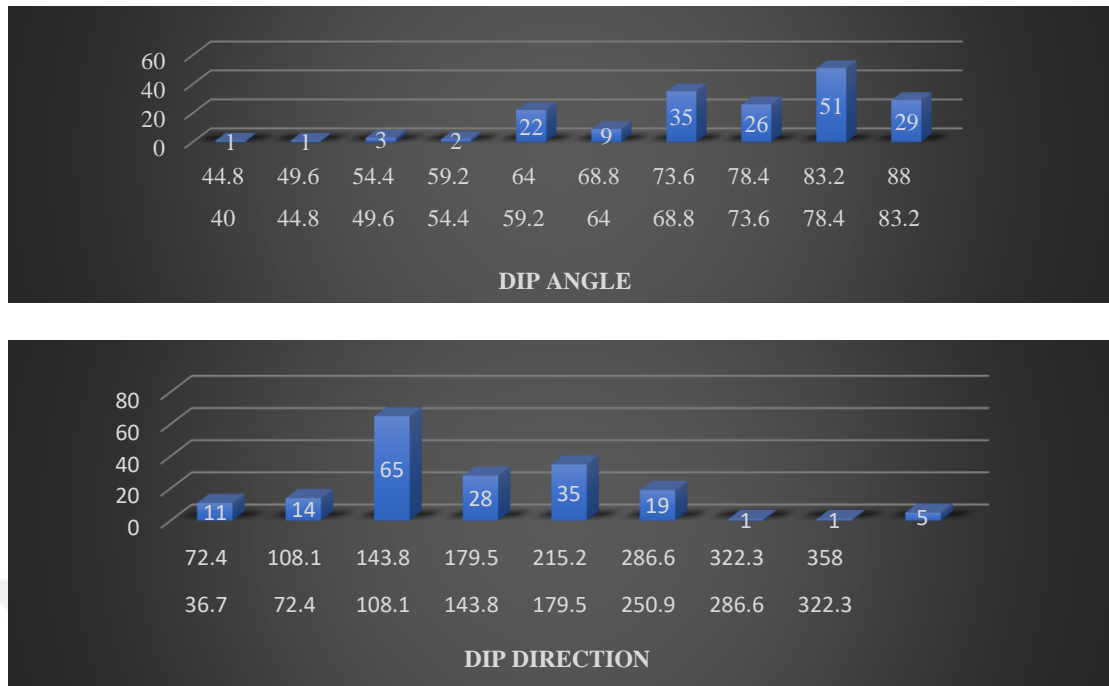
When the angular relationships of the discontinuities (both flexural and direct toppling) that cause toppling failures are examined, the average orientation of these discontinuity planes is determined as $75/093$. It was seen that this determined mean discontinuity orientation belongs to the Set 1 system specified in Table 2. In the kinematic analysis, the average orientation of the slopes where these toppling failures (both flexural and direct toppling) were determined was determined as $50/285$. The angular distributions of these discontinuities are presented in the graph in Figure 6.15.

Figure 6.15 Angular scatter plot of discontinuity planes that cause toppling failures

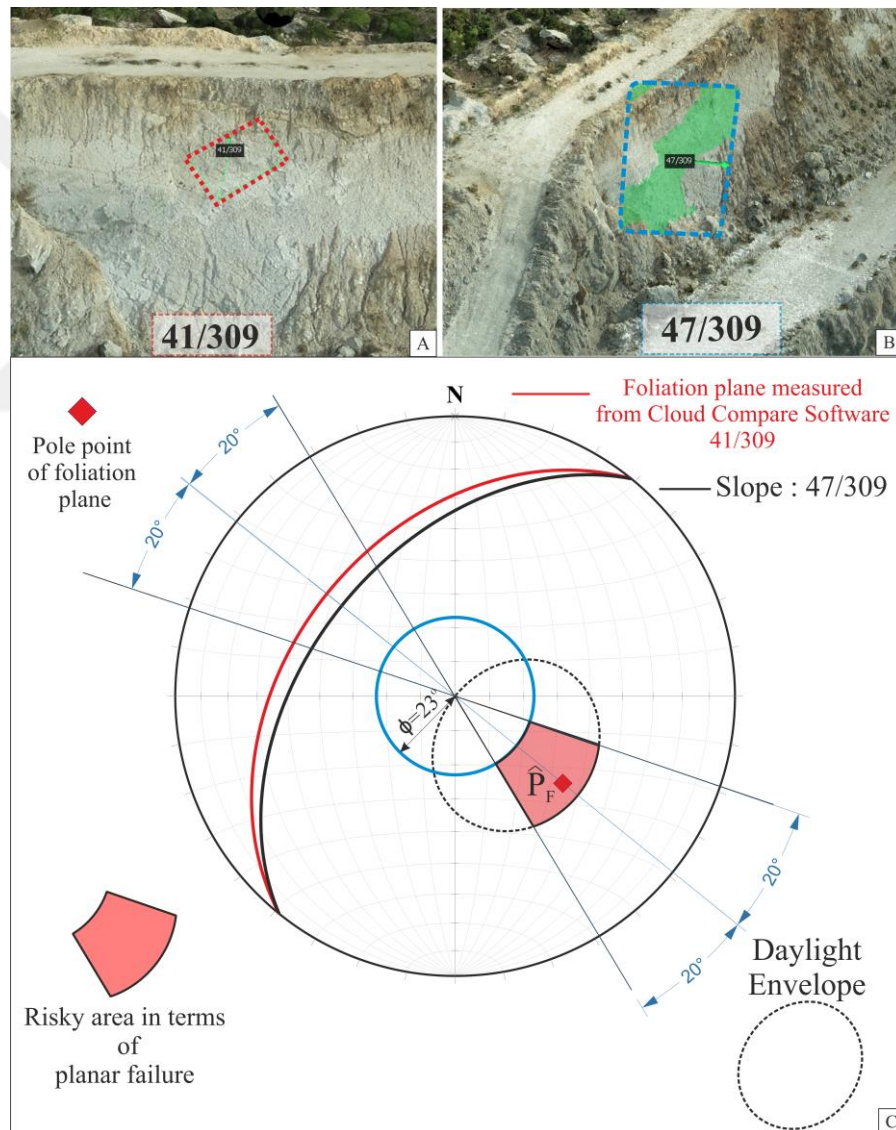
measurements made with the Compass attachment on the same slope and on the same discontinuity plane, these measurements are respectively; It was measured as 47/309 and 41/309. With these measurements, it was determined that there is a dangerous slope in terms of planar sliding failure in the kinematic analysis performed with the Dips V 7.016 (2019) software.

Figure 7.6 Planar sliding failure by remote sensing; (A) Foliation plane orientation, (B) Slope orientation (C) Kinematic analysis of planar sliding

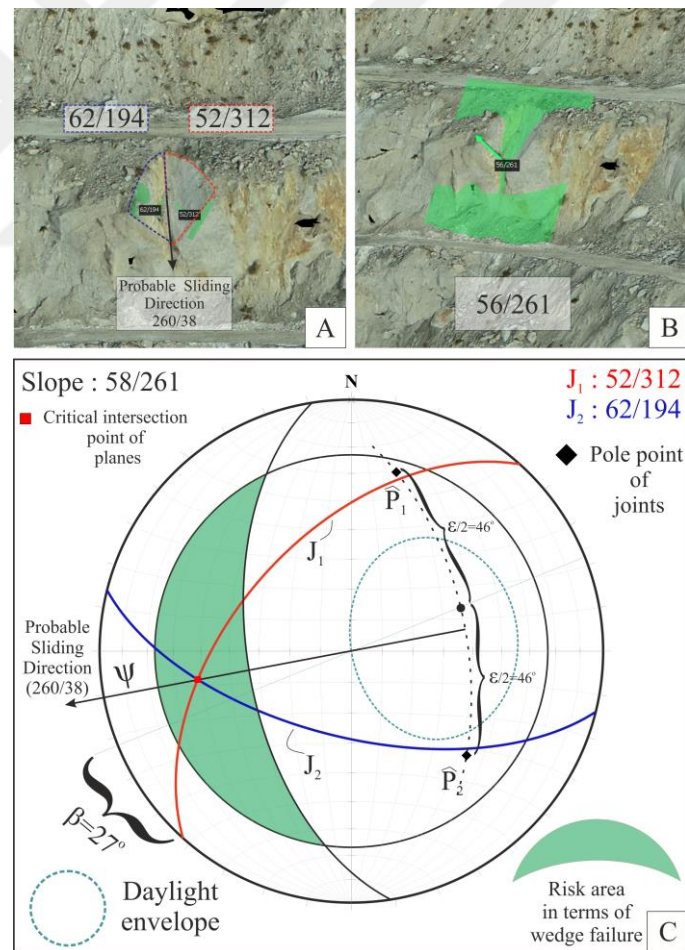
Under this heading, the orientation of two discontinuity planes located very close to the top of the slope (approximately 8 m above the ground (berm) and intersecting could not be measured with the conventional method (Brunton type geologist compass). The orientation of the slope and intersecting discontinuity planes at this observation point, where a large wedge block formation is observed, was obtained with the “Compass” plug-in in Cloud Compare software. These obtained orientations were analyzed using Dips V 7.016 (2019) software and it was determined that they pose a potential danger in terms of wedge-type sliding failure. In addition, the K factor and the factor of safety (FoS) in this wedge failure were calculated and stated in Equation 7.1. The images and kinematic analysis of the software on the screen of these measurements are given in Figure 7.7.

Figure 7.7 Wedge sliding failure with remote sensing; (A) Orientation of planes in the wedge block, (B) Orientation of the slope, (C) Kinematic analysis of wedge-type sliding

According to this solution, the factor of safety (Fs) was calculated as 0.340. When this factor is taken into account, this slope is not safe in terms of wedge-type sliding failure, since $Fs < 1$.

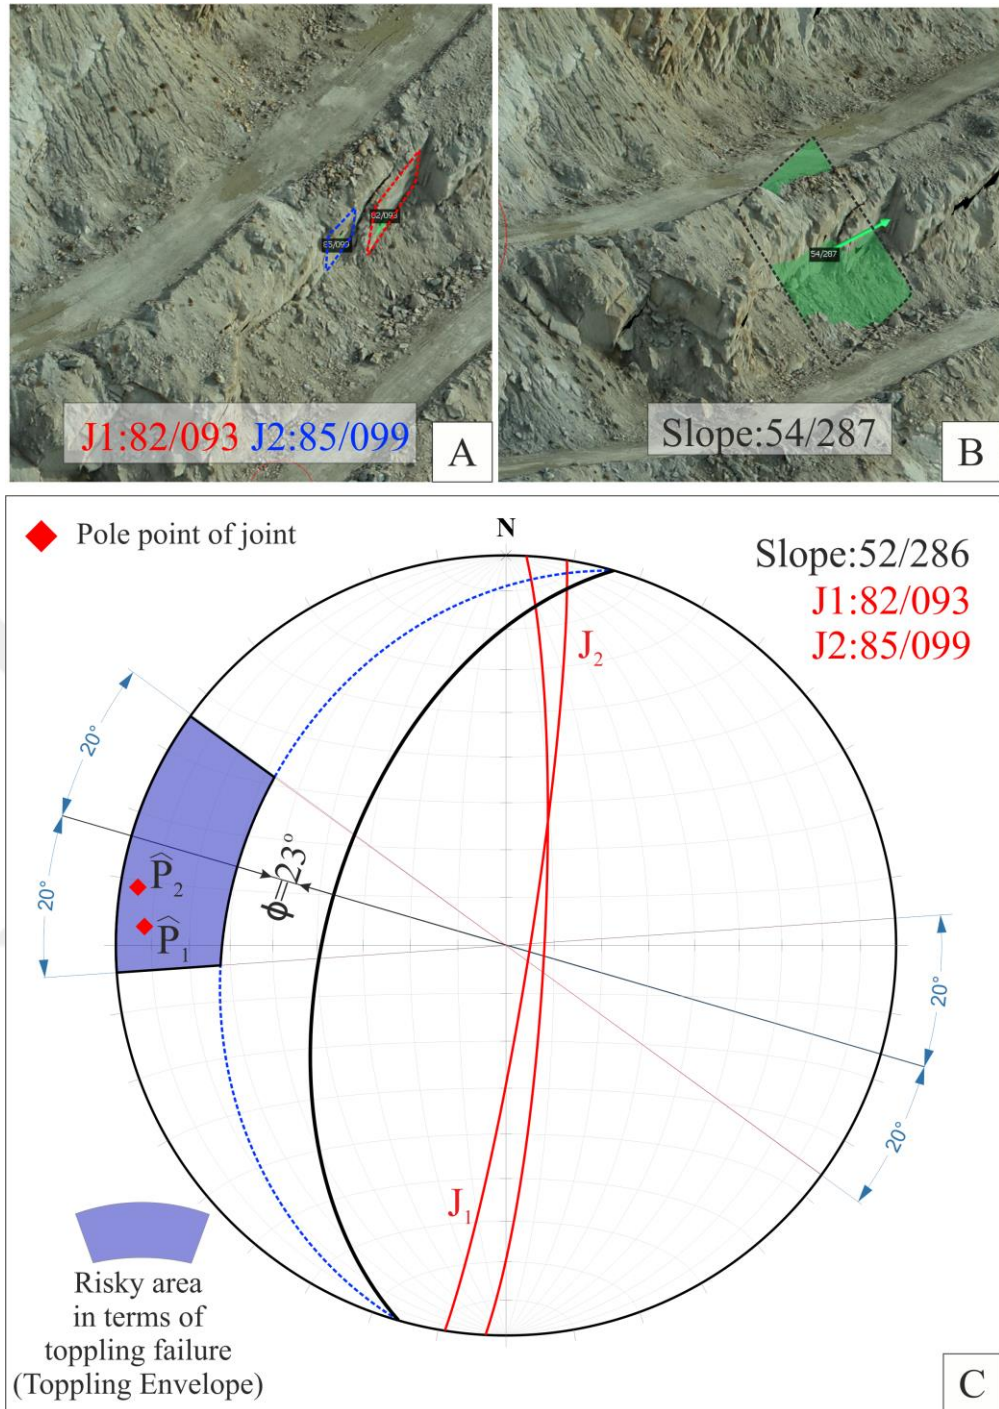
As seen in the image given in Figure 7.8, the orientation of these discontinuities in the region close to the toppling region is quite similar to the orientation of the discontinuity planes in the toppling failure indicated in Figure 6.12.

Figure 7.8 Toppling type failure (Flexural Toppling) with remote sensing; (A) Orientation of planes, (B) Orientation of the slope, (C) Kinematic analysis of flexural toppling type failure

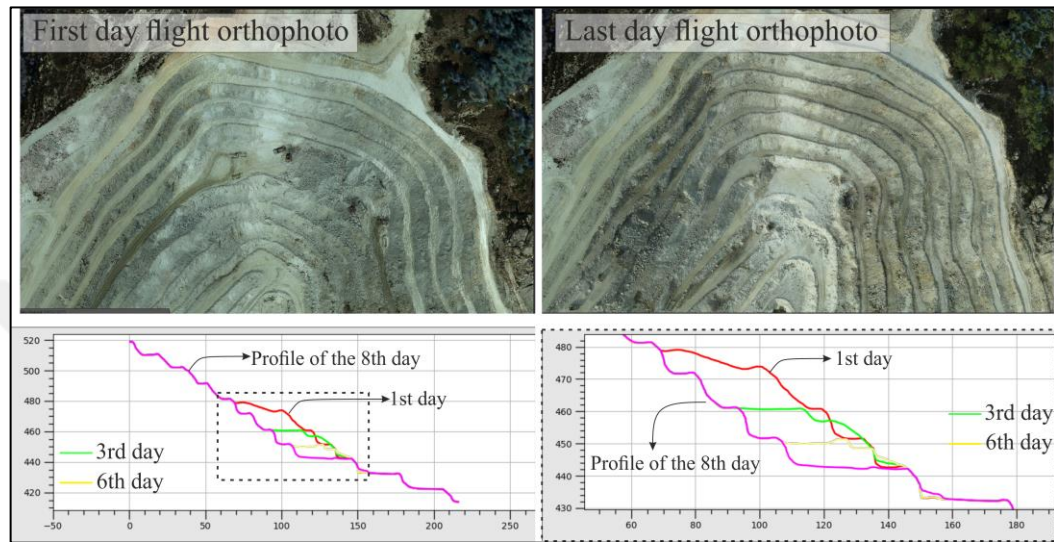
taking sections in the region (north of the study area) where the grading studies were carried out for the production activities of this quarry, which is located outside the study area in the same enterprise (Figure 7.10). As a result of the cross-sections taken in the production area, a difference was observed and the same method was applied for the regions in the heat map (Figure 7.11).

Figure 7.10 The difference seen in the region where the production and excavation activities continue, according to the topographic cross-sections taken from the DEM obtained from the flights on the first and last day

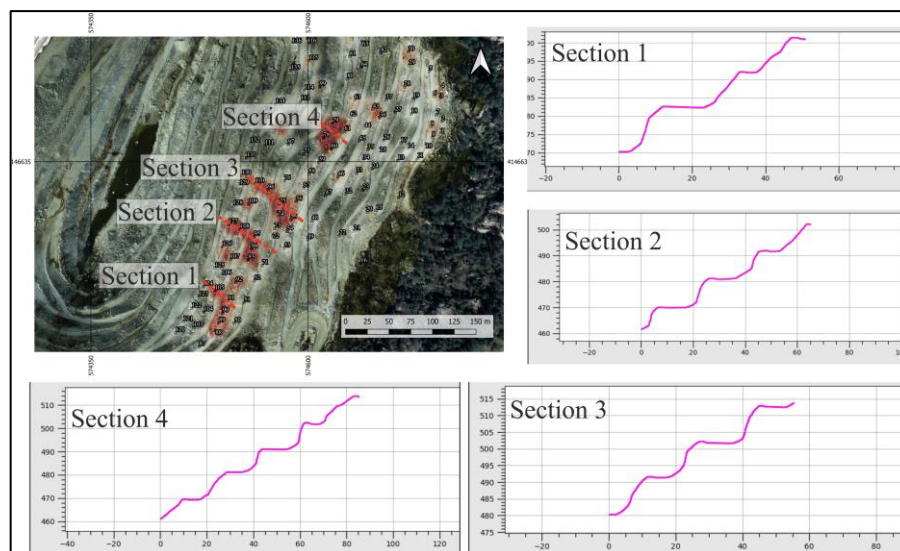
Figure 7.11 Topographical cross-sections taken from the regions where mass movements are concentrated by means of the Digital Elevation Model

As can be seen from a total of 4 cross-sections taken; No topographic changes (slopes) were observed in these regions due to failures (slidings). As the reason why the slope geometry did not change due to the slides despite the mass movements, which are numerous in these regions; Since the effect of water on failures is known, that is, the increase in the groundwater level during the rainy period and the saturation of the slopes, accelerating the failures (slidings) were mentioned in the relevant sections of this thesis. Since the study was carried out in the dry period, instability could not be determined from this point of view, since the groundwater level was low and did not affect the slides. Another factor is that, due to the cessation of production in this region where failures occurred, controlled blasting was not carried out and the lack of vibration (wave) caused by these blasting stopped slope failures in a controlled manner. Considering all these parameters, no significant (topographic change) change due to the slope geometry due to failures (slidings) was observed during the study period in the eastern part of the Open Albite Quarry (the problem area) and the slopes were considered stable in this respect.
